Reason of destruction side frame of the trolley

Explanation of the cause destruction of the side frame trolley during operation of the railway transport.

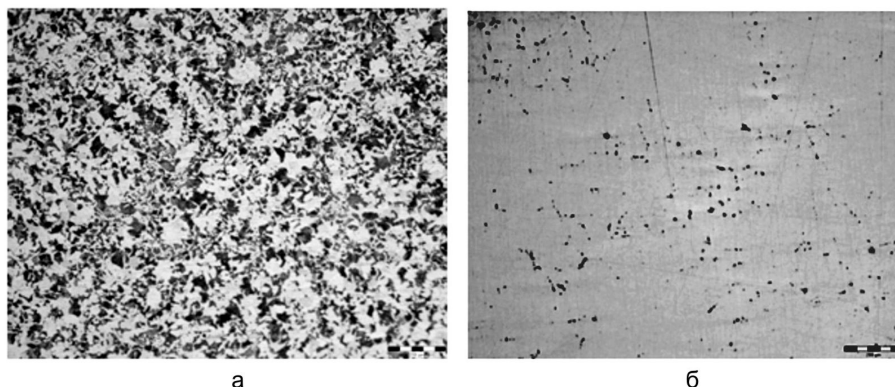
Based on a comprehensive study metal of the side frame trolley, the steel according to non-metallic inclusions (Fig. 1a), microstructure (Fig. 1b), and mechanical characteristics generally met the requirements of OST 32.183-2001.

Fig. 1. Microstructure of steel (a), line and point nitrides (b).

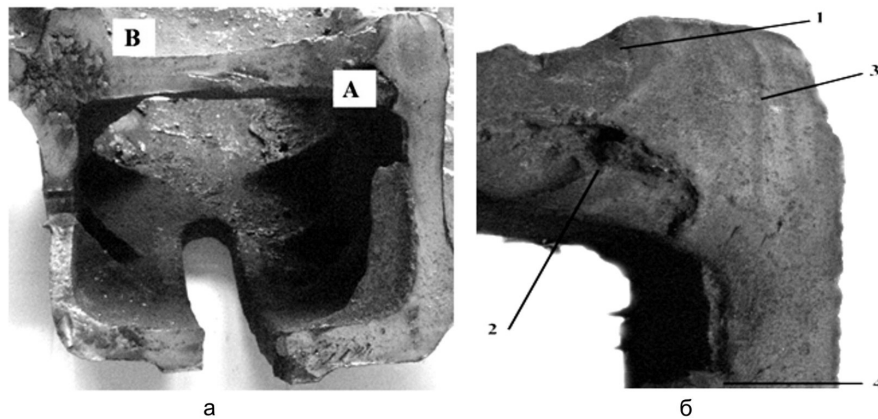
A general view of the fracture surface of the beam is shown in Fig.2a. Based on the analysis of fatigue lines location and the orientation of the formed steps [2, 4], the surface defect of foundry origin such as a blockage should be considered the focus of crack initiation (designation 2, Fig. 2b). A detailed study showed that this defect has exit to the outer surface of the side frame. The observed steps (designation 1, Fig. 2b) formed near the indicated inclusion and their gradual disappearance indicate the growth of a fatigue crack along several surfaces [2]. Moreover, after combining individual fronts into one, the fracture process develops with increasing speed, which is confirmed by an increase in the distance between steps of the fatigue crack (designation 3, Fig. 2b). After reducing the constructive strength of the side frame from the fatigue crack, conditions begin to create the transition crack growth process to the next stage. Given that after the completion of incubation phase of the crack growth, which corresponds to low values of the stress intensity factor at

Fig. 2. General view of the fracture surface side frame (a) and selected area (A) with place of origin fatigue crack (b): 1 - steps, 2 - non-metallic inclusion, 3 - front of the fatigue crack, 4 - signs of static fracture.

The asymmetric location of the crack nucleation center relative to the side walls of the frame (Fig. 2a) should lead to the differences in crack growth on the opposite walls, which was actually confirmed by the traces from the front of fatigue crack. In a first approximation, it can be assumed that the simultaneous presence of nonmetallic inclusions and increased metal porosity (symbols 1 and 2, Fig. 3) along the crack propagation path caused a violation of its growth conditions [6]. Similar cases of influence are known from the results of studies of the fracture surfaces [2]. Based on this, as a result of decrease in the constructive strength of the side frame from the presence of pores, the amplitude of cycle quickly reached a level for the transition process of metal fracture to the phase of final dynamic destroy. This is indicated by the presence of steps on the fracture surface and a change in the direction of movement crack front [7].

The cause of fracture side frame of the trolley is crack of fatigue in the corner of region radius R55 on the inner side of the supporting surface from the presence of a non-metallic inclusion, with a size significantly exceeding regulatory restrictions.

Thus, the evidence of formation and development destruction indicates that improving the operational safety of the side frame of the wagon trolley is possible due to the improvement of casting technology. At the same time, the development of amendments to the normative documentation to further limit the presence of non-metallic inclusions and pores in the metal should be considered as an additional factor in increasing the life of the side frame.

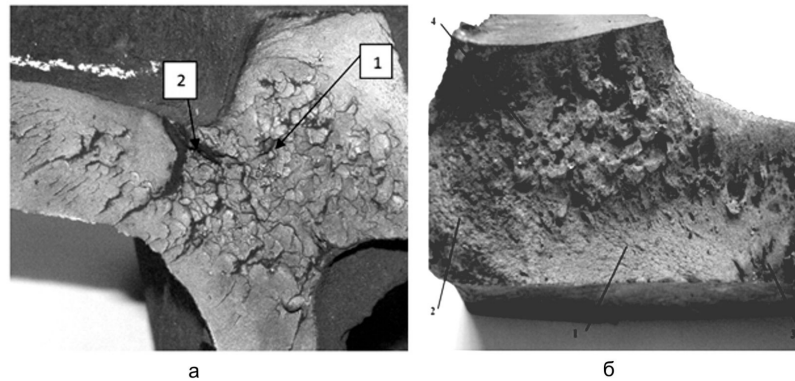
Fig. 3. The fracture surface (region B, Fig. 2a) with an increased concentration of non-metallic inclusions (1) and porosity (2) - (a); brookly pattern (1), facets (2), secondary crack (3) and metal discontinuities (4) - (b).

The presence in a separate volume metal of a side frame of the trolley concentrated porosity and non-metallic inclusions of various nature of origin was the reason for accelerated transition fracture process to the phase of a static destruction.
