REPAIR EXPLOSION CLADDING OF THREADED CHANNEL OF CAR AXLES

Keywords: explosion welding, explosion cladding, car axle, threaded channels, repair, fatigue test

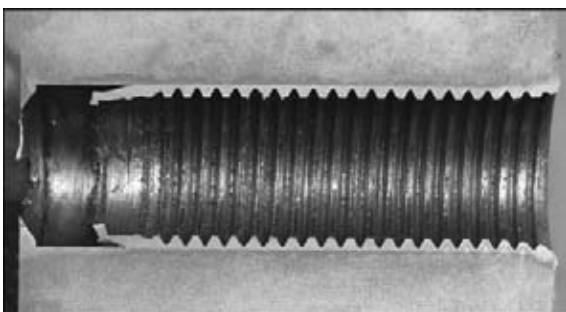
Figure 5 shows a cross-section of repaired threaded opening along the channel axis. A lack of penetration of 5 mm length is taking place close to the channel bottom that is character during realization of the process of explosion welding. The screw thread of only 45 mm length is to be cut according to Figure 1, therefore, presence of such a lack of penetration is insignificant and acceptable.

Figure 5. Macrosection of repaired threaded opening

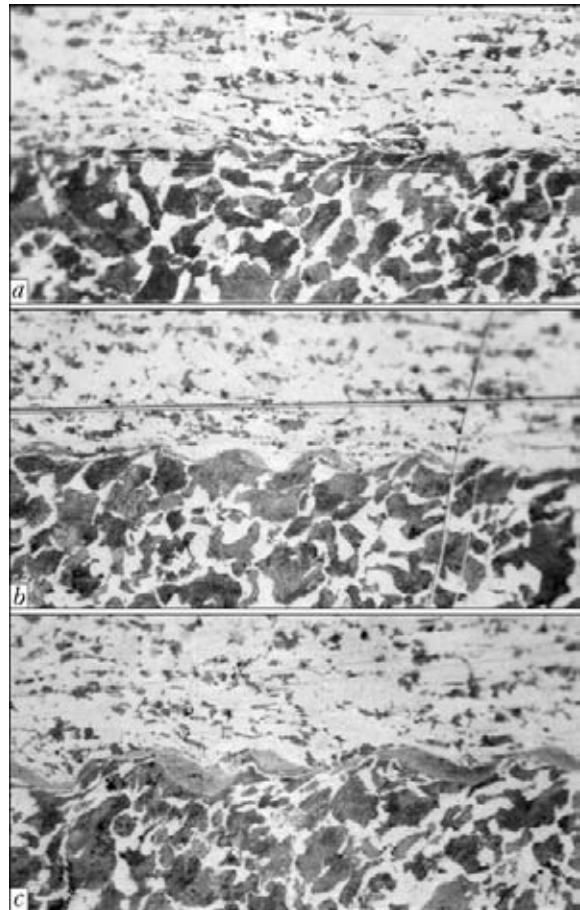
Figure 6. Typical microstructures ($\times 400$) of the joint metal of repair coating (steel 20 upwardly) and metal of axle journal at 3 (a), 15 (b) and 45 (c) mm distance from the beginning

Boundaries of the joining zone have mainly wave-like form and characterize by sufficient stability that indicate the presence of quality welded joint. At that dimensions of the wave are very small: excursion (two amplitudes) makes 2 μm and length is 6 μm . This is evidence of the fact that explosion welding was performed at low limit of welding parameter range. No changes of the metal structure outside the joining zone were found.

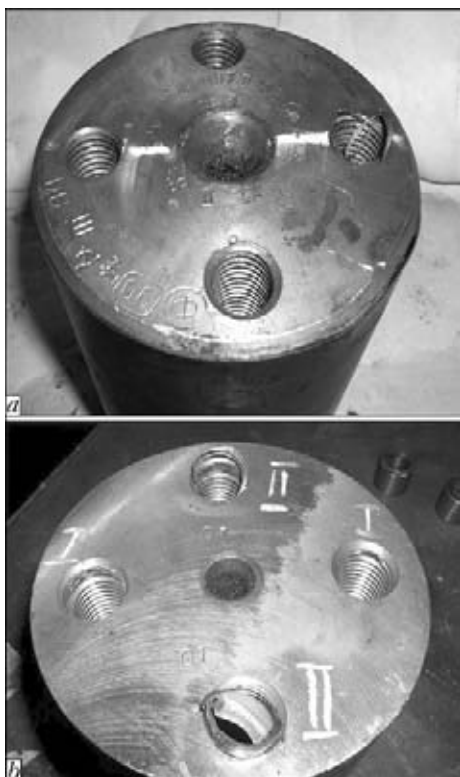
Results of fatigue tests of the samples of new axle journals of RU1-Sh type and journals with repaired threaded openings are given in the Table. Figure 7 shows the photos of the new and repaired openings of axle journals after the tests.

The minimum values of life time $N_p^{\text{min}} = 127,000$ cycles of loading for samples of journals manufactured from the new axles and $N_p^{\text{min}} = 122,000$ cycles of load-

Figure 7. General view of the openings in new (base) (a) and repaired (b) journals of axle after the tests

ing for samples of the axle journals with threaded openings repaired using explosion welding method were obtained after processing of the test results.

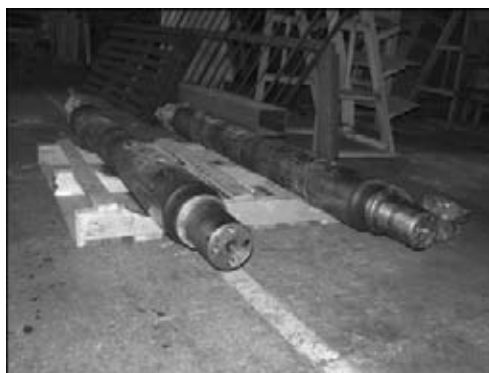
Repaired axles as a part of one car truck were put under the special car designed for transportation of mineral fertilizers in March 2011 and being used by SE «Ukrzalisnytsya» till present time. Current monitoring of repair welded joints was carried out. The car with repaired axles have already run 23 thou km without a damage and wear of the repaired threaded opening M20 as for October 2011.

Figure 8. General view of repaired axles RU1-Sh

Repair welding of threaded openings M20 on RU1-Sh full-scale axles. Two axles with damaged threaded openings (one per each edge) were represented for adjustment of the developed technology to RU1-Sh full-scale axles and further route tests of SE «Ukrspetsvagon». Figures 8 and 9 show a general view of the repaired axles and threaded channel. Reproducibility of explosion welding mode on full-scale axles and their models (quality of joint was controlled using metallographic investigations) was determined based on similarity of radial deformation of the clad channel. Diameter of the channel after cladding made 17.4–17.5 mm that is quite acceptable for cutting of thread M20-6N.

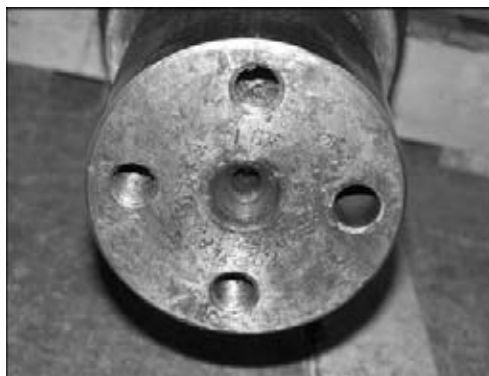
Figure 9. Repaired channel for thread cutting
