DETERMINATION OF THE CAUSES FOR CRACK INITIATION IN STRUCTURAL ELEMENTS OF THE TOWER OF NEW VENTILATION PIPE AT CHERNOBYL NPP

V.M. TOROP¹, E.F. GARF¹, A.V. YAKIMKIN¹ and E.E. GOPKALO²

¹E.O. Paton Electric Welding Institute, NASU

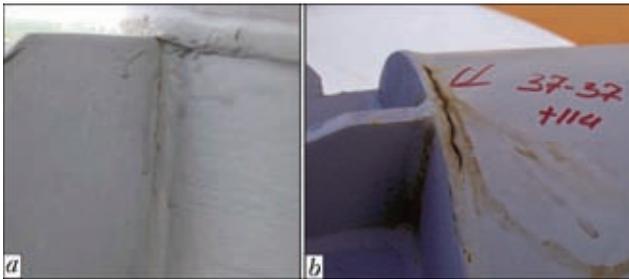
Figure 1. Cases of crack propagation in tower brace nodes (for *a* and *b* see the text)

Cracks are of different length. They initiate from the edge in the upper part of node gusset

(node of lattice elements abutment to tower post) and develop downwards along the gusset and in-depth (Figure 1, *a*). In the node of braces abutment to the straining sill cracks are found in the connection of the stiffener and brace pipe through a thin plug sealing the brace inner space (Figure 1, *b*).

Another specific feature: in tower post nodes cracks form from two sides of the gusset, propagating in-depth and moving towards each other. Cracks propagate along the boundary of transition from fillet weld joining the tower post to slotted gusset, to gusset base metal. In those cases, when fillet welds from one and the other side of the gusset have different legs, cracks propagate with the appropriate shifting.

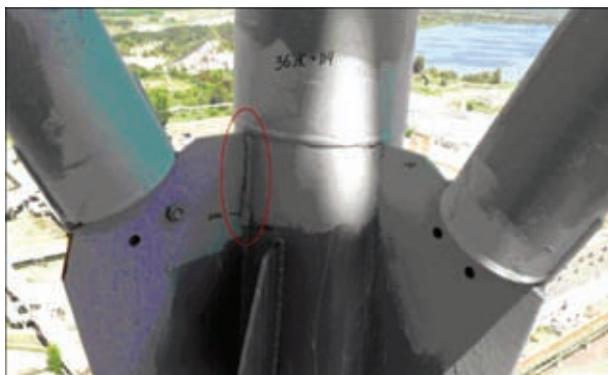
Figure 2. Crack-like defects in the node of brace abutment to tower post

The characteristic appearance of crack-like defects detected by NDT is given in Figure 2.

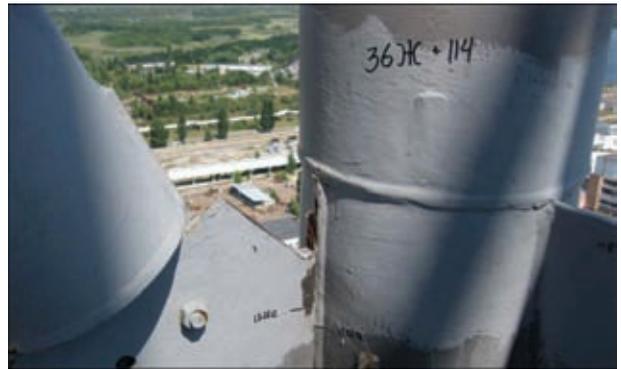
Figure 3. Node of brace abutment to tower post after cutting out template #1

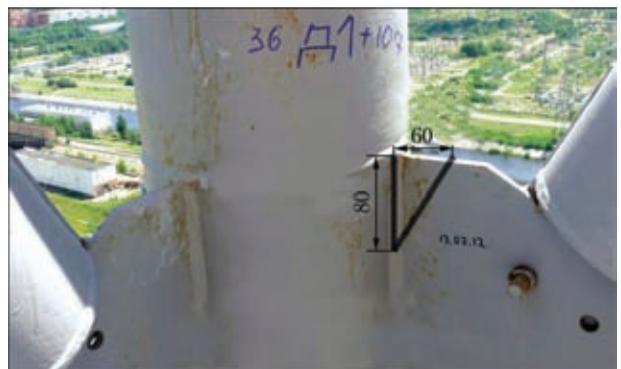
Figure 4. Schematic of cutting out template #2 (cracked fragment of gusset with complete weld structure up to the end of detected crack)

Metallographic and fractographic investigations were performed to establish the causes for initiation of crack-like defects in NVP metal structures. Templates of gussets with anticipated cracks were cut out at 36Zh + 114 (cutting out area is shown in Figure 3) – template #1 and 36D1 + 107 marks (cutting out schematic is shown in Figure 4) – template #2, respectively.

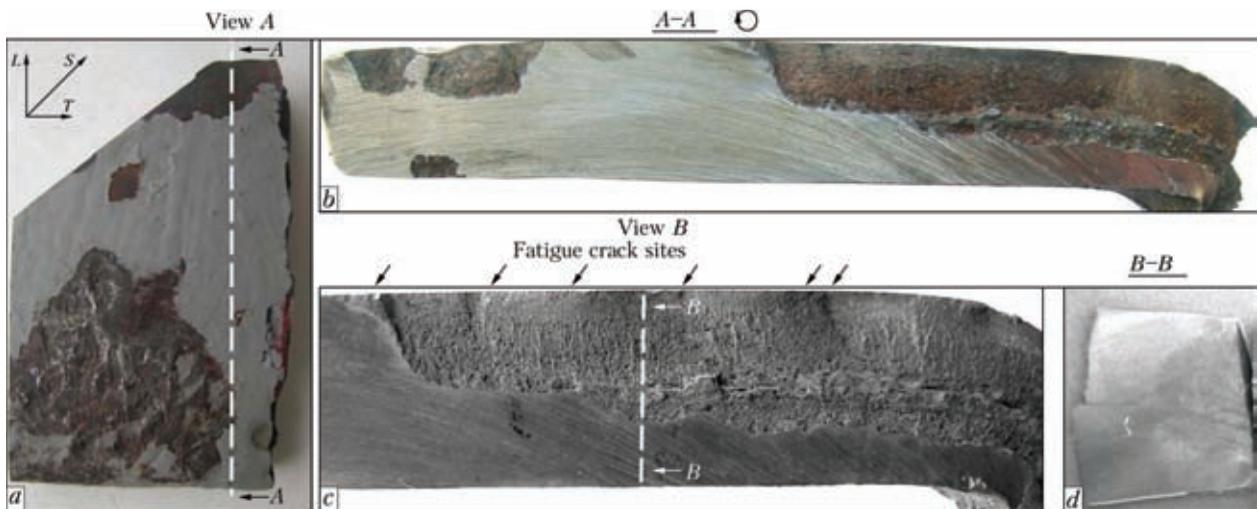
Figure 5. Template #1 with open crack: *a* – template appearance; *b*, *c* – fragment of gusset in crack plane *L-S* before and after crack surface cleaning to remove corrosion products, respectively (gusset section *A-A*); *d* – microsection plane in plane *S-T* (gusset section *B-B*)

Template #1 in as-delivered condition along one of the sides was cut out in crack plane L - S along the fillet weld normal to gusset sheet rolling plane L - T (Figure 5). Crack surface in cut plane is covered by corrosion products, and that is why ultrasonic cleaning of the surfaces from corrosion products was performed in ultrasonic disperser UZDH before fractographic investigation, using 2 % alcohol solution of oxalic acid and then pure ethyl alcohol. Figure 5, *c* shows a gusset fragment in crack plane L - S after removal of the protective layer from the sheet outer surfaces and crack surface cleaning from corrosion products.

The fact that in the post gussets cracks initiate and propagate along the boundary of transition from welded joint to base metal, and across metal thickness cracks develop normal to its surface, as well as the difference in crack dimensions in different nodes, are indicative of their fatigue origin. This is convincingly confirmed also by the above-described fractographic investigations, in particular, characteristic fracture surface, presence of crack initiation sites, striations characteristic for crack arresting and initiation (see Figures 5 and 6).

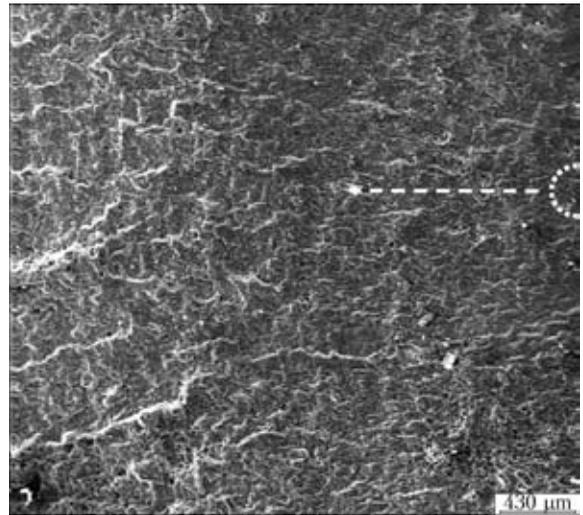
Fractographic investigations of opened crack surfaces in the cut plane revealed crack initiation sites and propagation mechanisms in welded connection of template #1, although the weld zone proper is not in the template. Proceeding from fractographic studies cracks are identified as fatigue, initiating on surface defects. Fatigue crack sites are marked by arrows in Figure 5, *c*. Figure 6 shows a characteristic fragment of fractogram of a gusset with fatigue crack (with initiation site, characteristic fracture relief and traces of fatigue crack front arresting). The main crack formed as a result of coalescence of several fatigue cracks, which initiated from different sites on the gusset outer surface and grew in-depth of the sample to 5 to 6 mm (approximately to half of gusset sheet thickness). In some fracture areas coarse globular non-metallic inclusions are observed, which are commensurate with ferrite of gusset base metal (crack might have crossed the fusion zone in such areas).

Figure 6. Fractogram of gusset (template #1) in plane L - S with fatigue crack (white contour marks fatigue crack site, arrow shows direction of crack front)

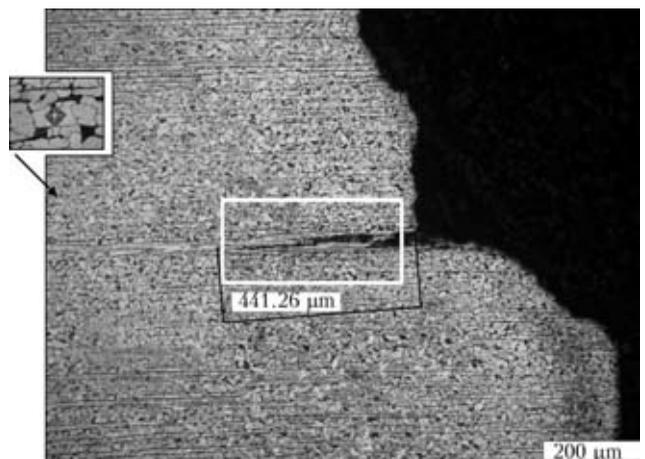
Here fine secondary delamination microcracks several micrometers long oriented along the rolling texture are observed along the primary crack profile line (in welded connection cross-section), and at about 5 mm distance from the outer surface already an extended secondary delamination crack of about 450–500 μm length formed (Fi-

gure 7), which was also due to rolling texture. It propagated along extended pearlite colonies and sulphide inclusions, which are observed in the studied template section (see enlarged fragment in Figure 7).

Figure 7. Fractogram of secondary crack of gusset delamination

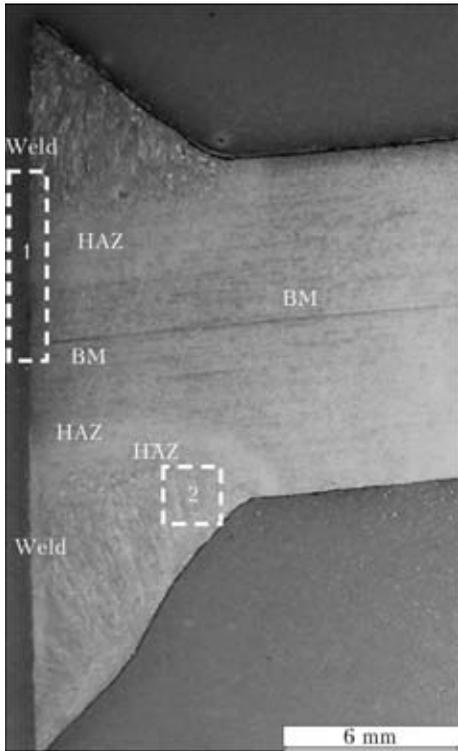
Figure 8 shows a fragment of template #2 of a welded connection in plane S - T after etching in 4 % solution of nitric acid in ethyl alcohol with marking of zones of weld, HAZ and BM.

Figure 8. Fragment of welded joint microsection (template #2) in plane *S-T*

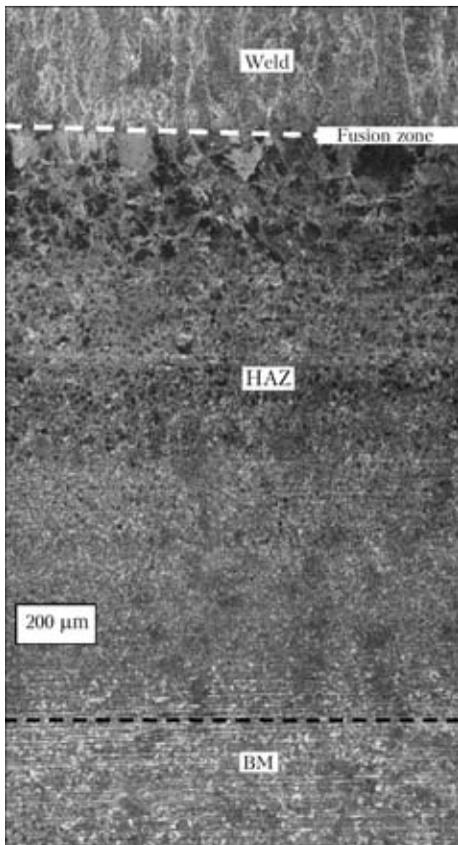
Figure 9. Panoramic view of microstructure fragment (template #2) of section 1 in Figure 8

Panoramic view of a fragment of microstructure in zone 1 (see Figure 8) including the structure of the weld, fusion zone, HAZ and gusset BM is shown in Figure 9. Overheating zone («coarse-grain» zone of about 400–600 μm width) is located near the fusion zone in the HAZ. Its grains are characterized by Widmanstaetten structure with lower mechanical properties. Total HAZ width is within 900–2900 μm.

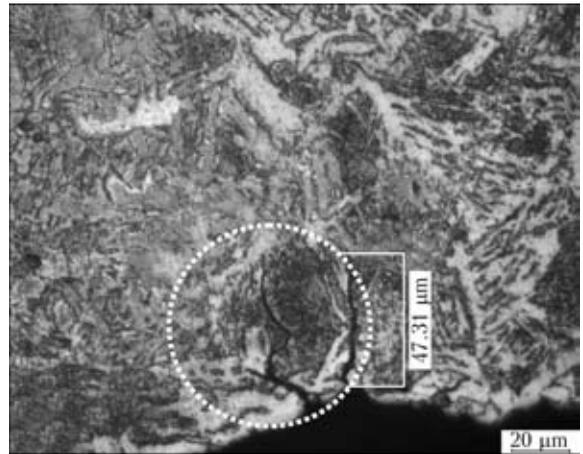
Figure 10. Microstructure fragment (template #2) of section 2 in Figure 8 (dot contour marks microcrack area)

Detailed investigation of welded connection microstructure in plane *S-T* of the microsection near the fusion zone revealed two microcracks of 50–60 μm size, initiating on the stress raiser in the form of a defect of template outer surface in the area of HAZ coarse grain (Figure 10). Such fine cracks could hardly be detected by other methods, in view of outer surface roughness, and presence of a layer of scale on it. As shown by investigations, thickness of scale layer on gusset surface reaches 30 μm in individual locations,

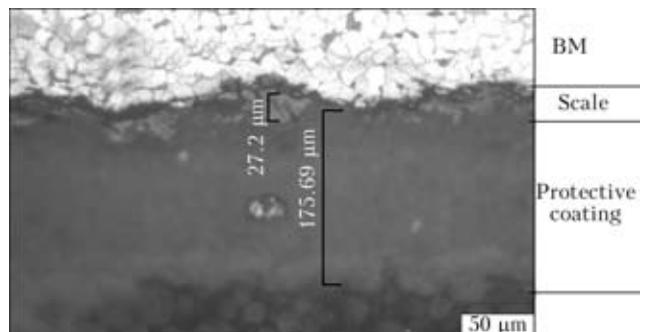
Figure 11. Fragment of gusset section with scale and protective coating

and protective coating thickness is 180 μm (Figure 11).

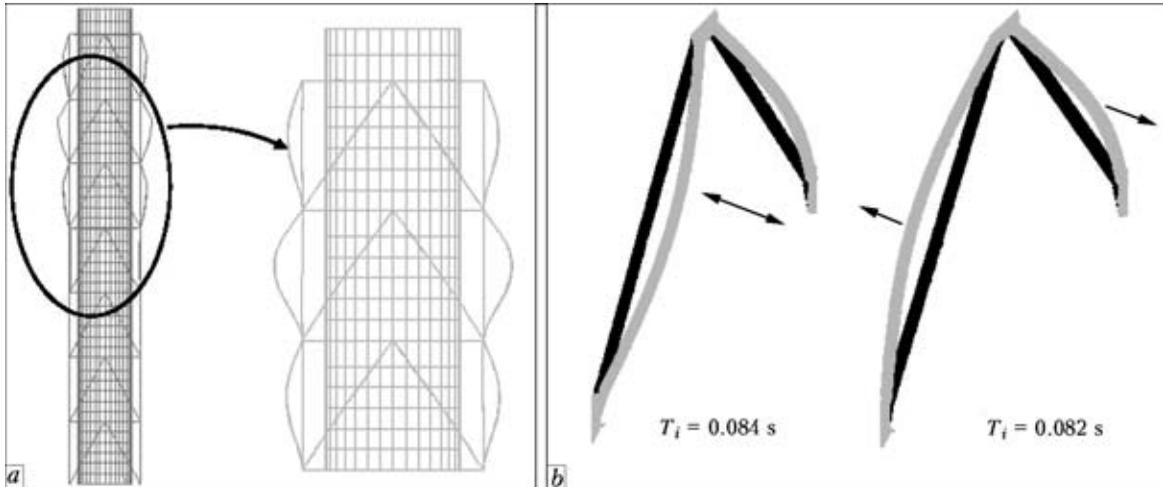
Figure 13. Forms of natural vibrations (for a and b see the text)

Detailed analysis of the derived results revealed that in a number of cases the forms of NVP natural vibrations are created by group deformation of braces of three upper sections (Figure 13, a). Brace vibrations are characterized by their buckling out of panel plane. Charac-

teristic forms of brace vibrations and respective magnitudes of natural vibration periods are given in Figure 13, b.

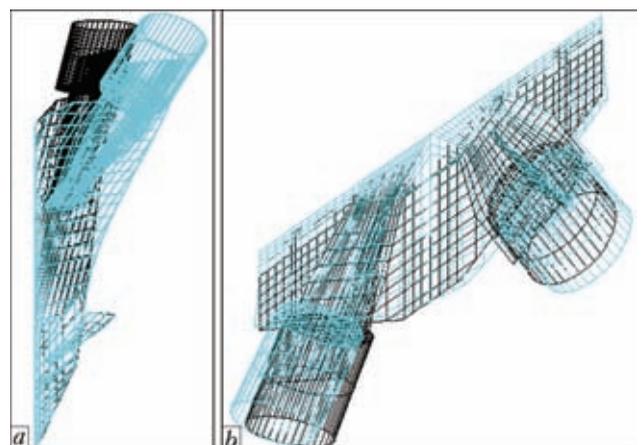
Figure 17. Schematics of supporting gusset deformation: a – lower; b – upper gussets

Analysis of the derived results showed that the applied forces cause out-of-plane deflection of supporting gussets. Figure 17 gives the deformation diagrams of supporting gussets.

Bending of lower supporting gussets leads to formation on their faces of stresses reaching values $\sigma_y = \pm 38.56$ MPa. Regions of highest stresses are located in upper zone of supporting gussets, in the area of their abutment to tower posts. In addition stress increase is observed in areas of variable rigidity, namely in zones of connection of supporting gussets to brace gussets. Isofields of stresses σ_y and σ_z in supporting nodes are given in Figure 18.

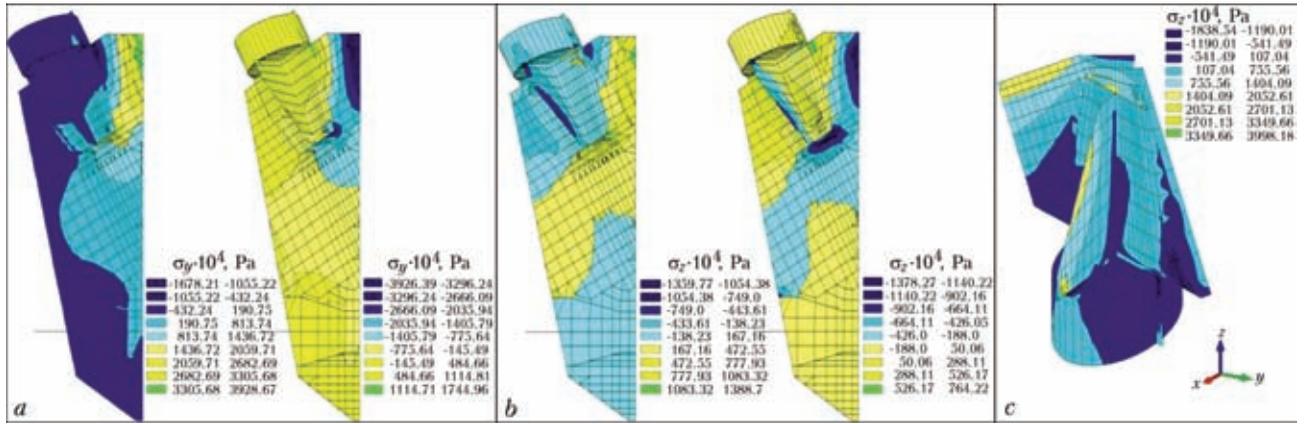
Figure 18. Isofields of stresses on faces of lower (a, b) and upper (c) supporting nodes

A zone with a pronounced stress raiser is found in the brace upper node, in the area of stiffener abutment to end plug. Schematic of deformation and isofields of stresses σ_z on the faces in the zone of upper supporting node are given in Figure 18, *c*. In these sections stresses reach the magnitudes of $\sigma_z = 39.9$ MPa.

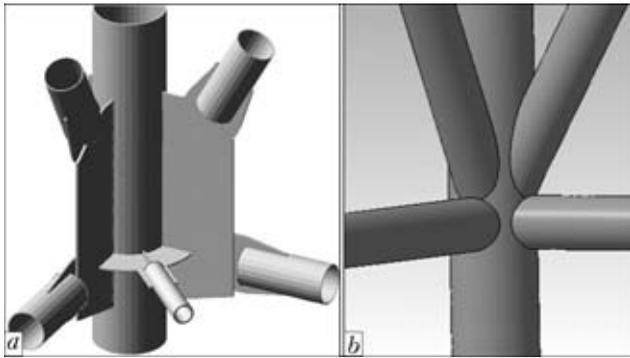
Figure 20. Schematics of node connection of NVP tower structural elements with the post: *a* – with slotted gussets; *b* – with direct abutment

rosion resistance owing to good air blowing and small surface area. These advantages, however, can be realized in full only at a rational design of node connections. It is known that in tubular structures node connections in a number of cases predetermine the strength and reliability of the entire construction [10].

7. The tower was designed using out-dated node design solutions, characterized by numerous zones of high stress concentration, low fatigue and corrosion resistance.

Over the recent decades, in connection with application of cylindrical pipes as load-carrying elements of stationary off-shore platforms and other critical constructions, a large volume of investigations has been performed, which are aimed at development of optimum node design solutions, and methods of assessment of their strength under static and cyclic loading. It is shown that the most rational solution is direct abutment of lattice elements to the post. The structure has a high strength, low stress concentration, small number of welded connections, and high corrosion resistance. For such nodes normative documents for their strength analysis [11, 12, etc.] at static and cyclic loading have been developed. For comparison let us give the node of NVP tower and a node, corresponding to modern concepts of tubular structure design (Figure 20). If the design of NVP tower was made on an up-to-date level, many drawbacks could have been avoided.
