REASONS OF STRESS CORROSION FAILURE OF ERECTION GIRTH JOINT OF MAIN GAS PIPELINE

Considered are some issues of stress corrosion failure of metal of main gas pipeline under operation. It is shown that, except for conventional orientation of stress corrosion cracks in longitudinal direction, the defects of such a type can propagate in transverse direction relatively to axis of the gas pipeline. Found transverse stress corrosion cracks, including ones passing through the whole thickness of the pipe wall, were formed in a zone of girth weld, joining 1420 mm diameter pipes of K60 strength class. Defective zone of 800 mm length was located from both sides of the weld and propagated at approximately 60 mm width from fusion line. Failure surface in zone of defects has specific step nature as a result of coalescence of finer semi-elliptical cracks, nucleated in different planes being displaced relatively to each other. The cracks are mainly characterized by rounded tips, that is typical for stress corrosion defects, formed as a result of anode metal dissolution. Failure of girth welded joint of the pipeline, except for corrosion factors, was promoted, to significant extent, by additional s

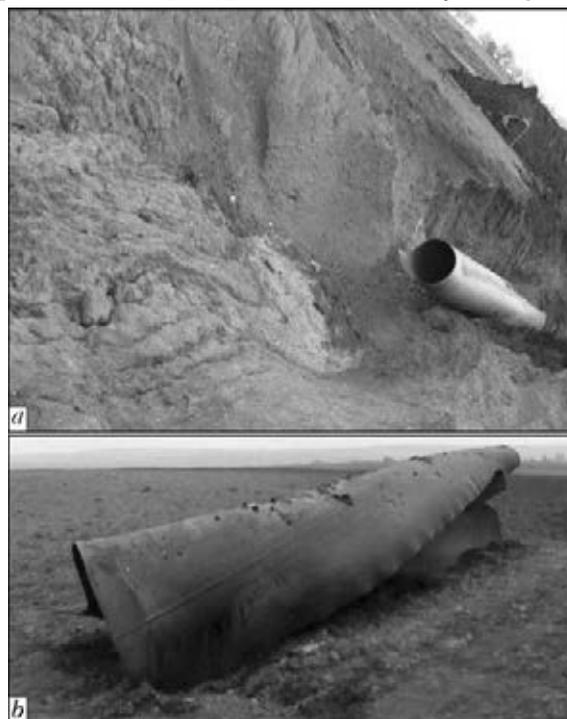
Consequences of failure of the gas pipelines due to SCC (SCC-failure) are sufficiently impressive. Figure 1 shows, as an example, the trench and fragments of 820 mm diameter pipeline after SCC-failure spread at 40–50 m.

Figure 1. Stress corrosion failure of main gas pipeline of 820 mm diameter (a) and fragments of failed pipes (b)

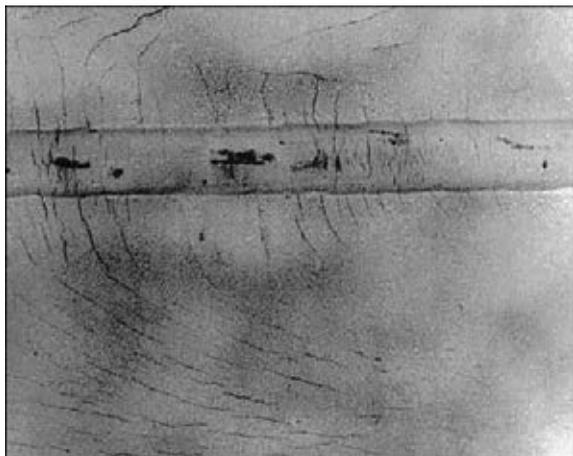
Figure 2. Effect of stress distribution in pipe metal on character of location of SC-cracks [1]

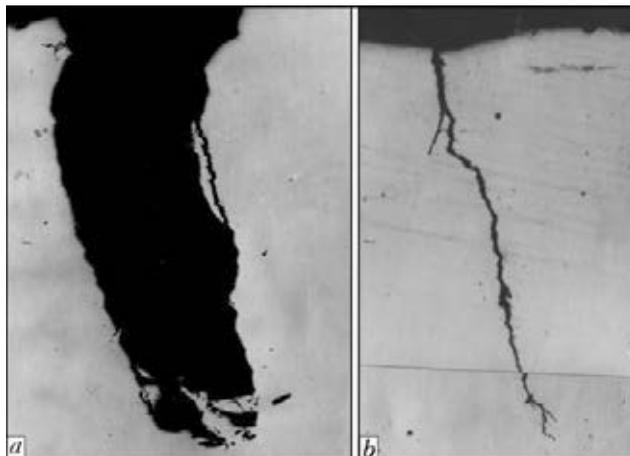
In accordance to current representations, SCC can propagate on two mechanisms, namely local anode dissolution and hydrogen cracking [4–7]. If the first mechanism is realized, electro-chemical process is localized on the surface of metal and its intensive dissolution takes place in a crack tip. Such cracks, as a rule, are characterized by wider opening, presence of corrosion deposits and their tip has blunt form (Figure 3, *a*). In the second case, diffusion of hydrogen in a metal lattice is performed under effect of stresses and corrosion media. More acute tip, transcrystalline nature of propagation and some splitting (Figure 3, *b*) are typical for the cracks of this type.

Figure 3. SC-cracks in metal of gas line pipe formed as a result of anode dissolution (*a* – $\times 20$) and hydrogen cracking (*b* – $\times 100$)

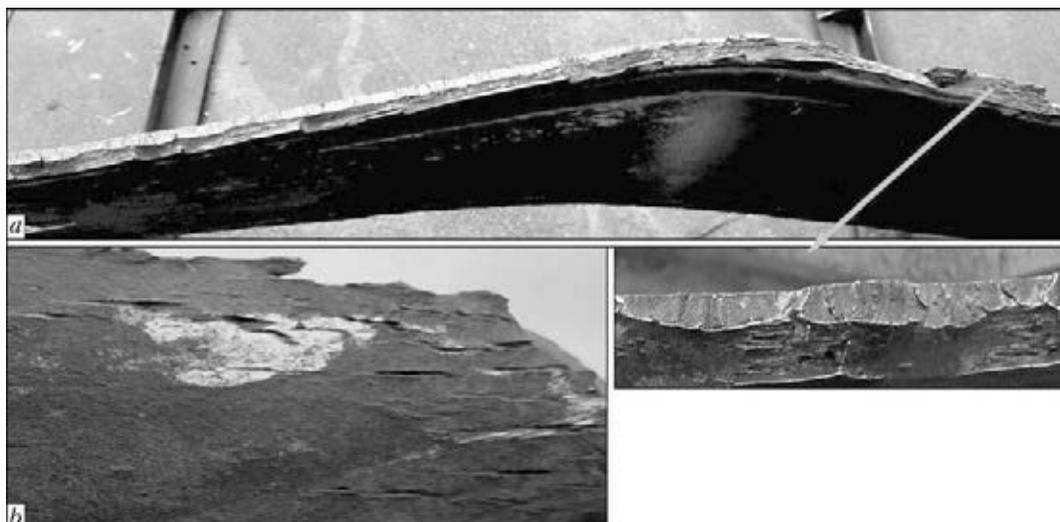
specimens with SC-cracks, cut out from the pipes of «Urengoy–Pomary–Uzhgorod» gas pipeline, failed in May, 2007. Similar failures on this gas pipeline were registered in May 2003 and in December 2007. In all described cases, SC-cracks and failures of gas pipeline were also oriented in longitudinal direction.

Figure 4. Fragments of failure of 1420 mm diameter gas pipeline with SC-cracks: *a* – fracture of specimen with crack of 470 mm length and 6.8 mm depth; *b* – colony of transverse macrocracks in zone of failure on pipe metal surface

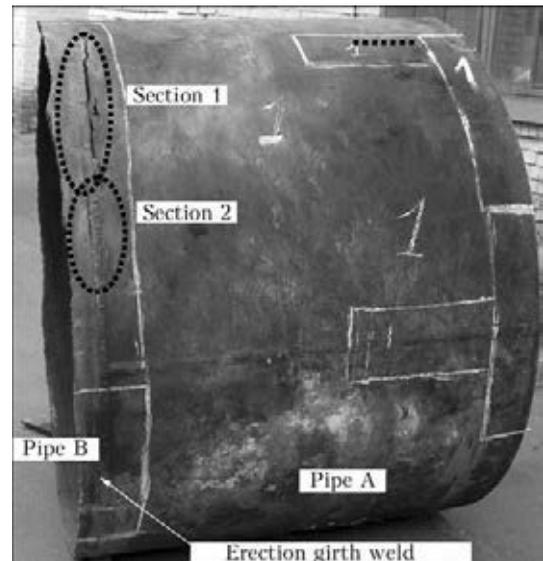
Local gas leakage and its ignition was detected during operation of main gas pipeline «Progress». Series of the through-wall defects was found in a zone of girth welded joints during test drilling of this section of gas pipeline. The girth weld in defective section was made by «tie-in» and it joints double-weld 1420 mm diameter pipe with 15.7 mm wall thickness of K60 strength class, manufactured at Khartsyzk Pipe Plant, to single-weld pipe of the same diameter with 15.4 mm wall thickness and X70 category of foreign delivery (Figure 5). Metal of both pipes was of similar chemical composition (the Table) and me-

chanical properties. It can be assumed based on this that role of metallurgical factor in formation of these SC-cracks is minimum.

Figure 5. General appearance of failed erection girth joint and sections with maximum accumulation of cracks

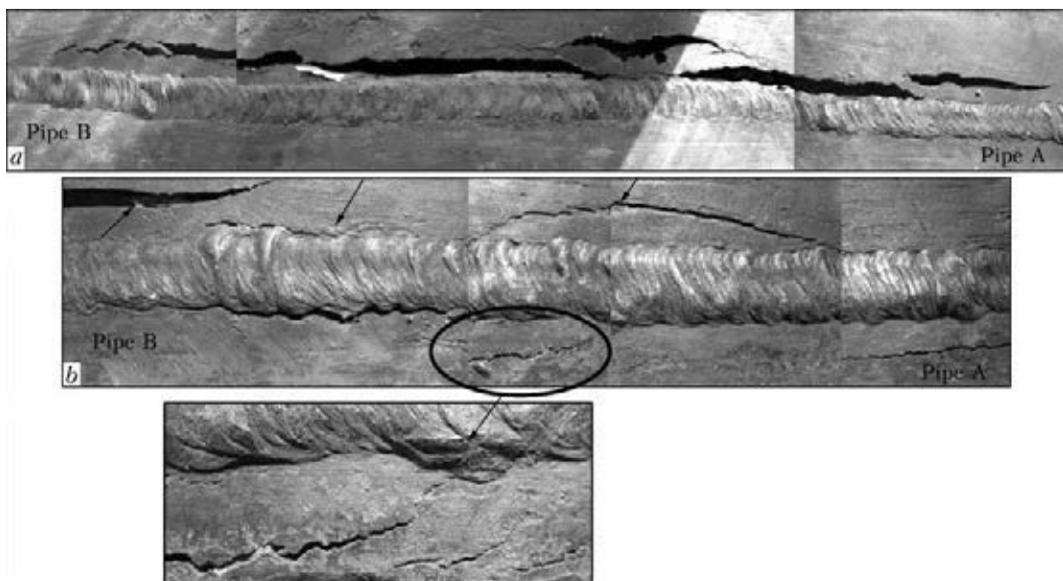
Damage zone with crack-like defects (through-wall and surface ones) was located across the pipe axis and along the girth welded joint at around 800 mm length from both sides of the weld (Figure 6). Area of location of defective section in the girth joint on a route corresponded to 5–7 h of conventional dial. Width of the section with cracks, starting from the fusion line in direction of the base metal, made around 60 mm from each side of the weld.

Figure 6. Sections of erection girth joint (see Figure 5) with maximum accumulation of cracks (arrows show crack location): *a*, *b* – sections 1 and 2, respectively

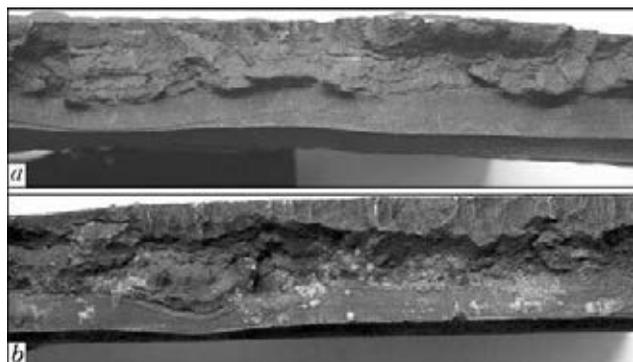
Two different zones can be clearly observed on fracture of through-wall cracks after their opening, namely zone of defect formation from the side of external pipe surface, and zone of the final rupture on its internal side. Figure 7 shows fractures of the through-wall cracks in different sections. Failure surface in the crack zone has specific step nature, typical for defect, formed as a result of coalescence of smaller semi-elliptical cracks, nucleated in different, displaced relatively to each other, planes. Corrosion deposits are observed on the surface of cracks. The metal

in the zone of final rupture failures on tough mechanism.

Figure 7. Nature of failure surface (through-wall crack)

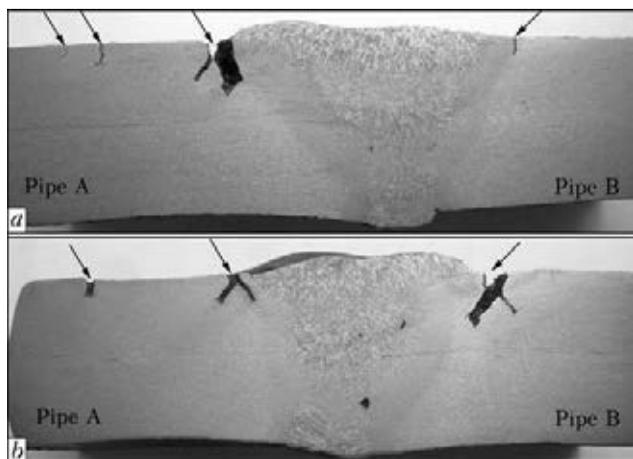
Multiple cracks of different depth, namely from surface ones to those passing through significant part of the wall thickness (Figure 8, *a*,

Figure 8. Transverse macrosections of girth welded joint in damage zone (location of cracks indicated by arrows)

b) were registered in the metal of damaged zone of both pipes, as was shown by investigations of macro- and microsections. The cracks have relatively wide opening with rounded tips (see Figure 3, a). In the most cases, they are located along the girth weld in a plane normal to pipe generatrix or at around 45° .

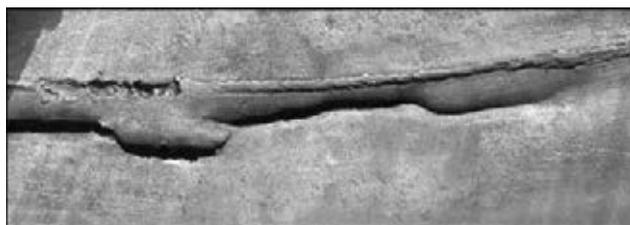
Girth weld of the studied joint was made by manual metal arc welding with some (maximum up to 2 mm) displacement of pipe edges in radial direction, that does not exceed a limit set by SNiP III-42-80 (not more than 3 mm). The girth weld from internal side of the pipe was performed with significant lack of penetration of root layer up to 3 mm (it is well-known that no lack of

Figure 9. Internal surface of the pipe in damage zone

penetration of root part of erection weld in pipeline of 1000 mm diameter and more is allowed). At that, presence of indicated defects, in this case, was not exactly the reason of girth weld fracture.

It can be assumed that SCC-failure of girth welded joint of the gas pipeline, besides the corrosion factors, was promoted, to significant extent, by additional stresses, typical for process of pipe assembly during «tie-in» performance. It is indirectly verified by significant plastic strain of the metal in formation of through-wall defects, which can be seen in Figure 9 showing internal surface of the pipe in defective section.
