RESTORATION REPAIR OF ELEMENTS AND UNITS OF GAS TURBINE ENGINES

V.M. NESTERENKOV¹, Yu.V. ORSA¹, K.S. KHRIPKO¹ and Yu.V. GUSEV²

¹E.O. Paton Electric Welding Institute of the NAS of Ukraine

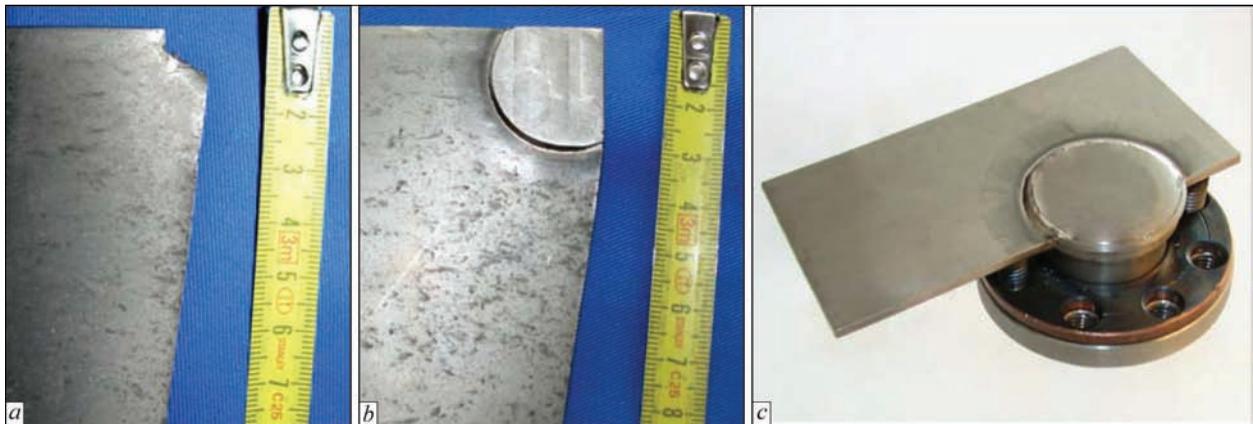
Figure 3. Repair of spot defects of angle of blade airfoil using cylinder repair «welded-in pieces»: *a* — damaged angle of blade before repair; *b* — repaired angle (ends of «welded-in piece» after EBW); *c* — assembly-welding fixture for EBW of cylinder «welded-in pieces» (blade simulator)

Repair of both types of spot defects is carried out using cylinder «welded-in pieces» (Figures 3 and 4). There are several dimension types of diameters depending on size of airfoil edge defect.

Such a structure is efficient by the fact that matching of diameters of «window» cut out in the blade and «welded-in piece» itself provides fixing and tight contact of butted parts in radial direction. Therefore, sufficiently simple assembly-welding device (Figure 3, c) should only provide pressing of the edge of the cut out «window» to mentioned above «overhanging shoulder» as well as holding the whole assembly in space during performance of electron beam pass along the arc of corresponding circumference.

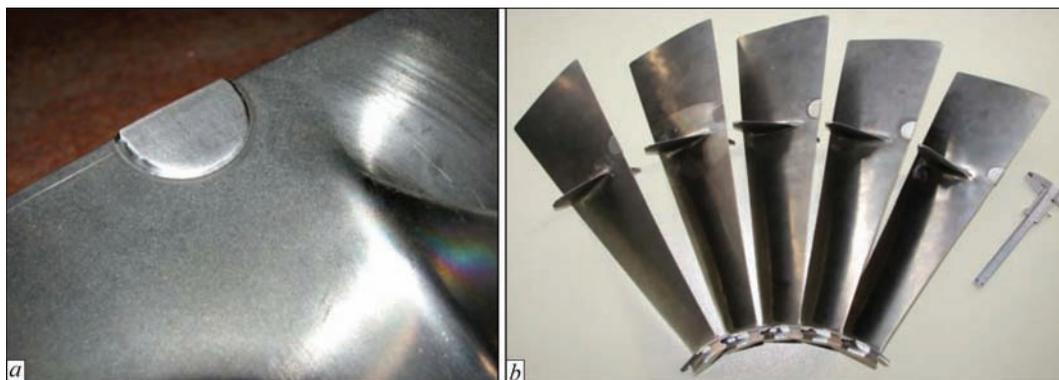
Figure 4. Repair of spot defects of main part of blade airfoil edge using cylinder repair «welded-in pieces»: *a* — cylinder repair «welded-in piece» at airfoil edge (its edge was cut out at initial mechanical treatment after EBW); *b* — pilot batch of GTE LPC blades with cylinder «welded-in pieces» on airfoil blade (before final mechanical treatment)

At the beginning the works were carried on the samples simulating real parts. Then the results were successfully tested on the pilot batches of defective blades, provided by SE «Ivchenko-Progress» (Figure 4, b).

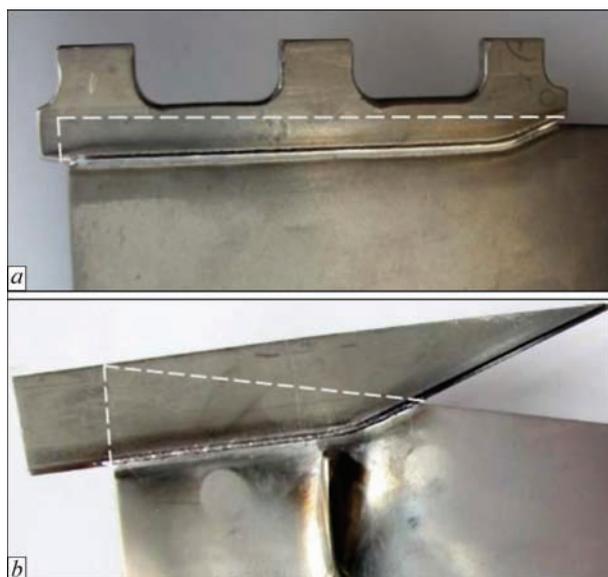
Figure 5. Repair of extended defects of blade airfoil edge: reconstruction of narrow zone adjacent to airfoil edge (a); reconstruction of wider zone with very damaged airfoil angle (b)

The corresponding extended «welded-in pieces» are used for the extended defects of different areas of the blade airfoil edge. Their form can be changed depending on width and shape of the damaged zone of blade airfoil edge. In particular, it can be a narrow band replacing only damaged part of the airfoil edge (Figure 5, a) as well as «welded-in piece», width of which is very widened to the corner for the case of significant damage of not only the edge, but the angle as well (Figure 5, b).

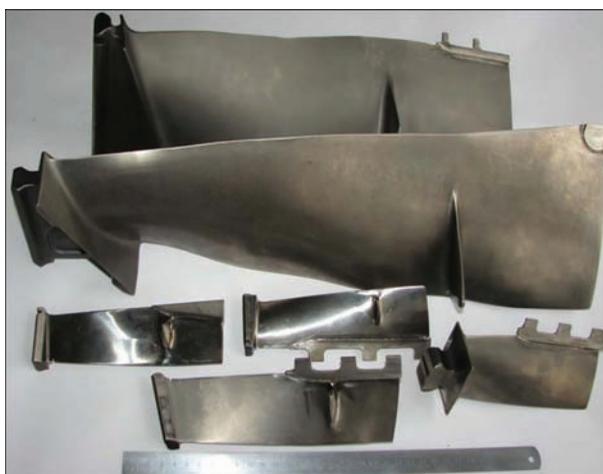
Figure 7. Examples of realization of developed repair technology for different dimension types of the blades (large — fan sections, small — LPC) as well as shapes and extension of airfoil edge defects

The developed repair technology was tested on the edges of blade airfoil of different sections and, respectively, dimension types in repair of the defects of various size and shape (Figure 7).

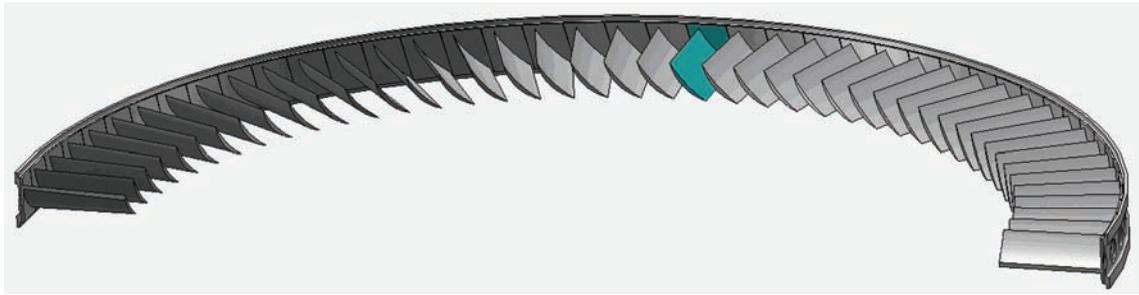
Guide cases of 3–8 stator stages of high-pressure compressor in gas-turbine engine consist of semi-rings with a set of brazed in them cantilever blades (Figure 8). The blades of 3–6 stages are made of alloy EP-866 (15Kh16K5N2MFAB-sh), and blades of 7, 8 stages are of alloy EP-718-ID (KhN45MVTYuBR-ID); working temperature of the units makes 300–500 °C.

In operation of such engines there are also the cases of appearance of nicks and cracks on the blades as well as their tear out due to local lack of their brazing with the semi-ring wall.

Figure 8. Scheme of semi-ring of stator guide case with set of brazed-in cantilever blades

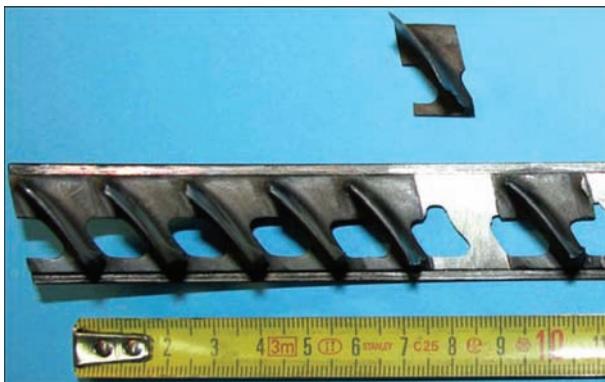
Figure 9. Semi-ring with prepared area for cantilever donor-blade installation

Replacement of the defective blades is allowed following «Engine overhaul manual». At that the defective blade is removed by milling from semi-ring till its wall, including the brazing filler material holding the blade, and this place is filled with an undamaged donor-blade (Figure 9). In other words a completely cleaned section is prepared in the semi-ring for instal-

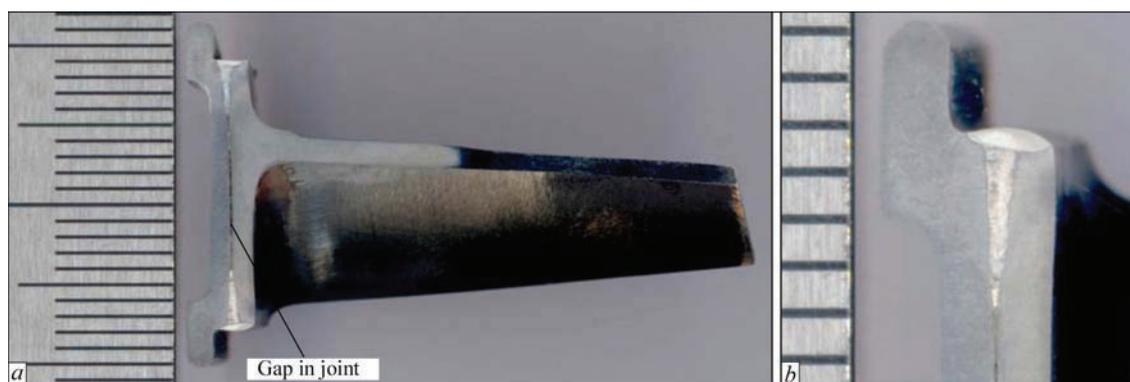
Figure 12. Macrosection of cross section of EB-joint of blade with guide case semi-ring received at up to 0.1 mm gap in joint (a) and section area containing the weld itself (b)

Figure 13. View of repair joint from end of guide case semi-ring nor-blade base. It is a result of difficulty of local mechanical removal of the damaged blade and formation of the area for the donor-blade. Such gaps are very critical, since thickness of the wall, to which the blade is welded, makes only 0.5 mm in some places.

The results of the experiments, carried out on the sample-simulators, provided the optimum compromise between the power parameters of the electron beam and possibility to form sufficiently deep weld in a thin-wall joint at gap presence in the butt. At that, pulsed EBW mode was used for improvement of weld formation and reduction of total heat input. This allowed getting quality joining of the parts at local gaps in the joint up to 0.1 mm. Then, selected EBW modes were corrected on real joints of the blades with semi-ring of the guide case (Figures 12 and 13).

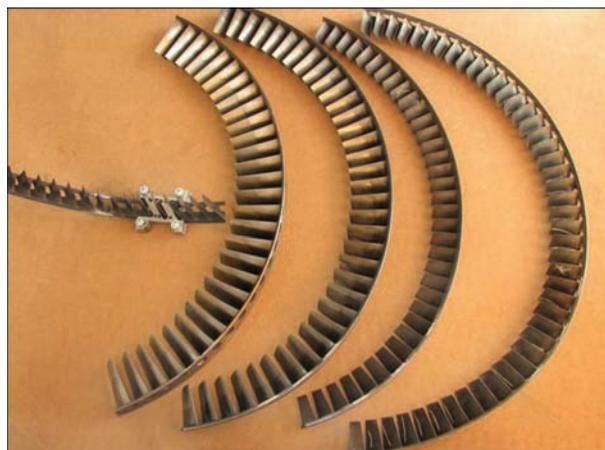
Figure 14. Repaired guide case semi-rings of different stages of LPC stator

The technology has passed successful test in repair of a batch of real guide case semi-rings of differ-

ent stages in HPC stator (Figure 14) under laboratory conditions at PWI and later at Lutsk Repair Plant «Motor».
