PECULIARITIES OF CONSTRUCTION AND SERVICE OF TANK RVS-200 FOR STORAGE OF DIESEL FUEL IN ANTARCTICA AT THE STATION «AKADEMIK VERNADSKY»

The analysis of materials of expert inspection of the welded tank RVS-200 for diesel fuel at the Ukrainian Antarctic Station «Akademik Vernadsky», made by the SE «Experimental Design and Technological Bureau of the E.O. Paton Electric Welding Institute of the NASU», is given. It was shown that according to the region of its location, the tank of only 200 m³ capacity is transferred to the highest criticality class CC3 with the fixed service life of not less than 40 years. Under these conditions the requirements to ecological purity of the object and the environment, at a complete isolation and limited capabilities of repair, predetermine the need in extraordinary constructive solutions on providing the maintenance-free service life. The specific technical solutions of the considered problem are given. 7 Ref., 5 Figures.

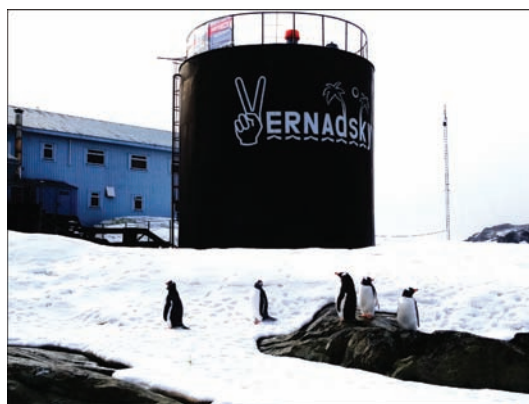
Figure 1. General view of the tank RVS-200 at the Antarctic station «Akademik Vernadsky»

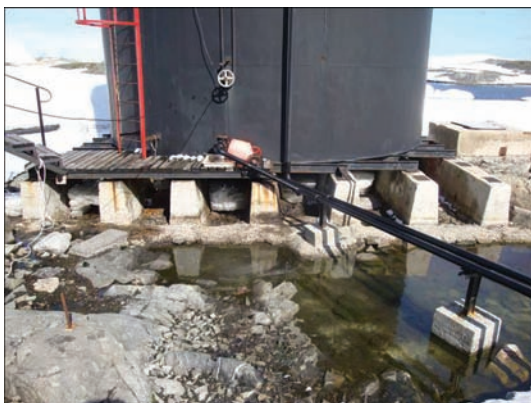
Figure 2. General view of basement arrangement of the tank RVS-200

Basement of the tank. The tank was constructed on the monolithic rocky foundation which represents a characteristic surface of Galindez Island. The basement of the tank was made as a two-tier system of girders (Figure 2). The lower tier is composed of seven parallel reinforced concrete girders of 650 mm height, 460 mm width in the lower and 330 mm in the upper part. The girders are fixed to the basement with anchors. The anchors are fixed in the boreholes drilled in the rock and welded-on to the girders reinforcement. The distance between the girders in the axes is 1.20 m. The upper tier of the girders is composed of 15 steel girders (double-T No.14), which are welded-on to the embedded parts on the upper surface of the lower girders. The distance between the girders in the axes is about 0.41 m. The bottom of the outer tank leans against the upper girders. According to the project, on the bottom of the outer tank the wooden girders are laid (the bars of 100×100 mm cross-section) at 300 mm pitch. The lower bottom at the top and the bottom as well as wooden and steel girders are not available for visual inspection and instrumen-

tal control. The bottom of the main tank lies on the wooden girders. The existing design of the tank base-ment virtually eliminates the subsidence of the outer and inner bottoms of the tank. According to the mea-surements, the maximum deviation of the outer and inner contour of the bottom is equal to 6 mm. There are remarks concerning small repair of the reinforced concrete girders and annual inspection and works on preventing corrosion of reinforcement of the lower girders, steel anchors and upper tier girders.

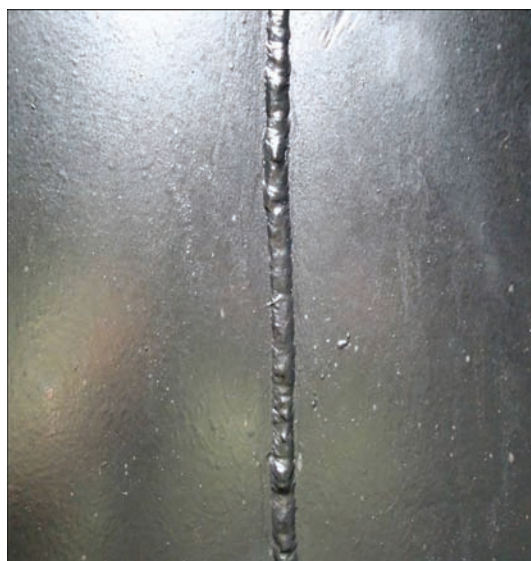
Wall of the inner tank. The wall is assembled of separate sheets previously rolled similarly to the out-er wall. The geometric shape of the wall meets the requirements of standards. On the surface the dents and convexities are absent. The deviation of genera-trixes from the vertical amounts to +38 and -31 mm, the difference of marks of the outer contour does not exceed 6 mm [5]. The vertical and horizontal welded joints are produced by two-sided butt welds with full penetration. The detected individual deviations in the shape of weld beads, undercuts and displacements of edges to 1 mm (Figure 3) do not affect the service-ability of welded joints. The 5 mm wall thickness is appointed from the condition of minimum normative admissible thickness for the given vessel, which is confirmed by calculations of the outer tank [5].

Figure 3. General view of vertical welds on inner wall surface of the main tank

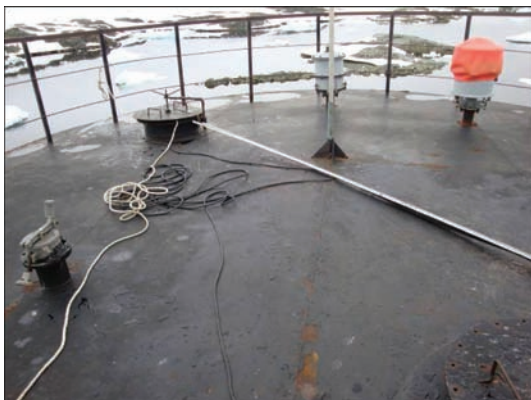
Roof of the tank. Each tank (outer and inner) has its welded conical girder roof. Between the roofs the clearance is about 300 mm. Each roof was assembled of two shields on the ground. The flooring of each roof around the perimeter is welded-on by continuous weld to the fringing angle piece on the outer and inner wall. The flooring thickness is equal to 4 mm, which corresponds to the project. All branch pipes of hatches and valves pass through the flooring of both roofs being welded-on to them around the contour. The general view of the tank roof is shown in Figure 4. On the surface of roof there are no unacceptable defects in form of deflections and fractures under snow load. The surface of the existing separate dents, with the absence of paint layer on them, is exposed to shallow atmospheric corrosion of 0.2–0.3 mm depth. The state of the roof is serviceable.

Figure 4. General view of roof of the tank RVS-200

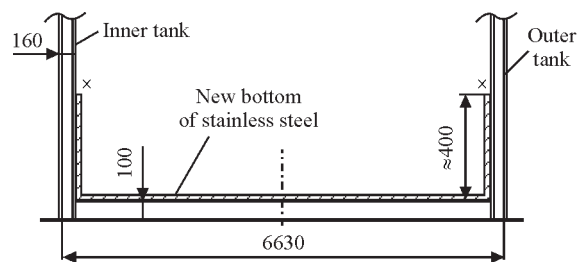
formed diagnostics of the tank showed that the most affected by corrosion are the bottom of the inner tank and the lower inner surface of its wall to the height of up to 300 mm. This is the zone of accumulation of sludge water and different salt deposits: sulfides, chlorides, etc. The certain areas of the bottom, mostly those adjacent to the welds, have extended pit corrosion damages. The pit corrosion damages are concentrated as the regions of 10–20 cm² at the depth of 2.0 mm. A damage of the wall adjacent to bottom has a more uniform character with the depth of pits up to 1–1.5 mm. The available corrosion damages indicate that the surface state of the main bottom and lower part of the inner wall will determine the estimated service life of the tank. At the same time it should be taken into account that when there are corrosion damages at separate places going to the depth of 50 % from the thickness and more, the bottom is subjected to replacement [7].

Figure 5. Scheme of constructive solution for protection of the inner bottom against corrosion

As one of the variants, the arrangement of a new bottom with the wall of up to 400 mm height on the bottom of the inner tank is proposed (Figure 5). The bottom and wall should be made welded of sheets of austenitic stainless steel of 3 mm thickness. The sheets of optimal sizes should be stacked and welded on the existing bottom without any special cleaning. Then the assembly and welding of sheets of the wall are performed between each other and along the entire upper perimeter to the wall of the inner tank. All the works should be carried out according to the project. In fact, a full impermeable lining of the lower surface of the main tank will be performed, which is subjected to active corrosion. The proposed solution ensures maintenance-free period of serviceability of the bottom for at least 40 years.

sider that one of such solutions, which are proposed in this publication, the arrangement of an additional protective bottom and a part of the wall of austenitic stainless steel can be.
