IMPROVING THE RELIABILITY OF POWER COMPLEX EQUIPMENT BY ELECTRIC ARC SPRAYING

A.V. Hruzevych¹ and V.V. Shvets²

¹Trypillia TPP PJSC «Centrenergo»

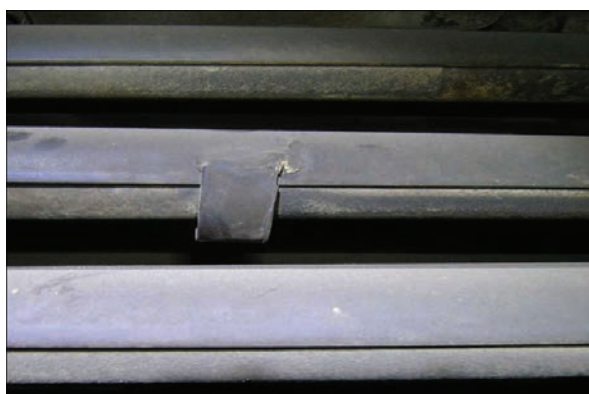
Figure 3. FWE tubes with butt plates of ash wear protection

The most vulnerable areas of FWE are the first and second return bends downstream with the gas flow in opening to the section until the first spacing bars, inner and outer return bends, extreme coils from the back side of the convection shaft over the whole width. Traditionally, for individual protection of coils, sealing rings of a segment shape are used (Figure 2) [6], which are mounted on the front part of tubes downstream with the gas flow. Butt plates (Figure 3) are mounted also in other areas prone to intense ash wear.

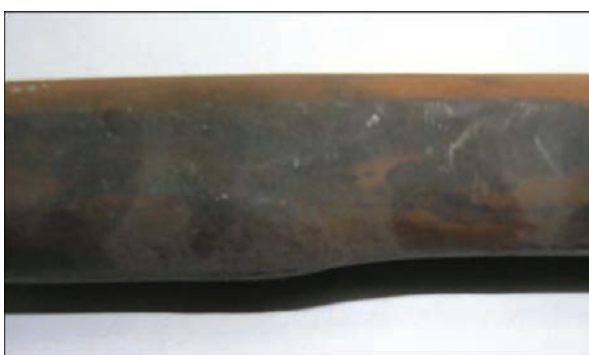
In connection with a significant wear of technological equipment, the issue of its effective repair is now very acute, which provides the restoration of serviceability, increase in reliability, extension in the service life while reducing the costs on repair and restoration works [7]. One of the ways to improve the reliability of power plant equipment [8, 9] is its protection against ash and corrosion wear by spraying. An intensive wear of heat exchange surfaces of TPP boilers, in particular, waterwall tubes and economizer tubes, is predetermined by the use of coal dust with most of the solid noncombustible impurities as a fuel [10–12]. According to classification criteria, analysis of damages [13] shows that the main cause of damage to boiler tubes is corrosion and erosion wear. According to [14], in some units its share reached 60 %. Especially often erosion affects FWE coils. Abrasive ash particles, which are captured by flue gases at a high speed, hit the surface of the tubes and cause ash wear (Figure 4).

Figure 4. Nature of damage to the FWE tube with a diameter of 32×6 mm as a result of action of ash wear

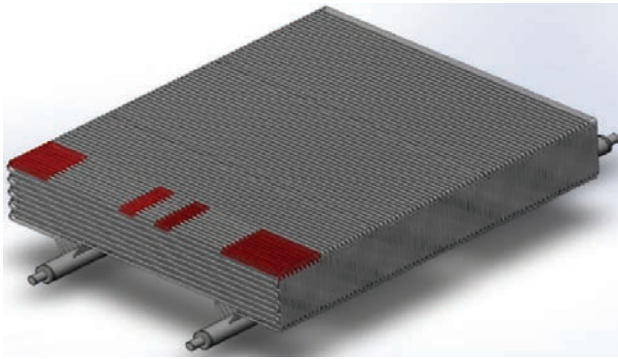
Figure 5. Areas of intensive ash wear of FWE tubes: straight sections and bends

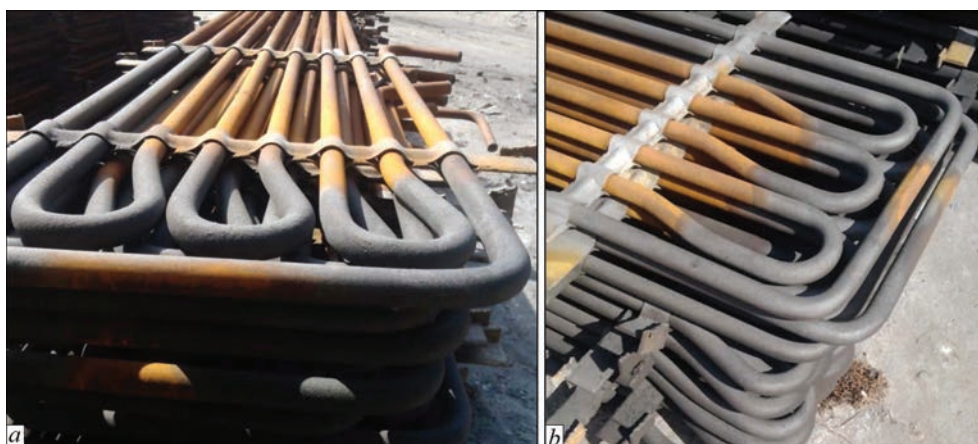
**Figure 6.** Appearance of sprayed coils

Electric arc spraying was carried out in 2013 on the most abrasive-worn sections of coils of FWE boilers TPP-210 A and TPP-312 A, corrosion-damaged sections of coil of steamer tubes in the spacing bars of the boiler TPP-312 A (low pressure). Photos of sprayed coils are shown in Figure 6.

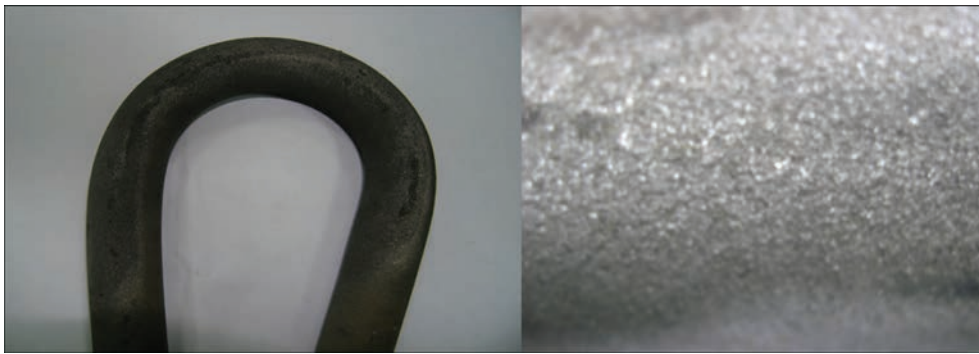
Figure 7. Appearance of tube bend and its surface after spraying sprayed zone. The sections were made by successive grinding and polishing. The etching of sections was performed in a 4 % solution of nitric acid in ethyl alcohol. For metallographic analysis, the microscope MIM-8M was used at a magnification of $\times 100$ and $\times 500$ times. The structure of the reference specimen is a ferrite-pearlite. Styloscopy was performed in a stationary styloscope SL-13. To external inspection, sprayed tubes and bends were subjected. Mechanical tests were carried out on flattening and determination of mechanical properties. At the Trypillia TPP after carrying out metallization of FWE coils with a diameter of 32×6 mm St.20, coils (production specimens) were cut out. Then, specimens were cut out of them, which were tested on flattening. Delamination of the coating layer occurs after bringing together the inner sides to $H_{in} = 15$ mm. Bringing of the sides together was performed up to $H_{in} = 10$ mm. The sprayed layer was subjected to measuring hardness in the ultrasonic hardness meter TKM-459.

Results and discussion. The inspection of tubes and bends showed that the sprayed layer has a rough surface with a metallic luster. At a detailed consideration of surface sprayings, separated large crystals are distinguished on it, which give it a significant roughness. Spraying has a uniform and solid distribution over the outer surface of the bends. As a result of performed spraying of tubes and bends at the Trypillia TPP, the photos of their macrostructure (Figure 7), as well as microstructure of the tube after spraying were made (Figure 8). The structure after metallization did not undergo changes and complied with the standard requirements.

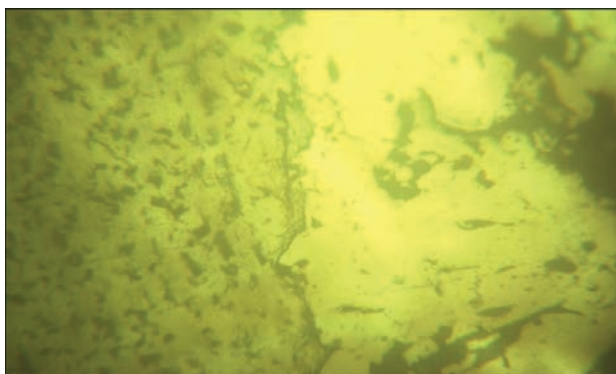
Figure 8. Microstructure ($\times 500$) of metal specimen with a sprayed layer

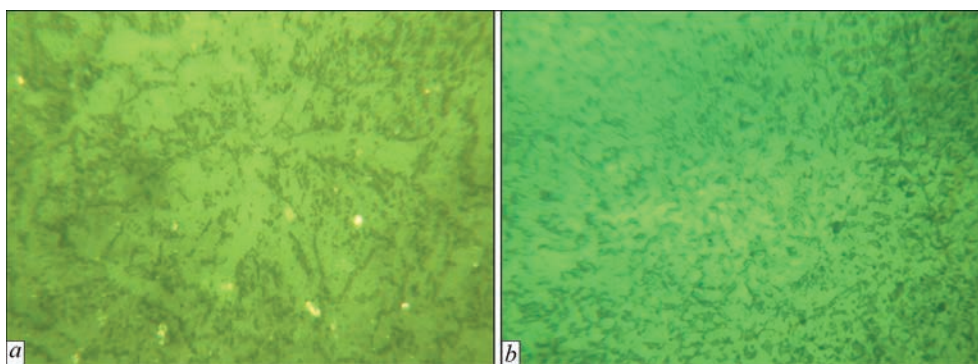
With the help of high-quality spectral analysis, it was found that a sprayed protective layer of FWE tube, produced by the method of electric arc metallization, represents a composite with a strengthening carbide phase in a metal matrix and contains such alloying elements as chromium and aluminium. The composition of the carbide phase is about 40 %. The base metal is carbon steel (alloying elements were not detected). In the microstructure of sprayed tubes from steel of grade 20 (Figure 9), the orientation on

Figure 9. Microstructure of sprayed tubes from steel of grade 20: *a* — $\times 500$; *b* — $\times 100$

the Widmanstatten structure should not exceed the 3rd point of the scale of the 2nd Appendix B «Scales of banding orientation and Widmanstatten structure of boiler tube metal» [21].

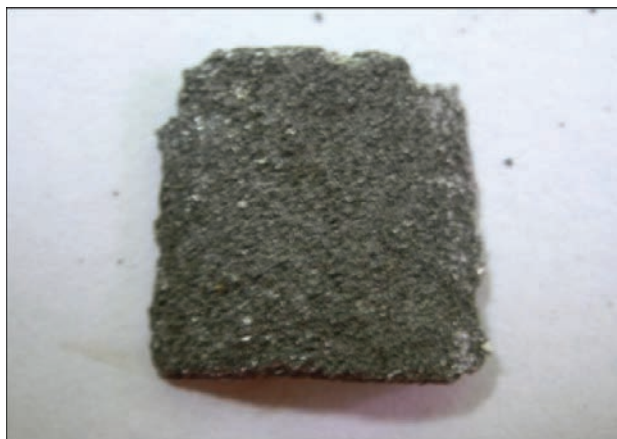
Figure 11. Delaminated layer after test on flattening

Destruction of the surface layer occurs by a delamination of large fragments of the sprayed layer. During mechanical tests for determining the tensile strength of the tube after spraying, the results were obtained given in Table 4.

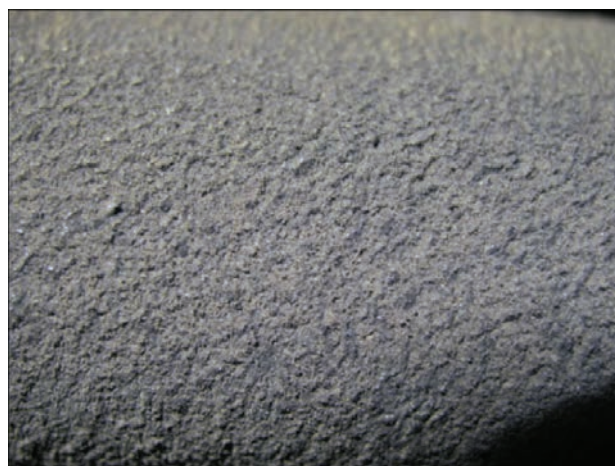
Figure 12. Macrostructure of sprayed tubes after six years of operation

features of electric arc metallization. In both cases, the thickness of the sprayed layer varies in different sections of the tube. Thus, in the frontal point of the tube, the thickness of spraying reaches 0.42 mm, and on the side points it amounts to 0.2 mm. Taking into account the boundary layer of the base metal, which was subjected to diffusion of the sprayed material in it, it can be stated that the largest spraying thickness is 0.57 mm (on the frontal part of the bend). When carrying out technological tests on flattening cracks, tears over the base metal of the tube were not detected. After tests on flattening (Figure 10) for a delaminated layer (0.55 mm) (Figure 11), the X-ray fluorescence analysis was conducted, which showed the following chemical composition, wt. %: 11.7–12.21 Cr; 0.12 Ni; 4.0–5.65 Si; 4.37–5.87 Al; 0.37–0.44 S. Photo of the macrostructure of sprayed tubes after six years of operation is shown in Figure 11.

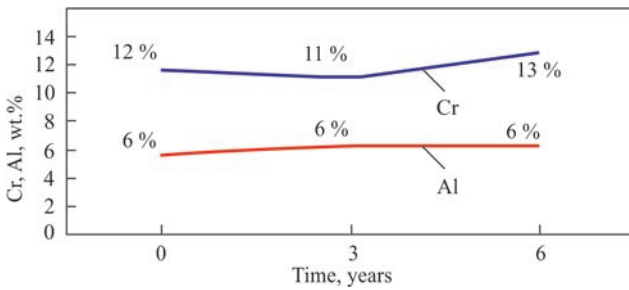
Figure 14. Change in the concentration of chromium and aluminum in the surface coating layer depending on service life

Horizontal lines in Figure 14 show that during six years, the concentration of chromium in the surface layer almost did not change and even slightly increased, its accumulation in the surface layer occurs. An increase in the concentration of aluminium in the surface layer is most likely associated with precipitation of aluminium-containing elements, formed in the process of combustion of organic fuel on the tubes of coils.

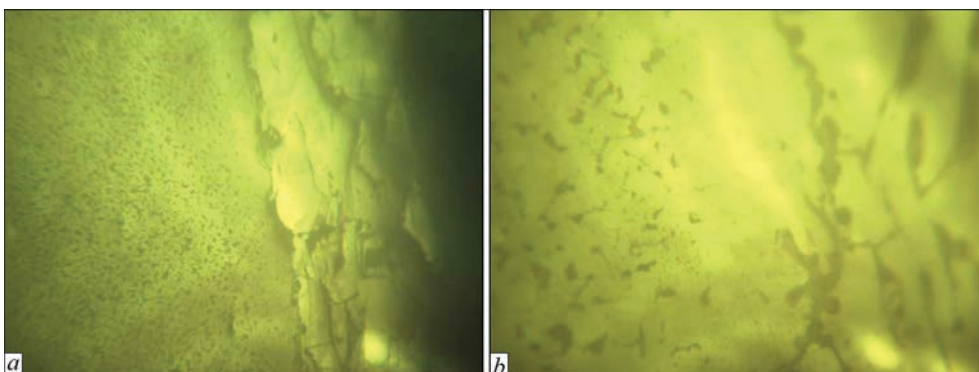
When carrying out cuts after six years of operation, macro- and microstructure of sprayed tubes (Figures 12, 13), the composition of the surface layer were also recorded (Table 6). Technological tests on flattening, the measurement of hardness was not carried out. During operation, the surface becomes more rough, on the surface protruding carbides of different size are visible.

Figure 13. Microstructure of sprayed tubes after six years of operation: *a* — $\times 100$; *b* — $\times 500$
