# EVALUATION OF DAMAGE OF ALL-WELDED LONGITUDINAL MAIN BEAMS OF THE E.O. PATON BRIDGE ACROSS THE DNIPRO RIVER

The problem of general evaluation of technical condition of main longitudinal beams of the E.O. Paton Bridge was considered based on the results of selective non-destructive testing of truss elements. It is shown that the main cause of damage to the elements of the main beams is corrosion of the nodal welded joints in the places of debris accumulation. High quality of welded butt joints made by automatic and semi-automatic submerged arc welding was noted. 10 Ref., 18 Figures.

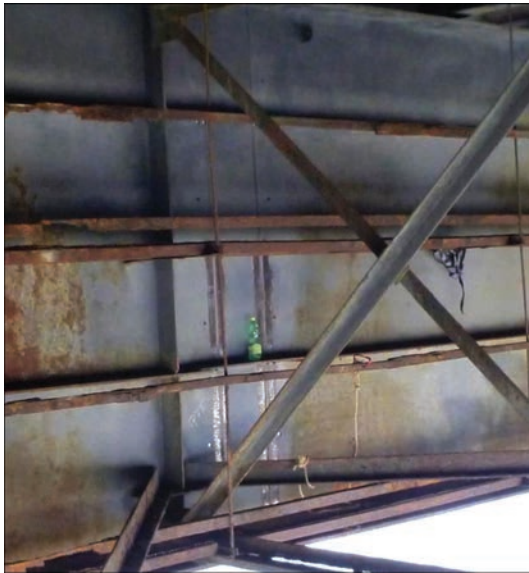
**Figure 5.** Example of testing butt vertical welds of the joining insert

The main attention during the selective ultrasonic testing of butt welds was paid to the places where defects were detected during the erection and manufacture of truss elements [3, 4, 9], and to the maximum stressed areas. At a total length of erection and shop welded joints of about 110 km, 150 m of welded joints were inspected, 50 % of which amounted to erection welds at the places of joining trusses (Figures 2, 3, 5, 6).

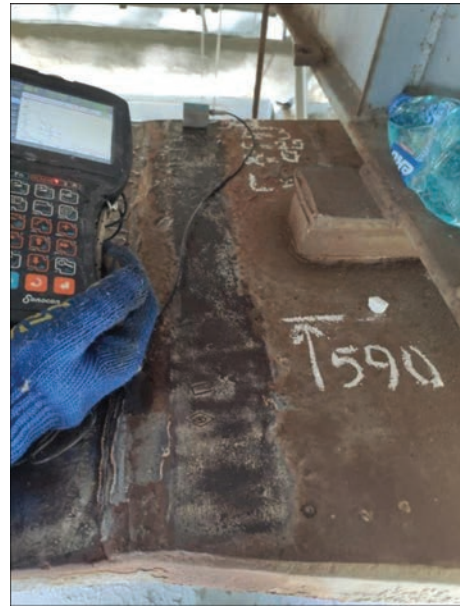
**Figure 6.** Example of testing butt weld in the upper girth of the joining insert

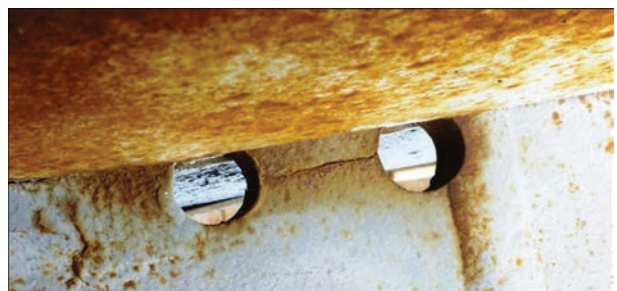
defects that were detected already at the stage of construction of the bridge, did not propagate in the process of a long-term operation (Figure 7).

**Figure 7.** Example of absence of growth of a defect left during erection (ends of the crack were arrested by drilling method) [4]

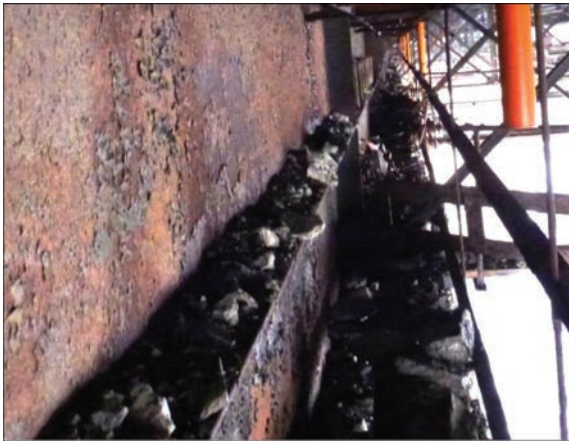
**Figure 8.** Area of debris accumulation and condition of inspection passages on the inner side of the end beam of the five-span structure

of thickness from corrosion. This was especially observed in the areas of large debris accumulation on the lower horizontal stiffeners, the lower girths of the end beams and at the ends of the supports of the span structures (Figures 8–10).

The greatest loss of metal thickness as a result of corrosion was found in the trusses of the end main beams No.1 and No.4 (Figures 14, 15). The main cause for such a damage was the presence of debris on the lower horizontal stiffener and the lower girth of these beams, which retains moisture (Figures 8–13).

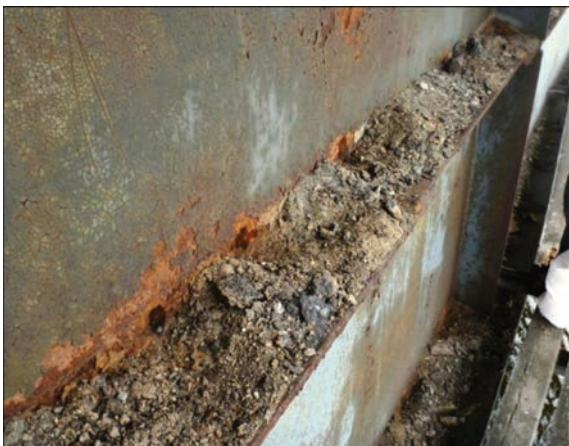
**Figure 9.** Area of debris accumulation on the outer side of the end beam of the five-span structure

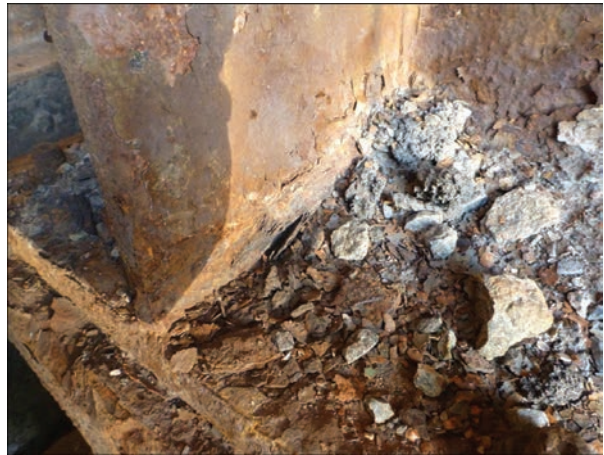
**Figure 10.** Area of debris accumulation in the supporting part of the four-span structure

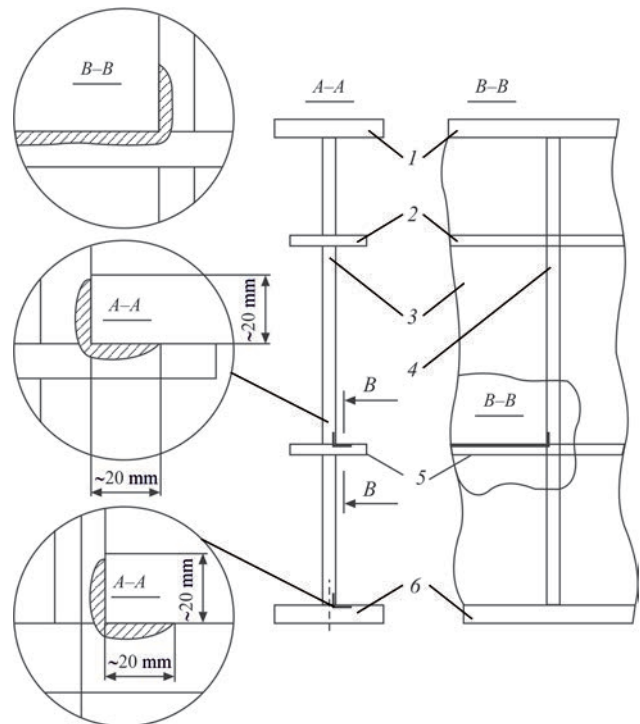
**Figure 11.** Typical corrosion damages of welded joints of truss elements of the main beams: 1 — upper flange; 2 — upper horizontal stiffener; 3 — wall; 4 — vertical stiffener; 5 — lower horizontal stiffener; 6 — lower flange

was carried out and on the generalized schemes of span structures. The most typical places of corrosion damages of welded assemblies of the main beams of the bridge are presented in Figure 11.

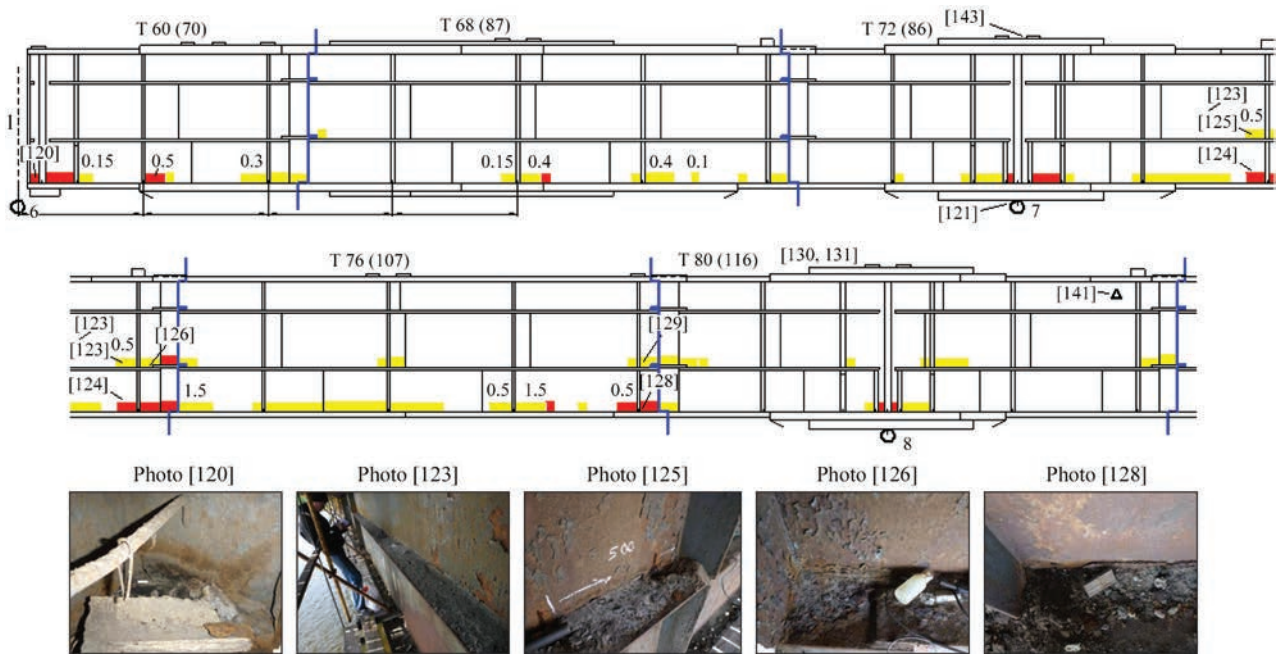
**Figure 12.** Fragment of tabulated results of testing elements of the beam No.1 of the five-span structure located between the 6-9 support

As an example, Figures 12, 13 present the sections with detected corrosion damages and a delamination of the main beams of span structures.

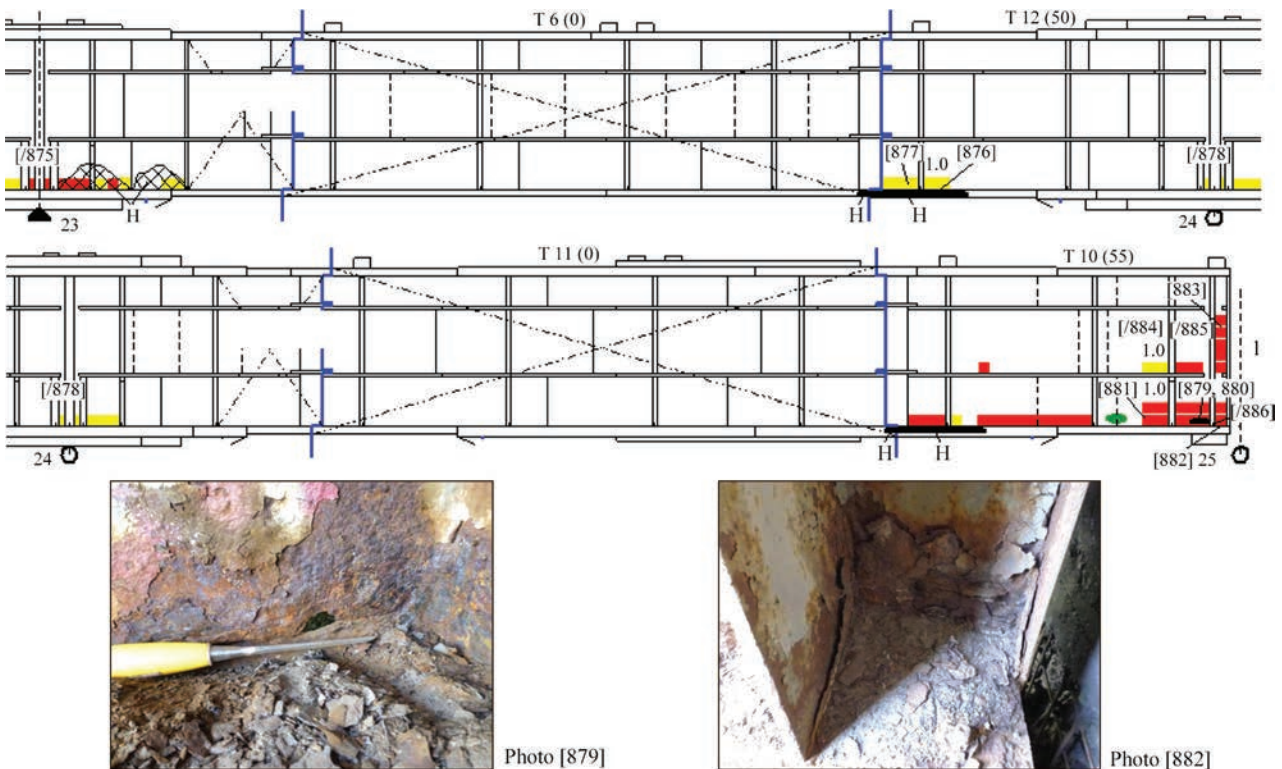
**Figure 13.** Fragment of tabulated results of testing elements of the beam No.1 of the four-span structure located between the 21–25 support

The maximum corrosion damages to the elements were detected in trusses T10 and T15 of the four-span structure of the main beam No.1 and trusses T1 and T3 of the four-span structure of the main beam No.4. In these trusses deep corrosion damages (rust-through in some places, Figure 13), which need urgent repair.

5. The deepest corrosion damages (in some places through) were observed in the trusses T10 and T15 of the main beam No.1 and the trusses T1 and T3 of the main beam No.4. These trusses need urgent repairs.

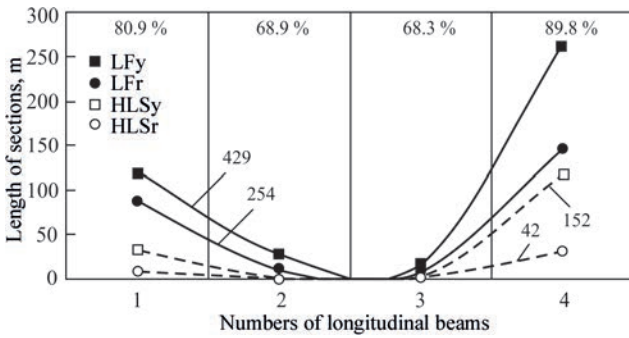
**Figure 14.** Total length of detected corrosion damages of the main longitudinal beams in the welding assemblies of the following elements: middle wall of the truss to the lower horizontal stiffener — HLS (y, r); lower wall to the lower flange of the truss — LF (y, r) (marks «y» and «r» characterize the depth of corrosion damages from 2.0 to 4.0 mm and more than 4.0 mm, respectively)

The smallest depth of corrosion damages was observed near the expansion joints in the trusses of the middle main beams No.2 and No.3, where debris was absent (Figure 14). In addition to the sections of the main beams No.2 and No.3, located near the expansion joints, other elements of these beams are in satisfactory condition.

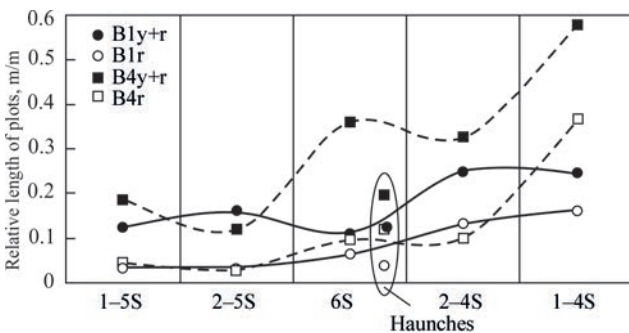
**Figure 15.** Relative length of detected sections damaged by corrosion in the welding-on assembly of the lower wall to the lower flange of the truss for the structures 1-5S; 2-5S; 6S; 2-4S; 1-4S of the end beams No.1 and No.4 to the controlled length of the structures (B1y+r is the total length of damages with a depth of more than 2.0 mm of the beam No.1; B1r is the total length of damages with a depth of more than 4.0 mm of the beam No.1; B4y+r is the total length of damages with a depth of more than 2.0 mm of the beam No.4; B4r is the total length of damages with a depth of more than 4.0 mm of the beam No.4)

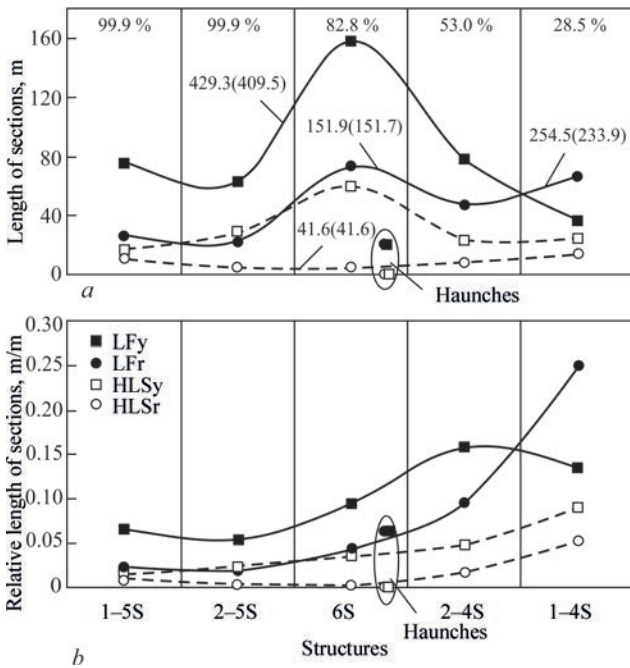
Thus, Figure 16, *a, b* shows a dependence of the detected corrosion-damaged areas of the inspected structures, where in the top of the diagram the percentage of the performed testing on the structures is indicated.

**Figure 16.** Length of detected sections damaged by corrosion of structures and percentage of performed testing (percentage of testing is indicated above) (a) and the relative length of detected sections damaged by corrosion of structures to the controlled length (b). The numbers indicate the total length, taking into account the data on haunches (in parentheses — without haunches) requires other approaches using probable methods. Thus, Figure 18 shows diagrams of distribution of detected damages to the trusses in the assemblies of welding-in the lower girth to the lower wall between the supports for the main beams No.1 and No.4. From the analysis of the results of this diagram it was found that the sections of detected damages are chaotic. The

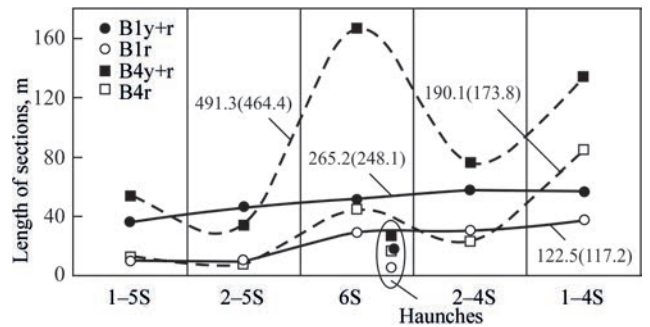
**Figure 17.** Example of predicting length of detected sections damaged by corrosion in the welding-on assembly of the lower wall to the lower flange of the truss for the structures 1-5S; 2-5S; 6S; 2-4S; 1-4S of the end beams No.1 and No.4 (designation of curves as in Figure 15)

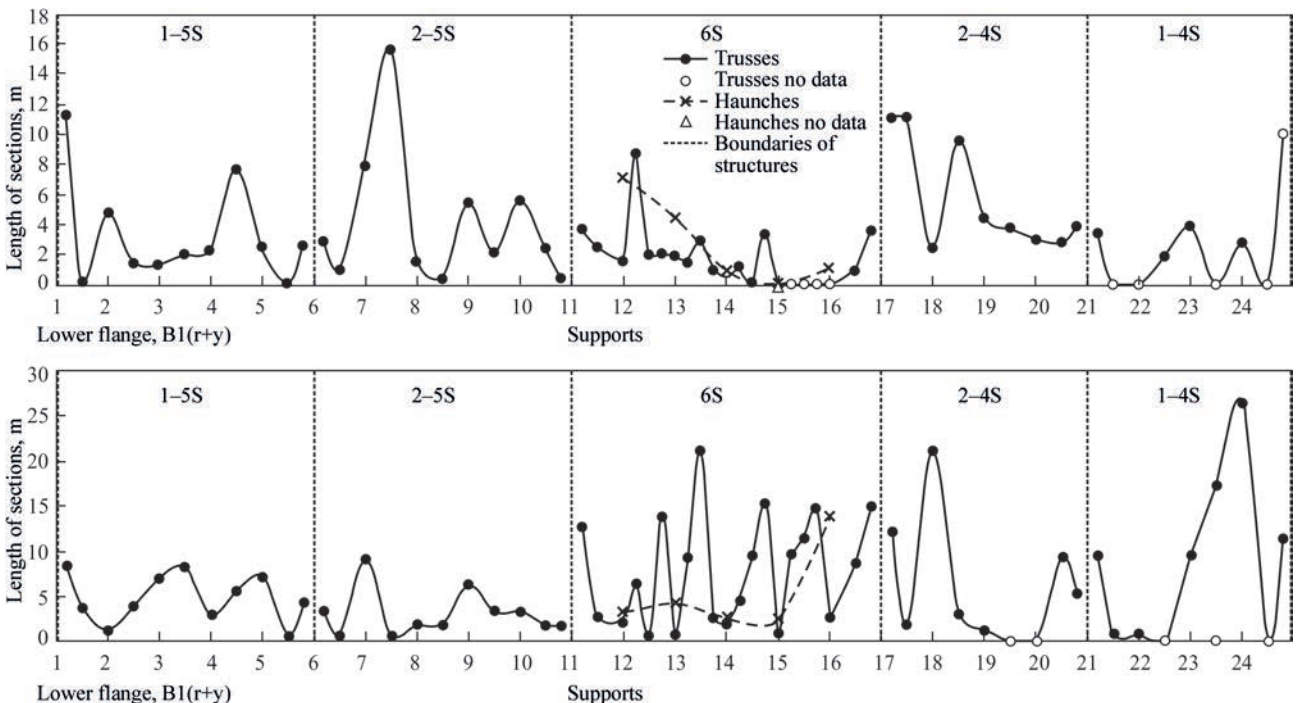
only similar pattern is an increase in damages along the boundaries of the structures.

**Figure 18.** Distribution of detected damaged sections in the welding zone of the lower girth to the truss wall between the supports for the main beams No.1 and No.2 (designation as in Figures 15, 17)
