ANALYSIS OF CAUSES OF FAILURE OF FIELD WELDED BUTT JOINTS OF MAIN PIPELINES AFTER LONG-TERM OPERATION

L.I. Nyrkova, L.V. Goncharenko

E.O. Paton Electric Welding Institute of the NASU
11 Kazymyr Malevych Str., 03150, Kyiv, Ukraine

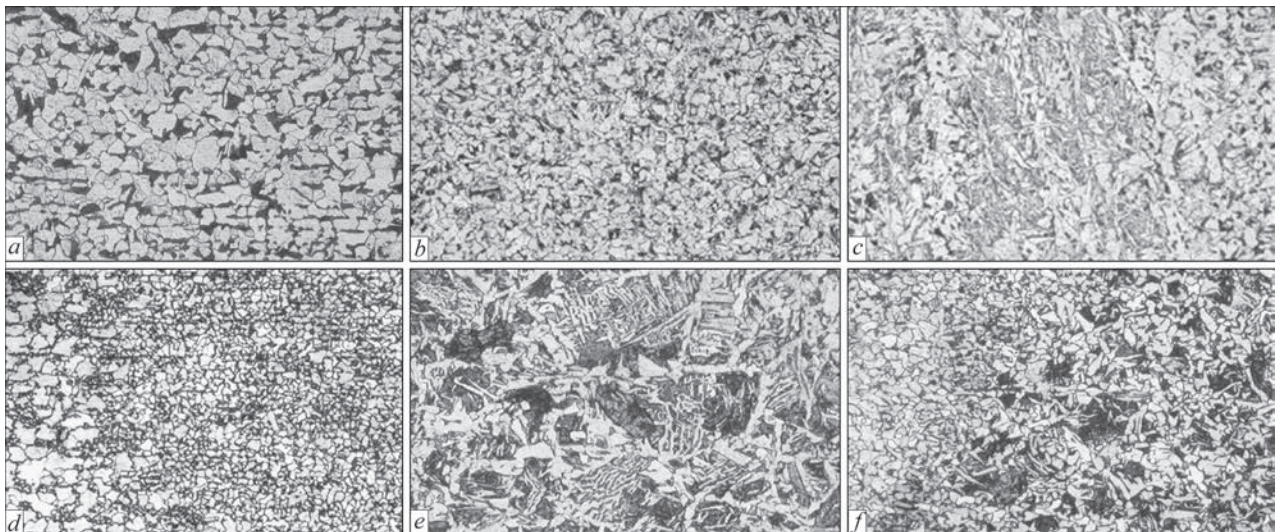
Figure 1. Metal microstructure of the circumferential welded joints of pipes of 17G1S steel, ×200: *a* — base metal; *b* — metal of root layer; *c* — metal of facing layer; *d* — zone of coarse grain of root layer; *e* — zone of coarse grain of facing layer; *f* — weld and zone of coarse grain of filling layer

structure of the metal of the root layer and filling layers, which are subjected to reheating while producing the subsequent layers, is mainly ferritic-perlitic with more equiaxial grains of ferrite (Figures 1, *b, d, 2, c, d*). A typical microstructure of metal of facing layers (Figures 1, 2) is a mixture of different forms of structural components of mainly polygonal ferrite, bainite, and smaller individual areas of Widmanstaetten and lamellar ferrite and pearlite. It should be noted that the change in the amount of impurities of alloy elements in steels and welds affects mainly the ratio of hypoeutectoid ferrite and intermediate decomposition structures that replace pearlite. Therefore, in the circumferential weld on the 15GSTYu steel (Figure 2), compared to the weld on the 17GS steel (Figure 1), the amount of bainite increases, and pearlite is almost absent, the amount of hypoeutectoid ferrite remains stable. The sample of the structure of the facing layer of circumferential joints of the pipe of 17GS and 15GSTYu steel is shown in Figure 1, *c* and Figure 2, *c*.

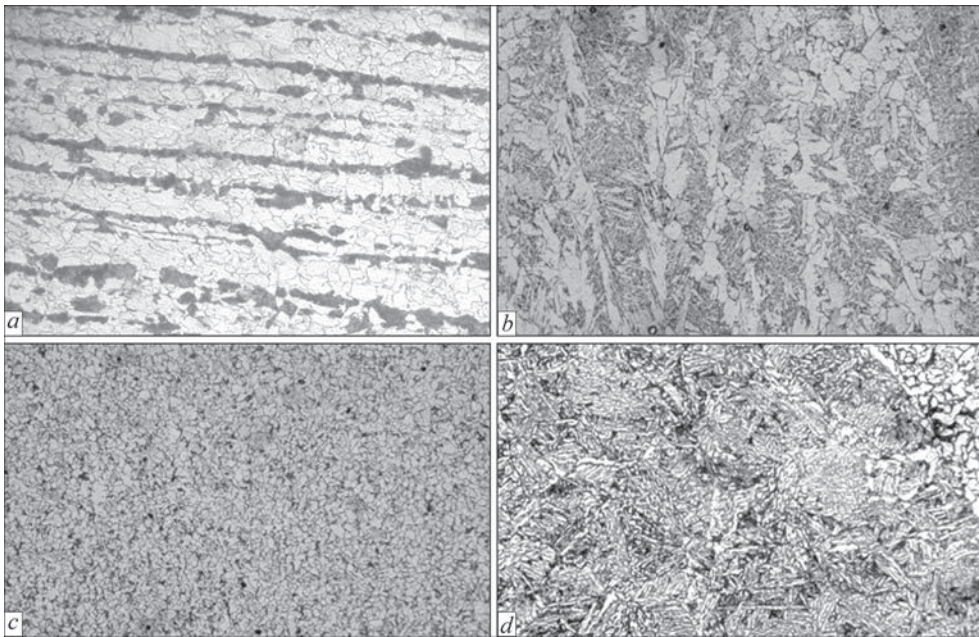
Figure 2. Metal microstructure of the circumferential weld of pipes of 15GSTYu steel: *a* — base metal; *b* — facing weld, $\times 200$; *c* — root weld, $\times 200$; *d* — zone of coarse grain of facing layer, $\times 320$

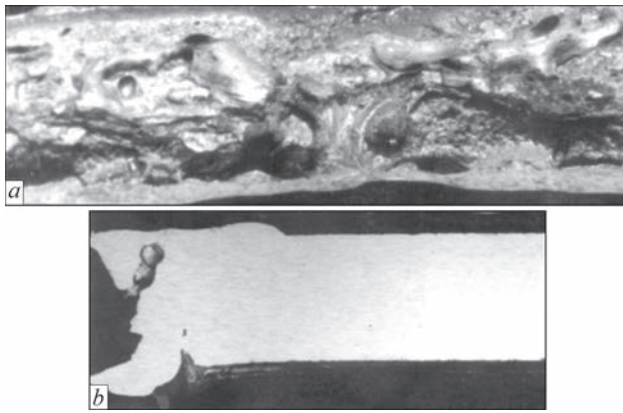
In the first case, the failure of the circumferential weld of the welded joint of the main gas pipeline, constructed approximately in 1987 from spirally-welded pipes of 17G1S steel, occurred mainly over the area of fusion of the circumferential weld with the base metal (Figure 3) at the area of about 3/4 perimeter of length of this butt. The root and filling layers of the circumferential joint are produced by manual arc welding, and the facing layer — by submerged arc welding. On the surface of the fracture, at one of the areas of failure, a large number of pores with a diameter of not more than 3 mm and with a depth of not more than 7 mm (Figure 3, *a, b*) were found. On the transverse macrosections of the samples from this area, deep pores (Figure 3, *b*) are seen, which spread to the metal of circumferential weld from the zone of its fusion with the base metal on the outer surface of the pipe. The pores are combined with a lack of fusion zone (300 mm long, 8 mm deep) of the filling and facing layers with the base metal, which led to weakening of the weld intersection. On the opposite side of the failure, a part of the unmolten edge is seen. Also, a displacement of the axis of the outer weld relative to the root by 3 mm is observed. In the specified area, lack of fusion of the root weld with the base metal (up to 3 mm deep) is observed. The total length of this defective area is approximately 350 mm, the depth does not exceed 7 mm. In other areas of the failure around the perimeter of the circumferential weld, only separate pores with a diameter of not more than 2 mm are present. The peculiarity of this joint of pipes with a circumferential weld is reduction in the hardness of the HAZ metal by $50 HV_{49}$, which is a consequence

Figure 3. Appearance of fracture (*a*) and defects (*b*) in the metal of the failed weld of the gas pipeline of spirally-welded pipes with a diameter of 1020 mm of 17G1S steel: *a* — lack of fusion of 8 mm depth, pores of 7 mm; *b* — welds displacement, pores of 8 mm depth

of metal softening during welding. The width of the area of the strength decrease is 4–5 mm. The revealed metal softening in the case of welding of heat-treated pipes is a typical phenomenon and it did not cause failure of the investigated welded joint.

In view of the abovementioned, it can be assumed that the cause of the failure of the field welded joint of the gas pipeline from the spirally-welded pipes are defects of a circumferential weld formation in the form of elongated (about 300 mm) lack of fusion of the root and filling layers with one of the edges of the joint and pore clusters. These defects were formed during welding operations in the construction of the gas pipeline as a result of displacement of the mentioned layers relative to the butt of the joint edges and were not detected by non-destructive testing.

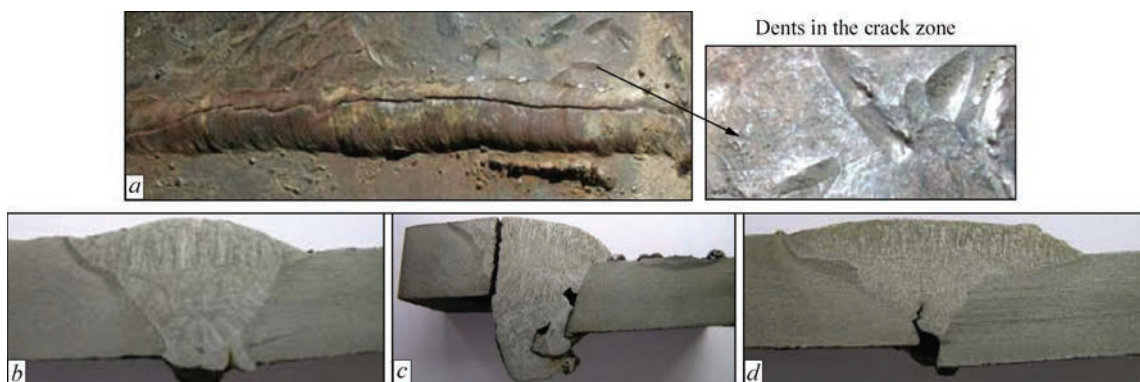
In the second case, on the main gas pipeline of 15GSTYu steel, the construction of which dates back to 1970, while performing diagnostic works, gas leakage was detected. The working pressure in this gas pipeline was 4.7 MPa. The gas pipeline is covered with bitumen-rubber insulation. At the upper part of the circumferential joint in the weld, a through crack-like

defect was revealed (Figure 4). The circumferential weld, produced by one-sided manual welding, joined a spirally-welded pipe with a size of 1020×10.6 mm of 15GSTYu steel with a 1020×9.5 mm pipe of the Kh60 steel. The detected defect is located along the weld at some displacement relative to its center. The length of the defect is approximately 250 mm. The edge preparation is insignificant (does not exceed 1 mm). The welded joint at a length of approximately 170 mm was produced with a significant edge displacement in the radial direction and with a wide gap of the edges (Figure 4, *c*). The edge displacement in this area is 6 mm, which is much higher than the allowable rate (not more than 3 mm). On the outer surface of the pipes in the defect area near the fusion line of the circumferential weld, traces of plastic deformation of the metal formed during the assembly of edges of the pipes with the purpose of their alignment for welding are observed.

At the fracture it is seen that the initial crack passes along the edge of the root layer and begins from the lack of fusion with one of the edges of the butt joint (Figure 4, *d*). The depth of the lack of fusion is approximately 3 mm. The back formation of the root layer of the weld is completely absent. The location of the crack coincides with the area of the metal flow in the zone of significant edge displacement (Figure 4, *c*). In the defect zone adjacent to the inner surface of the butt joint, there are pores and their clusters. The size of individual pores reaches 4 mm.

Taken into account the abovementioned, it can be stated that the cause of the failure of the circumferential weld of the specified main gas pipeline was a poor quality of assembly of edges of the circumferential welded joint (inadmissible sizes of radial displacement of welding edges and a wide gap), which led to the appearance of defects of formation (lacks of fusion, pores) in the root weld in the process of its welding, and subsequently provoked the occurrence

Figure 4. Defects in the circumferential weld of the pipeline with a diameter of 1020 mm from 15GSTYu steel and Kh60 steel: *a* — crack of ~250 mm long in the circumferential weld; *b* — macrosection of the circumferential weld outside the crack; *c* — macrosection of the circumferential weld in the crack zone, edge displacement of up to 6 mm, lack of fusion of edges; *d* — macrosection of the circumferential weld in the end part of the crack, lack of fusion and crack in the root layer, edge displacement of up to 3 mm

of a through crack. The formation and propagation of a crack was facilitated by local stresses, caused by attempts of a forced elimination of the inadmissible radial edge displacements. The crack surface is significantly damaged by corrosion indicating a long-term operation of a pipe with a defect.

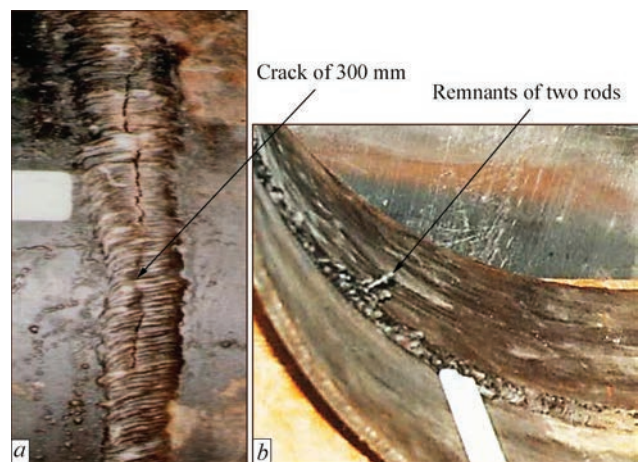
Further, the failure of two circumferential welded joints of the oil pipeline with a diameter of 720 mm, built from pipes with a wall thickness of 7.4 mm of the strength class K54 was considered. In the first circumferential weld, a through crack-like defect of about 300 mm in length was revealed (Figure 5). In the crack zone, the exceeding sizes of the edges at a length of 600 mm were observed, which reached 7 mm, and a large gap between the edges of up to 10 mm at a length of 740 mm. In order to reduce the gap, contrary to standard documents, 2 rods with a diameter of 6 mm and a length of up to 150 mm were welded into the edge preparation (Figure 5, *b*). In the weld root, the formation of the inner weld is poor, here inadmissible lacks of penetration and lacks of fusion of the edges of up to 3 mm deep were found. In the second circumferential weld, in the fracture of the failed joint such defects as lacks of fusion and lacks of penetration on the side of the inner surface of the weld with a total length of about 100 mm were also detected. The minimum thickness of the deposited metal in the intersection between the outer surface and the area with defects (defect-free area) did not exceed 1 mm.

Therefore, the cause of oil leakage in the 3rd investigated case is the formation of defects in the welds of the circumferential joints as a result of improper performance of the welding process with a clear violation of rules of butt joint assembly, in particular, in the presence of a significant (up to 7 mm) excess of the edges and the gap (up to 10 mm) between them, as well as the use of additional embedded elements to fill the edge preparation. The occurrence of cracks in the circumferential welds was facilitated by the presence of inadmissible lacks of penetration in the weld root and lacks of fusion in them, caused by a low quality of assembly of the butt joint. The propagation of cracks and the formation of a through defect occurred, most probably, as a result of a variable load during the operation of the oil pipeline.

Figure 5. Circumferential joint of the oil pipeline with a diameter of 720 mm with a crack in the weld: *a* — on the side of the outer surface of the pipe; *b* — on the inner surface of the pipe

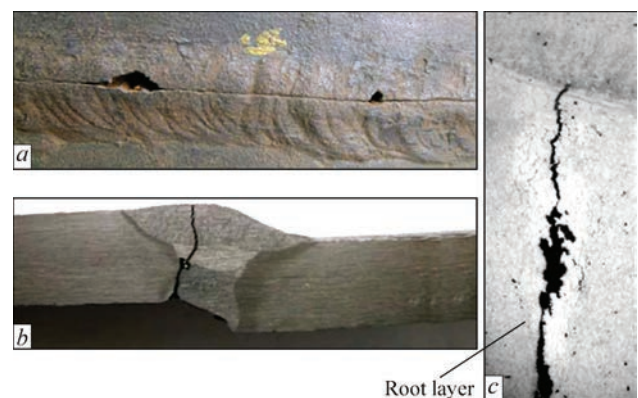
As for the 4th case, there non-structural embedded elements were detected to fill the excessive gap in the welded joint of the gas pipeline with a diameter of 1020 mm, built of the pipes made of coiled hot-rolled 15GSTYu steel. The detected through defect in the circumferential weld was oriented almost in the center of the weld and had a length of about 200 mm (Figure 6, *a*). The part of the weld of 700 mm long, which included also an area with a crack, the edge displacement of the pipes in a radial direction is pres-

ent (Figure 6, *b*). The largest edge displacement (up to 5 mm) was recorded in the crack zone. Namely in the part of the crack, in the zone of the root layer, lacks of fusions of edges were observed, the depth of which reached 3.5 mm. On the inner side of the circumferential joint, there are areas of significant metal leakage (up to 7 mm in height).

The analysis of the chemical composition of the root layer metal in the crack zone revealed an excessively high content of vanadium, up to 1.7 % (usually, the content of vanadium in the welds in a low-alloy or a microalloy pipe steel does not exceed 0.1 %). This indicates that while producing the circumferential weld with a large edge displacement, metal billets were used to prevent metal leakage in this area, which led to a significant increase in the content of vanadium in the root layer and the occurrence of a hot crack in its center (Figure 6, *c*).

Figure 6. Crack in the circumferential welded joint of the pipeline with a diameter of 1020 mm from 15GSTYu steel: *a* — general appearance of the circumferential joint with a crack; *b* — crack in the weld, edge displacement in the area with a crack (up to 5 mm); *c* — anomalous structure of the metal of root and filling layers of the field joint (vanadium content is ~ 1.7 %), produced by manual welding in the crack zone

ed joint of the gas pipeline, built from the pipes with a diameter of 1020 mm of the 15GSTYu steel, is a crack formed as a result of using additional foreign elements, gaps and excesses of edges during welding of the root layer, which are unacceptable according to standard documents. This led to a local enrichment (up to 1.7 %) of the root weld metal with vanadium and occurrence of a crack of hot origin. Thus, it can be assumed that during the operation of the gas pipeline, it gradually propagated in the filling and facing layers of the circumferential weld before the formation of a through defect. The formation of a through defect was largely facilitated by defects in the circumferential weld and disadvantages of edge assembly, first of all, excessive one, up to 5 mm, their exceeding and unacceptable gaps.

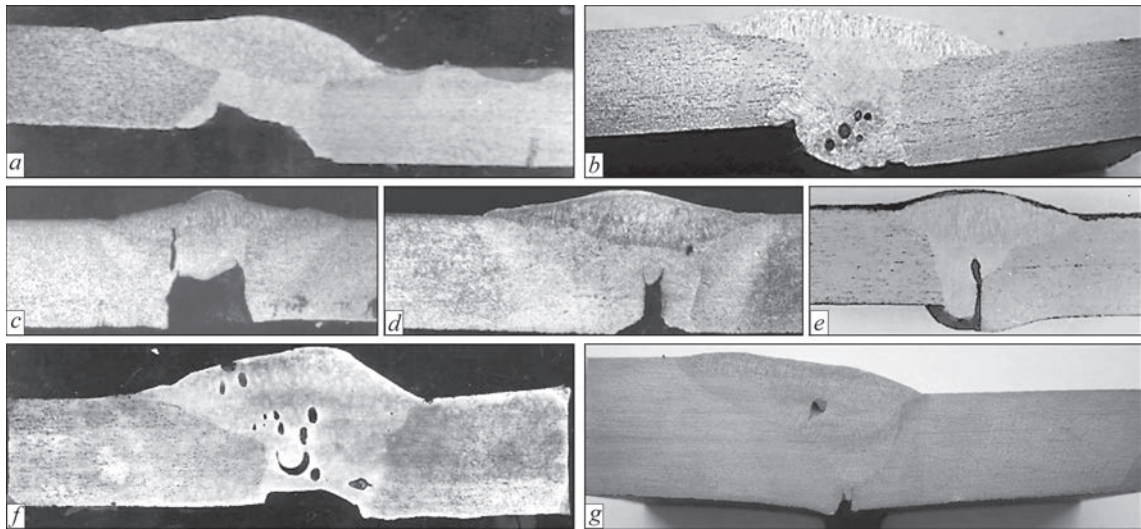
Figure 7. Defects in the circumferential welded joints of gas and oil pipelines of pipes with the sizes: *a* — 720×9mm of 17GS steel, edge displacement, wide gap, lack of filling the root part of the weld; *b* — 820×9 mm of 19G steel, edge displacement, wide gap, deformed ends of pipes, accumulation of pores; *c* — wide gap, lack of root layer, lack of fusion of the weld with the base metal; *d* — 720×7.5 mm of 17GS steel, lack of penetration in the root layer with a depth of 4 mm; *e* — 720×8mm of 16GB steel, edge displacement, lack of fusion (4 mm) in the root part of the weld; *f* — 720×9 mm of 19G steel, gap exceeding the standard, accumulation of pores; *g* — different thickness joint of 17G1S steel of 1020×10 and 1020×14 mm, deformed ends of pipes, lack of penetration in the root layer

and propagated during operation. Typical defects are shown in Figure 7.

Most often, it was possible to identify the following defects: radial edge displacement (Figure 7, *a*, *b*, *e*), excessive gap between the edges (Figure 7, *a*, *b*, *f*), lack of penetration of the root layer (Figure 7, *a*, *c*, *d*, *e*, *f*), lacks of fusion of the root or intermediate layers (Figure 5, *e*), pores and slag inclusions (Figure 7, *b*, *f*), deformed ends of pipes (Figure 7, *g*). It should be noted that in most cases the revealed defects were formed as a result of poor performance of the operation of assembly of edges (their excessive displacement or gap) of adjacent pipes in the process of pipeline construction.
