REMOTE ASSESSMENT OF DAMAGES OF THE KYIV TV TOWER BASED ON THE USE OF AERIAL PHOTOGRAPHY AND THE METHOD OF PHOTOGRAMMETRY

L.M. Lobanov¹, D.I. Stelmakh¹, V.V. Savitsky¹, V.P. Diadin¹, O.P. Shutkevych¹, A.G. Kozachek²

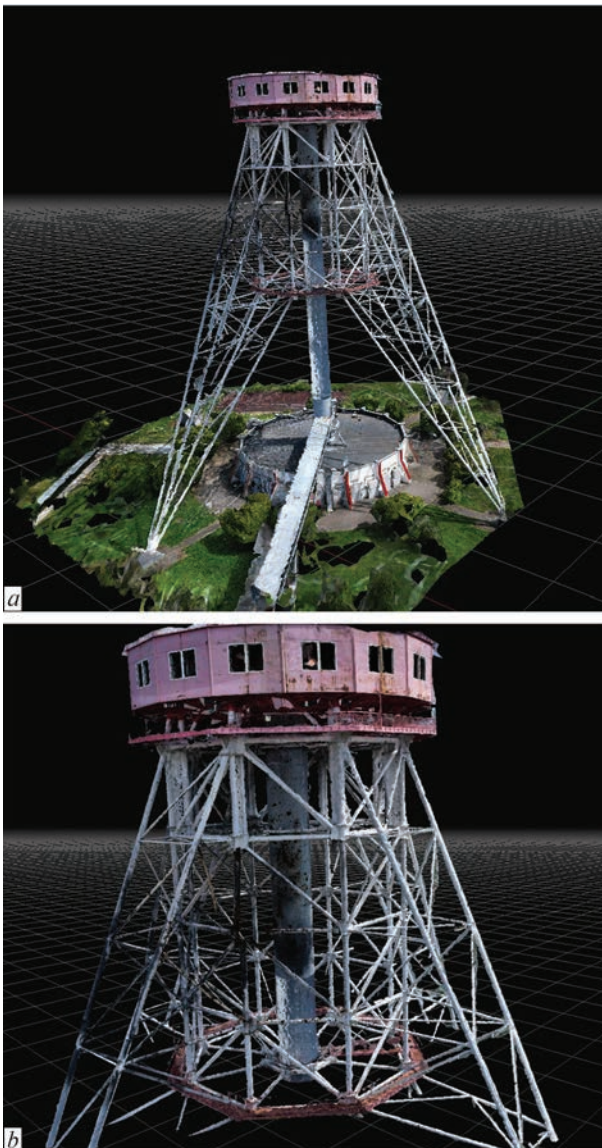
Figure 1. Models of the lower tier of the Kyiv TV tower: *a* — full-scale model; *b* — place of explosion

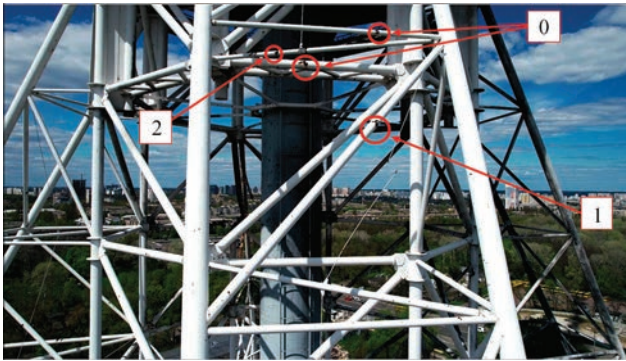
Figure 2. Photo of support element obtained with an unmanned aerial vehicle at aerial photography of the TV tower

Figure 2 shows defects formed from a missile explosion. Defect 0 represents a destruction of the protective coating of the structural element and is not dangerous for the tower in the short term. Defects 1 and 2 are the holes formed as a result of penetration of a fragment through the wall of the pipe and through them water and moisture gets into the middle of the pipe elements, which leads to their corrosion and a significant decrease in strength characteristics.

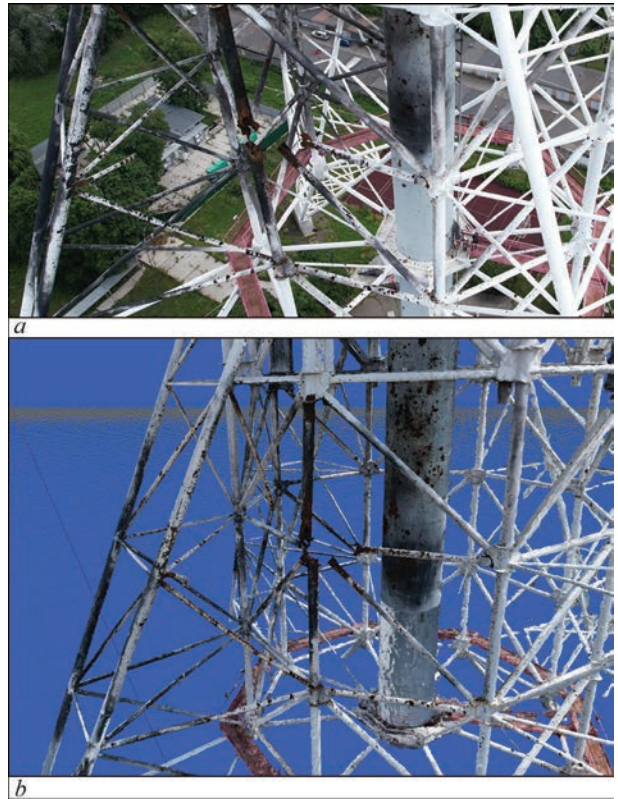
Figure 4. Area of the TV tower at the epicentre of the explosion: *a* — photo; *b* — 3D model

The 3D model allowed successfully visualizing large damages with their real appearance and sizes (Figure 4).

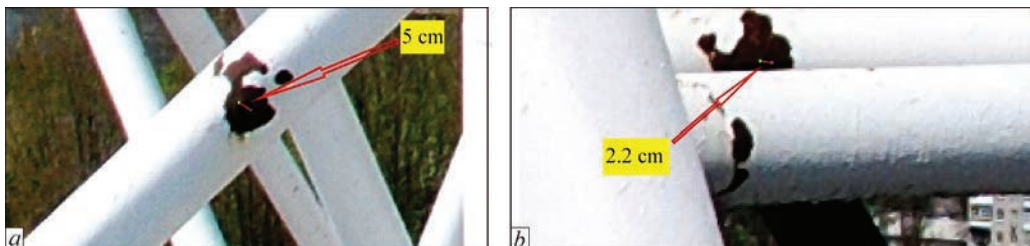
Figure 3. Photos of damages in the structural element of the TV tower: *a* — defect 1; *b* — defect 2 (see Figure 2)

Based on the analysis of photographs and their projections on a digital 3D model obtained by the method of photogrammetry, the typical sizes of these defects were measured. Thus, for example, with the help of the Measures tool it was found that the diameter of the first defect is approximately 5 cm (Figure 3, a), and the second one is 2.2 cm (Figure 3, b). It is worth noting that these defects were found on the least damaged support of the TV tower.
