GAS-POWDER SPRAYING AS A HIGH-EFFICIENT METHOD OF INCREASING THE OPERATION RELIABILITY OF POWER EQUIPMENT

In the work the spraying is suggested as the promising and high-efficient method for improvement of operation reliability of TPP power equipment. As the main type of wear of pipe elements of TPP power equipment is the ash wear and corrosion, then to increase their reliability, service life and working capacity it is suggested to apply the electric arc spraying using material PP 70Kh10R3Yu5 as a method of thermal modification of heating surfaces. The aim of the work is the investigation of efficiency of spraying application for improving the operation reliability of TPP power equipment. Spraying of heating surfaces was carried out in two thermal power plants of PJSC «Centrenergo» in 2013. A feasibility study showed that the implementation of spraying technology allows 1.5–2.0 times decreasing the expenses as compared with losses, incurred by TPP in case of emergency shutdowns, and increasing the service life of the equipment approximately by 1.4 times. 15 Ref., 7 Tables, 12 Figures.

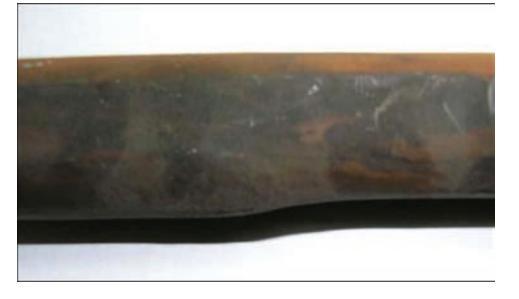
Figure 1. Nature of damage of 32×6 mm diameter pipe of water economizer as a result of ash wear effect

pipe surface occurs nonuniformly over a large area, it is localized in definite places and when reaching the critical thickness of pipe wall its burst takes place, which leads to the power unit shutdown. The thermal load to the outer pipe wall is also increased due to sedimentation of salts on inner surfaces of water-wall tubes, which, in addition, undergo the corrosion-erosion damages. Therefore, the development of new effective methods of improving the operation reliability of power equipment of TPP is the urgent direction.

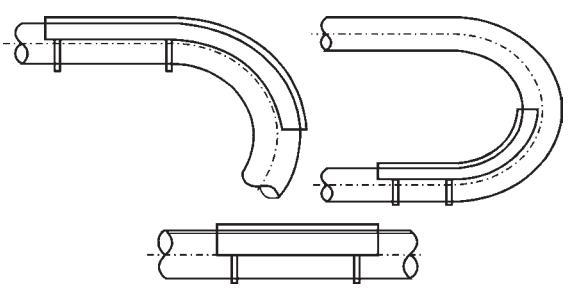
Figure 2. Individual collars for protection of bends and straight regions of pipes of a water economizer of TPP boilers

of heating surfaces in places of distance-type straps location is not rational due to a local increase in section, as the collars do not possess special properties for pipes protection from the corrosion-erosion effect. The corrosion-erosion processes will be proceeding in any case, and the additional increase in pipes weight (due to collars application) will increase the load on coiled pipes, which was not taken into account in designing, that can influence the workability of welded joints (cracks in welded joints and HAZ, pinchings). Moreover, due to application of collars the local increase in pipe diameter occurs, resulting in decrease of a passing section for fuel gases between the separate pipes, which deteriorates the aerodynamics of gas flows and leads to increased wear of pipes of the neighboring coiled pipes, complicates access to separate packs of coiled pipes and reduces their maintainability.

The corrosion developing can be seen in a technological gap of an overlap joint (between pipes), and the presence of collar outside do not allow making required inspection of pipe metal state under it.

It was suggested to apply a local gas-powder spraying with special metallic coatings to provide local protection of pipes under the distance-type straps [10].

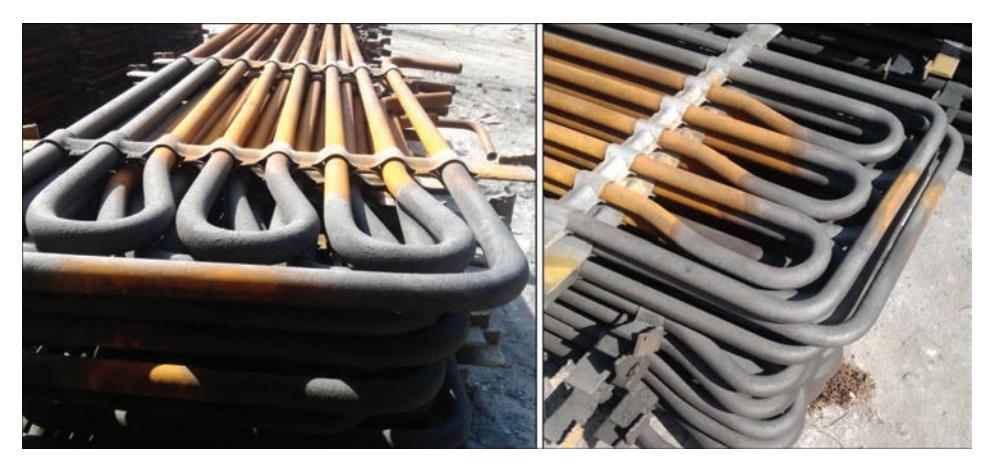
Results of investigation. Visual inspection of pipes and bends showed that the sprayed layer has a rough surface with a metallic glittering. During the detailed inspection of the sprayed surface the separate large crystals are seen, which impart the roughness to the surface. The spraying has a uniform and continuous distribution over the outer surface of bends. Figure 4 shows the appearance of pipe bend and macrostructure of its surface, and Figure 5 presents microstructure of pipe surface. The structure after metallization did not subjected to changes and corresponded to the standard requirements.

Figure 3. Appearance of sprayed coiled pipes

The electric arc spraying was carried out in 2013 at the most abrasively worn-out regions of coiled pipes of the water-wall economizer of boilers TPP-210 A and TPP-312 A, corrosion-damaged regions of coiled pipes KPP n/p in distance-type straps of boiler TPP-312 A.

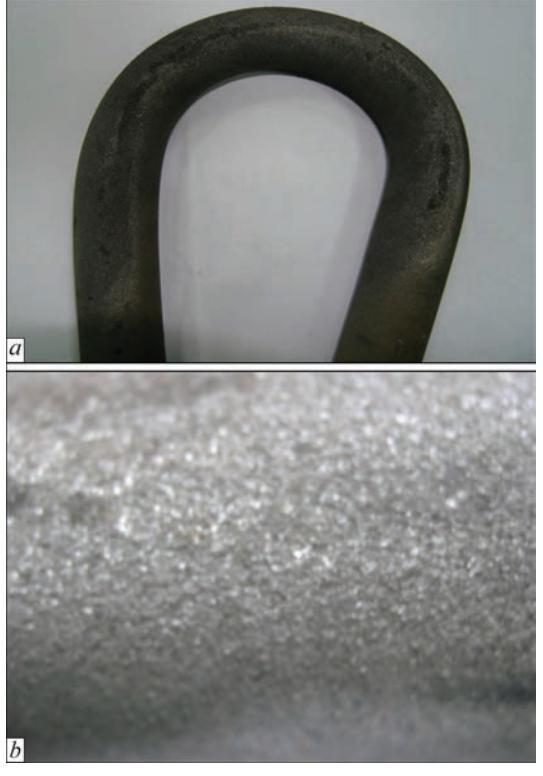
Figure 4. Appearance of pipe bend (a) and macrostructure of its surface (b)

In both cases the thickness of the sprayed layer is varied at different pipe regions. Thus, in frontal place of pipe the thickness of spraying reaches 0.42 mm, and on the sides — up to 0.2 mm. With account for the boundary layer of base metal, which was subjected to sprayed metal diffusion into it, it can be stated that the largest thickness of spraying is 0.57 mm (at the bend frontal part).

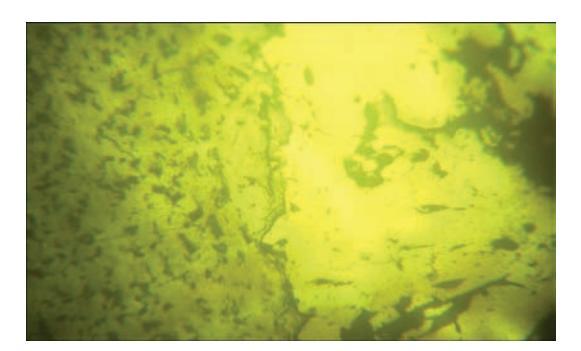
Figure 5. Microstructure (×500) of sprayed layer

The used etching agent could not distinguish any structural components in the structure of sprayed metal (special chemical reagents were not used). However, it allowed detecting the loose-laminar and porous (nonmonolithic) constitution of spraying, which is caused by technological features of the electric arc metallization.

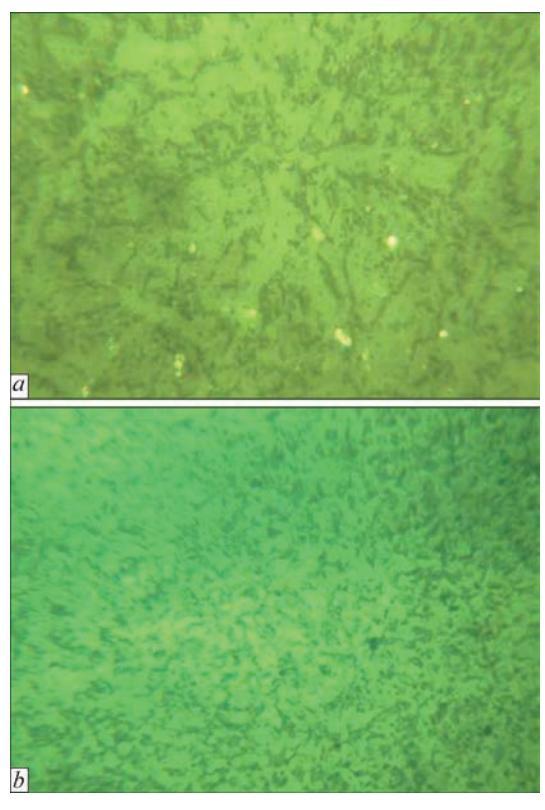
In the microstructure of sprayed pipes of steel 20 (Figure 6) the orientation by Widmanstatten structure should not exceed the third point of scale 2 of Appendix B «Scales of striation and Widmanstatten structure of metal of boiler pipes».

Figure 6. Microstructure of sprayed pipes of steel 20: $a - \times 500$; $b - \times 100$

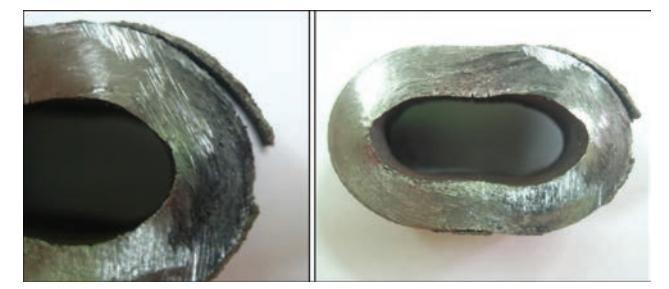
During technological tests for flattening the cracks, tears in the pipe base metal were not revealed. After tests for flattening (Figure 7) the X-ray fluorescent analysis was made for separated layer (0.55 mm) (Figure 8), which showed the following chemical composition: 11.7–12.21 % Cr; 0.12 % Ni; 4.0–5.65 % Si; 4.37–5.87 % Al; 0.37–0.44 % S.

Figure 7. Specimens after tests for flattening

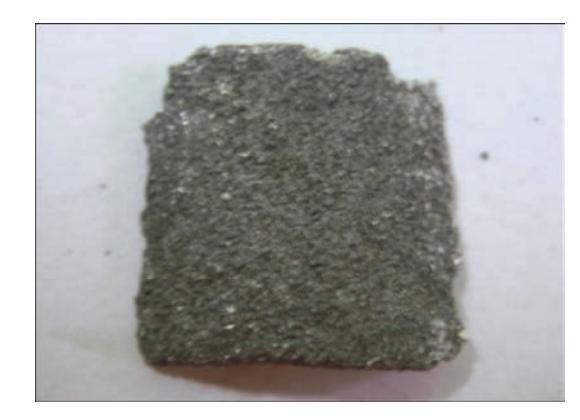
Figure 8. Appearance of separated sprayed layer after test for flattening

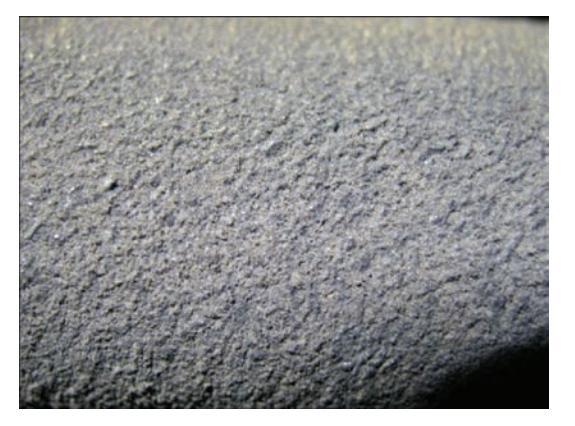
Macrostructure of sprayed pipes after 6 years of service is given in Figure 9.

During service the surface becomes rougher, projected carbides of different size are seen on the surface. Examination of microstructure before and after wear in the flow of coal dust at working parameters of the water-wall economizer shows reorientation of carbide frame in matrix. The surface diffusion layer has the following chemical composition: 3.27 % Cr; 1.87 % Si; 0.9 % Al; 0.3 % S.

Figure 9. Macrostructure of sprayed pipes after 6-year service

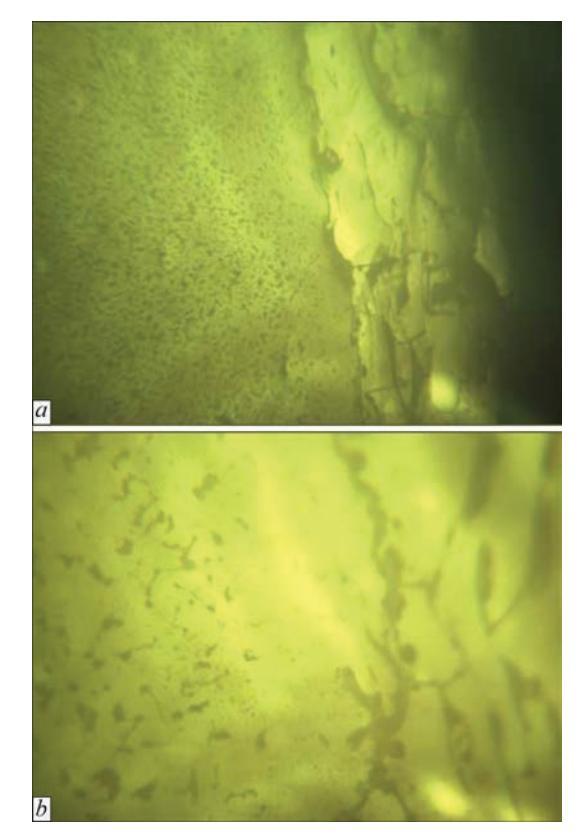
In making cut-outs after 6 years of service the macro- and microstructure of sprayed pipes (Figures 9, 10), composition of surface layer (Table 6) were also recorded. Technological tests for flattening were performed, hardness was not measured.

Figure 10. Microstructure of sprayed pipes after 6-year service: $a - \times 100$; $b - \times 500$

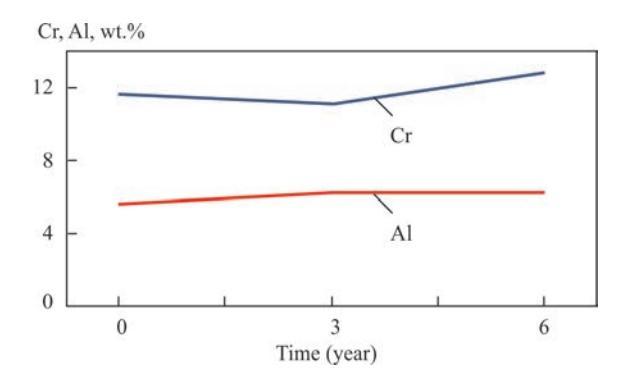
The horizontal nature of line in Figure 11 shows that during 6 years the concentration of chromium in surface layer almost was not changed and even increased a little, its storage in surface layer is occurred. The increase in aluminium concentration in surface layer is largely connected with deposition of aluminium-containing elements, formed in the process of combustion of organic fuel, on coiled pipes.

Figure 11. Change in concentration of chromium and aluminium in coating surface layer depending on service life term

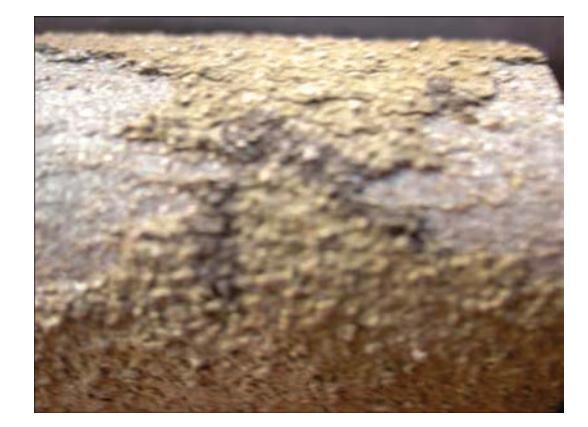
Fracture of surface layer during testing of specimens is occurred by cracking of coating into fine fragments and its spalling (Figure 12). As we see, holding of coatings at working parameters leads to change in mechanics of their fracture, which is possibly caused by change in structure of dispersed phases. It was not managed to measure the hardness of the sprayed layer. Hardness of surface under the layer of spraying is HV 180.

Figure 12. Appearance of pipe after 6-year service (test for convergence of sides)
