STRUCTURE № 18 OF 'NEAR SUBURBS' OF DYKYI SAD FORTIFIED SETTLEMENT

The purpose of the research paper is to characterize and determine the arrangement and constructional features of structure № 18 located within the territory of the 'Near Suburbs' of Dykyi Sad fortified settlement dated to the Final Bronze Age (12/13-12/11 centuries BCE).

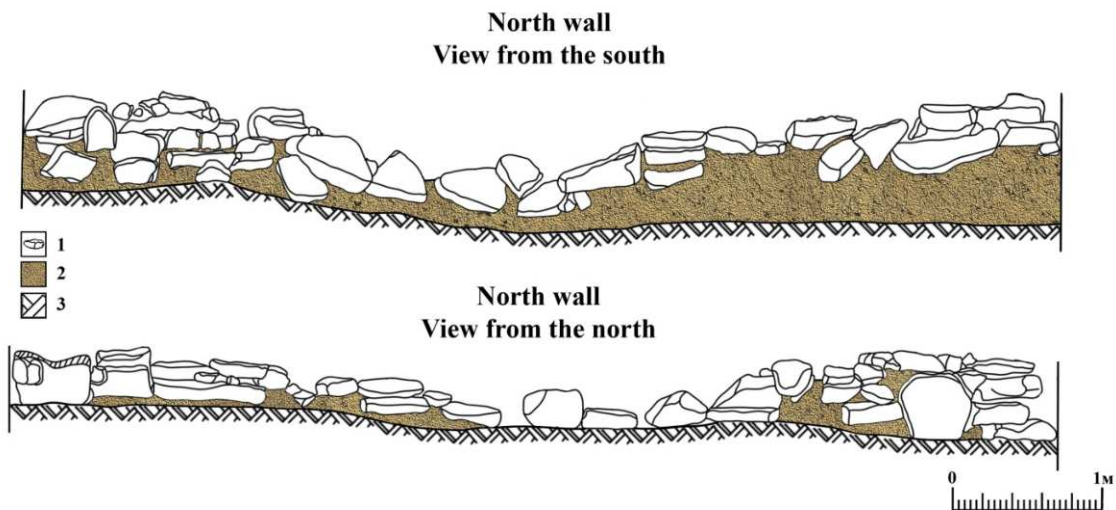
Fig. 5. Structure № 18. Section of the northern wall.
1 – masonry (limestone); 2 – sandy loam layer; 3 – mainland.

The **northern masonry** is a two-facade construction. The southern facade faces the interior of the structure; the northern facade faces the courtyard (the lower course is located on sandy subsoil). The masonry stones partially slipped inward. They are set in a bed-spoon pattern or with an inclination. It can be assumed that some of the stones were originally in the masonry and moved inward. The length of the northern masonry is 7.40 m, with height – from 0.15 m to 0.60 m, and width – from 0.20 m to 0.50 m. Coursed masonry – one to four courses are preserved, but, based on the piles of stones, the masonry was from 3 to 5 courses in the central part and up to 8 courses in the western and eastern corners. The western and eastern

corners of the masonry are reinforced using the orthostat system. The masonry is made using a mud mortar. Small, medium, and large crushed limestone and flagstone of different sizes (0.08 – 0.80×0.04 – 0.25×0.10 – 0.40 m) are used in the construction of masonry. There are no processing marks, the stones are torn along the layers. However, the flat or slightly marked sides of the slabs may be the result of the splitting of massive flat slabs into smaller ones (fig. 5).

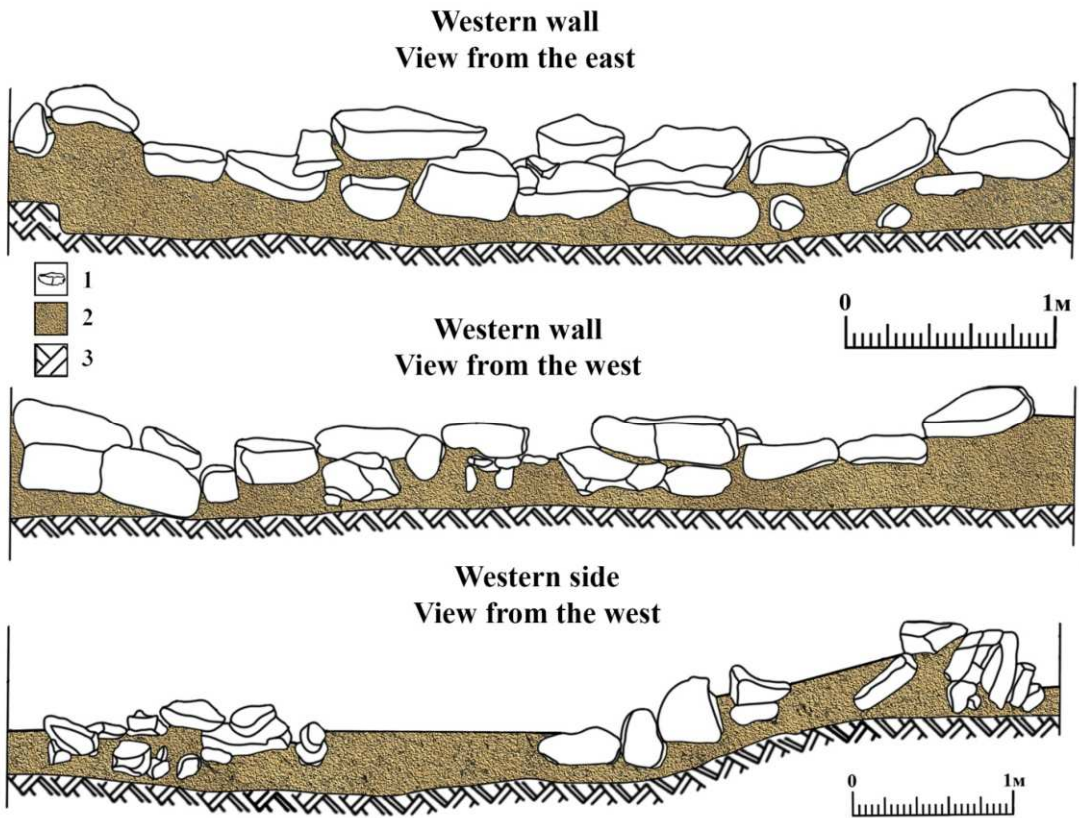
Fig. 6. Structure № 18. Section of the western wall.
1 - masonry (limestone); 2 - sandy loam layer; 3 - mainland.

The **western masonry** is partially preserved in the northern and southern parts of the western wall of the structure (along the entire western wall, there is a massive pile of stones that fell inside the structure from the western masonry). Probably, it also was a two-facade construction. The eastern facade faces the inner side of the structure, and the western one – the courtyard (the lower course of stones rests on the sandy subsoil). Masonry stones are set in a bed-spoon pattern. It can be assumed that some stones were originally in the masonry and moved inward. Based on the preserved corner parts, the approximate length of the western masonry was 6.25 m, height – from 0.20 m to 0.60 m, width – from 0.15 m to 0.80 m. Coursed masonry – from one up to three courses have been preserved, but, based on the piles of stones, the masonry was up to 4 courses in the central part and up to 6 courses in the northern corner. The masonry is made using a mud mortar with joints having a width of 0.01-0.03 m. The joints are not pointed. Small, medium, and large crushed limestone and flagstone of different sizes (0.08 – 0.50×0.06 – 0.35×0.03 – 0.20 m) are used in the masonry construction. There are no processing marks, the stones are torn along the layers. However, the flat or slightly marked sides of the slabs may be the result of the splitting of massive flat slabs into smaller ones (fig. 6).

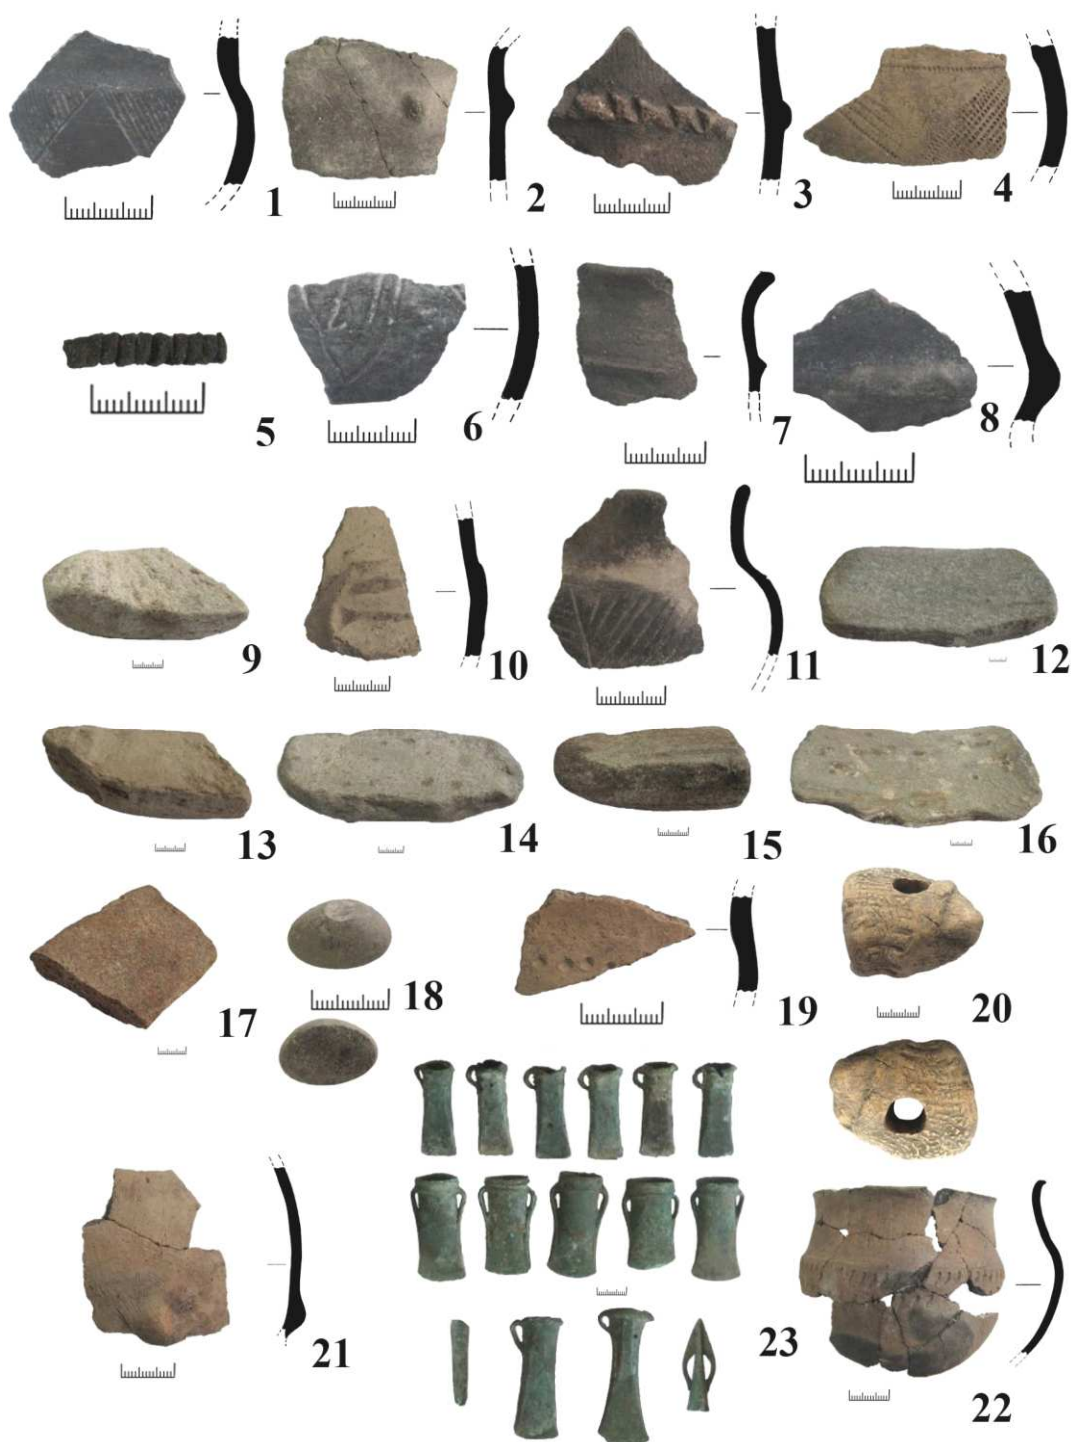
Fig. 9. Structure № 18. Artifacts.

Ceramic ware (1-4, 6-8, 10-11, 19, 21-22): pots (2, 3, 4, 7, 8, 10, 19, 21, 22), cups (1, 6, 11);
 Stone objects (13-18, 20): grinders of various shapes (9, 12, 13-16, 18); anvil (17);

Hammer made of deer antler (20);

Bronze items (5; 23): thread (5); treasure (23).

Fragments of pottery (pots, beakers, bowls, roasters, etc.), fragments of stone tools (rounded and hemispherical stone grindstones made of tight sandstone) (fig. 9, 18), remnants of clay coating of the walls, bones and horns of animals and fish, fragments of turtle shells, shells, limestone, fragments of human bones (Table 1) prevail in the main filling of the structure.

made of tight sandstone) (figs. 9, 9; 13-15); two slabs with tool marked edges and worn down work surfaces of tight sandstone (grindstones) (figs. 9, 12; 16); a fragment of a granite anvil (figs. 9, 17), and the accumulation of astragals (10 pcs.).

Under the stone foundation of the wall in the northwestern corner of the structure, fragments of a ceramic pot with ornamentation (teardrop-shaped impressions in two rows) were found (fig. 9, 22). Probably, the pot originally stood in the foundation of the wall in a specially created niche (it is possible that it was an element of sacrifice during the construction of the structure).

At a depth of 0.20 m, a fragment of a tool made of a burr part of an antler (a hammer for processing bronze produced items: dimensions: 10.0×8.5×6.2 cm) was found (fig. 9, 20).

At a depth of 0.45 m, in the eastern part of the pit, a spiral bronze borer with a diameter of 0.5 cm, and a thickness of 0.1 cm was found (fig. 9, 5).

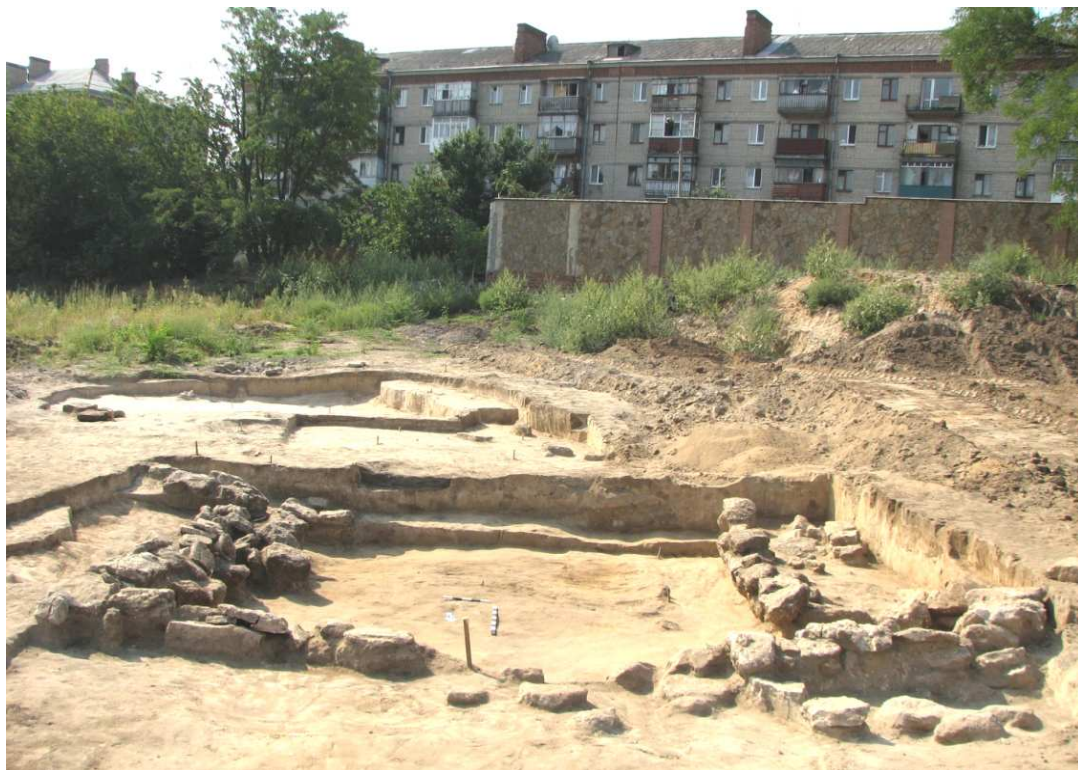
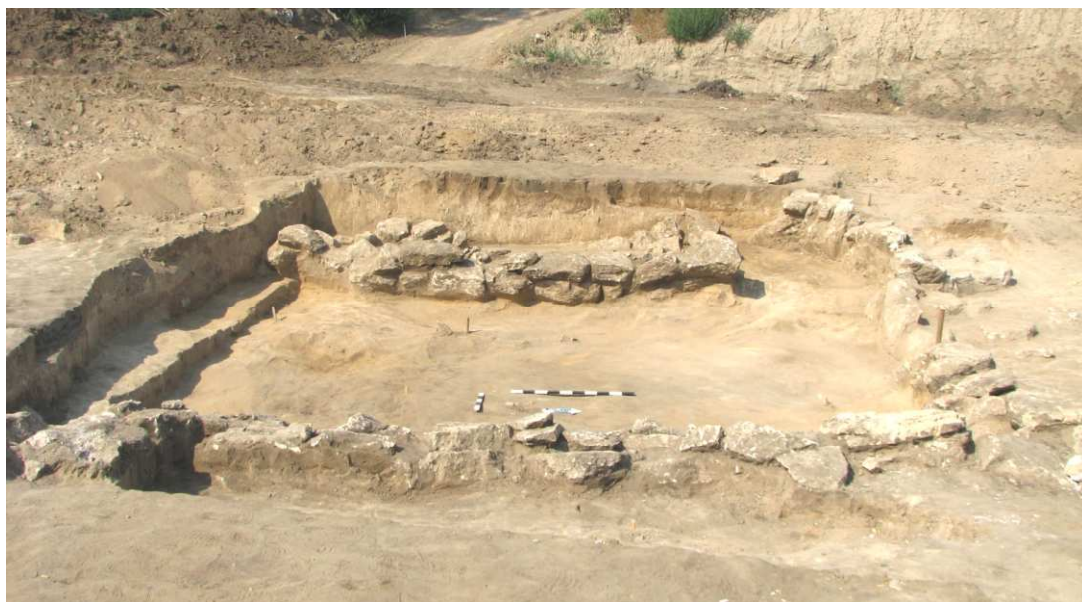
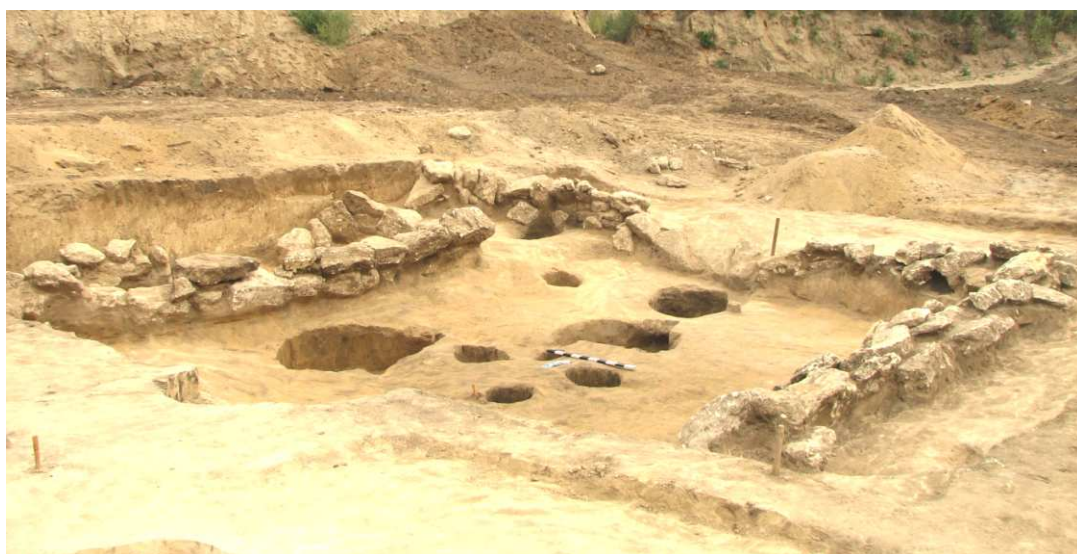
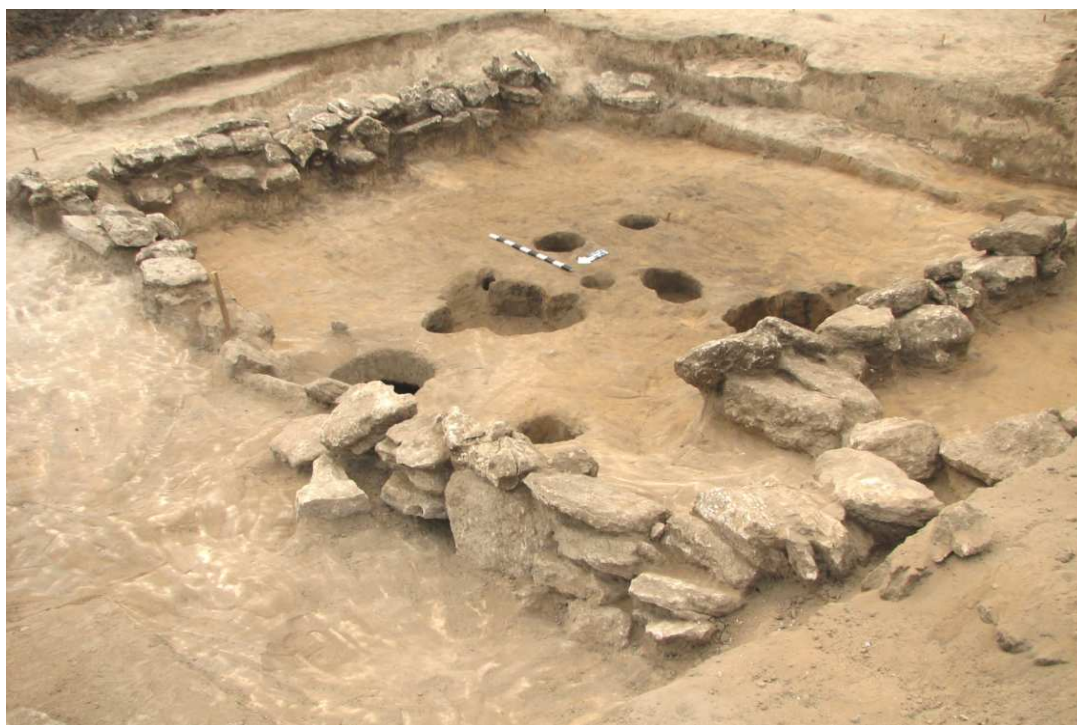
Fig. 10. Structure № 18.
View from the north.

Fig. 11. Structure № 18.
View from the east.

Fig. 12. Structure № 18.
View from the southeast.

Fig. 13. Structure № 18.
View from the northwest.

The walls of the structure have stone foundations, except for the southern one (wattle and daub). Stones in the foundation pit are set in combination (socle and siding systems) (fig. 10-13).
