Modern risk assessment of the influences of natural and military man-made factors on the state of the historical buildings of the Kyiv-Pechersk Lavra

T.V. Kril¹, I.A. Cherevko², S.V. Shcherbyna³, O.O. Chalyi³, 2024

Key words: military events, vibration, deformation, velocimeter, laser inclinometers.

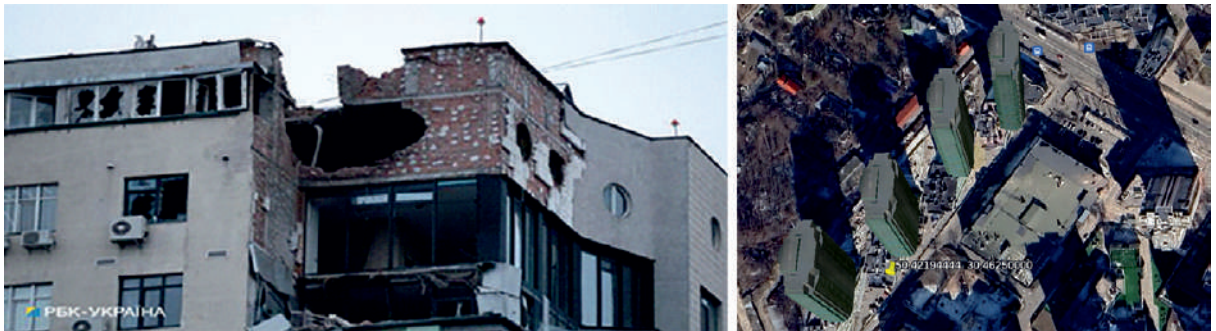
Fig. 1. A 26-story building in the Solomyanskyi district of Kyiv, damaged by debris from a downed Russian drone on the night of December 21—22, 2023. On the left is a damaged part of the house.

An infrasound event of the «technical explosion» type was also recorded on the night of December 21—22, 2023 at Solomyansky district, V. Lobanovskiy avenue, 4-B, 50°25'19" N 30°27'45" E, type of weapon: kamikaze drone Shahed (Fig. 1). The distance from the explosion to the observation point in building No. 3 of the KPL is 6738.52 meters. Records of three components of the infrasound waves from the explosion are presented in Fig. 2.

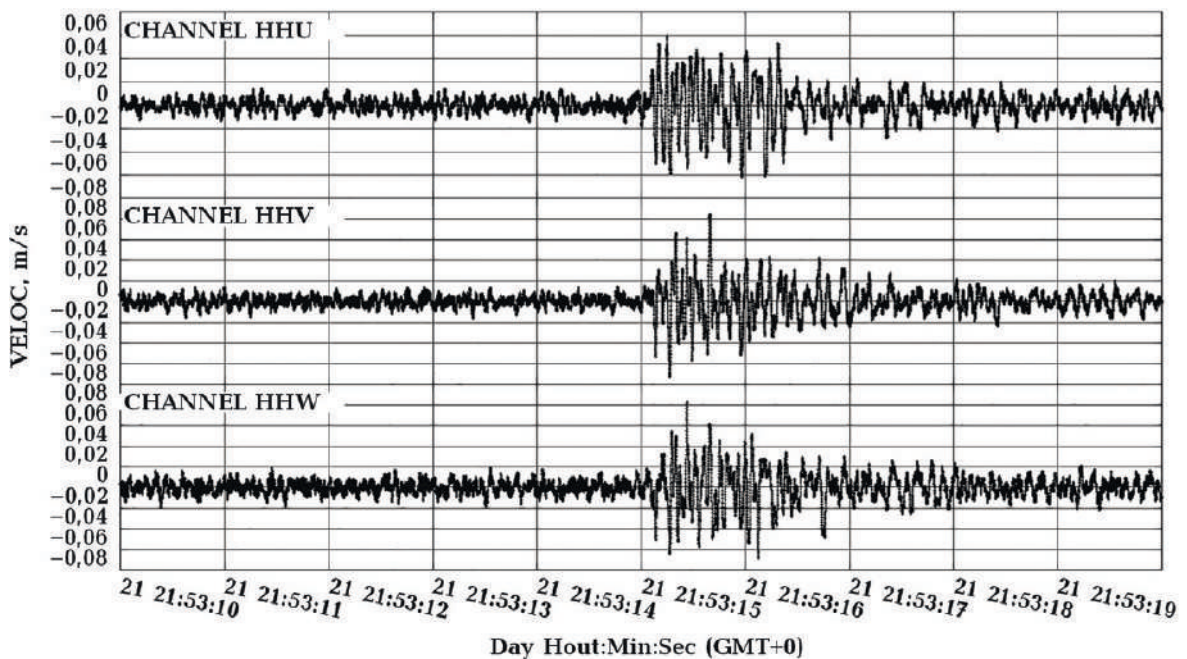
Fig. 2. Three components of an infrasound event of the «technical explosion» type, which occurred on the night of December 21—22, 2023, on the top floor of a 26-story building in the Solomyansky district of Kyiv as recorded in Lavra.

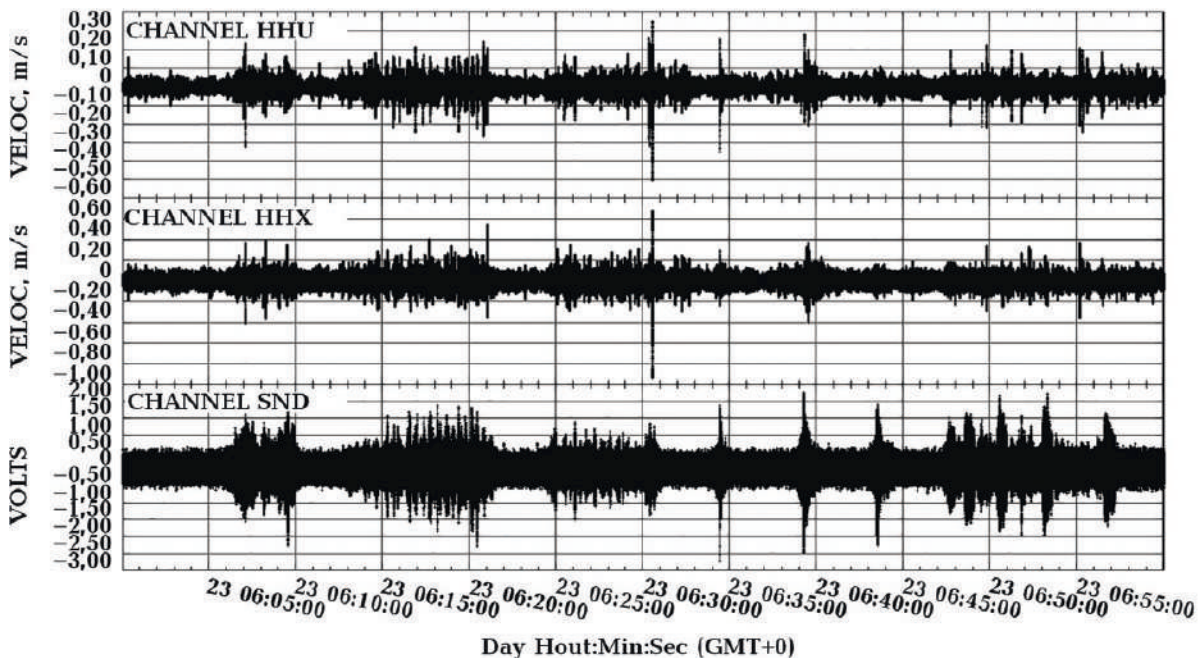
Fig. 3. General forms of recordings of various types of military events during the shelling of the Kyiv lasting one hour, which were recorded by three different devices — two different velocimeters 3D, 1D and 1D microphone.

On January 23, 2024, Kyiv was shelled for almost one hour (see Fig. 3). Various military technical events were recorded during this time.

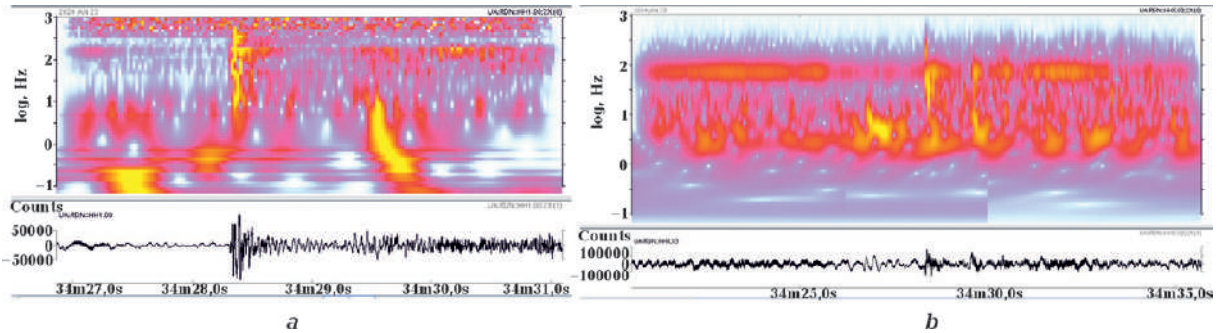
Fig. 4. Recording of an infrasound signal from an enemy «rocket» type weapon with 3D and 2D devices for measuring speed in building No. 3 of the KPL during the shelling of Kyiv. Spectrogram of one infrasound event in the frequency range: *a* — 6—467 Hz (D3 device for KPL), *b* — 10—549.09 Hz (device 1D).

This simplified approach allows for the exclusion of sound recordings of the 1D microphone records from the analysing, because the velocimeters independently recorded the infrasound signals. (Fig. 4, 5).

Comparative analysis of records in Fig. 4, 5 shows that, according to the results of the spectral transformation in the time domain, it is possible to identify different types of events that differ significantly from each other precisely in the frequency domain and that are purely natural, technical or military events of various types. To test the method of spectral

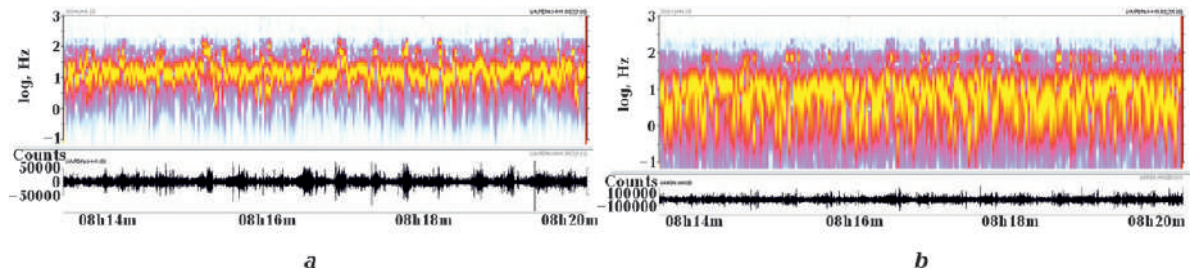
Fig. 5. Fixation of sequences of infrasound signals from the operation of anti-missile anti-aircraft systems by velocimeter-type devices with 3D and 2D code in building No. 3 of the KPL during the shelling of Kyiv. Spectrogram of the infrasound signal from the operation of the anti-aircraft missile complex: *a* — basic frequency 68.37 Hz, shot interval 16:30.118—16:57.938, 25—30 seconds (3D device); *b* — basic frequency 70.06 Hz, shot interval 16:34.328—16:57.124, 20—25 seconds (device 1D).

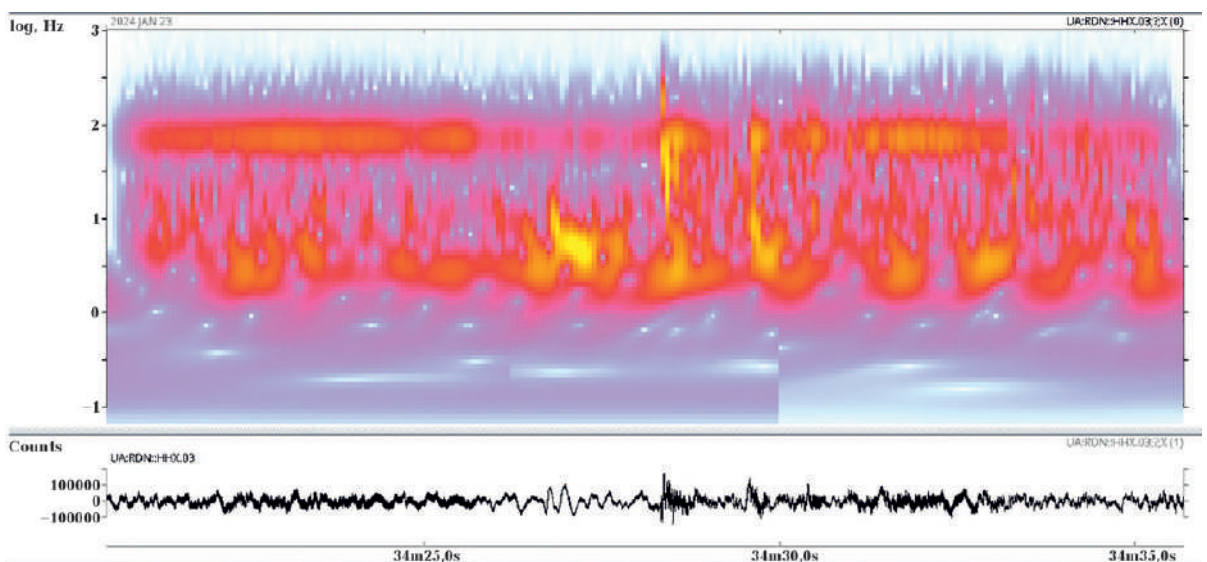
Fig. 6. Spectrogram of one infrasound event of the «rocket flight» type in the frequency range of 10—549.09 Hz, recorded by a velocimeter with the «device 1D» model.

time domain — the flight of the missile itself (Fig. 6) and the operation of the anti-missile anti-aircraft complex (Fig. 7).

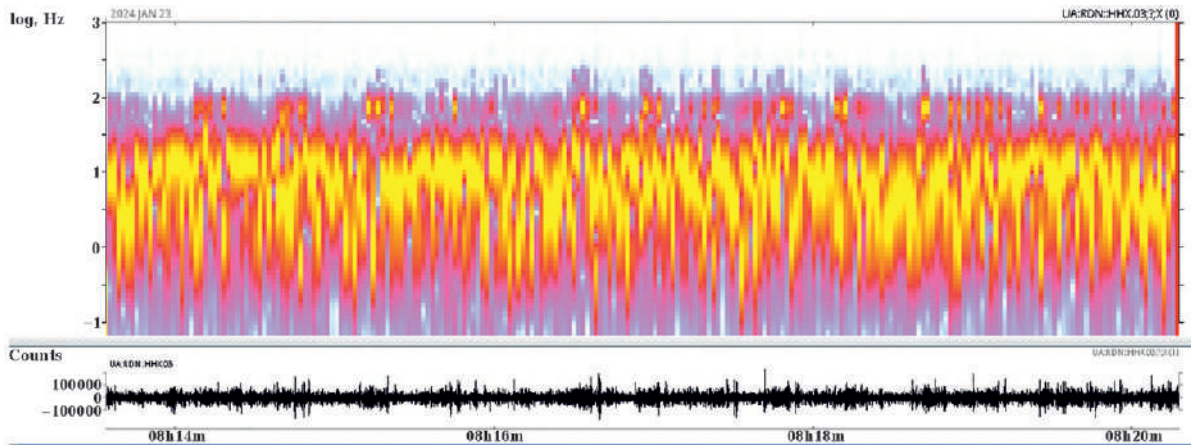
Fig. 7. Spectrogram of sequences of infrasound events from the operation of an anti-missile anti-aircraft complex, with a basic frequency of 68.37 Hz, with a shot interval of 25—30 seconds, recorded by a velocimeter of the «device 1D» type.

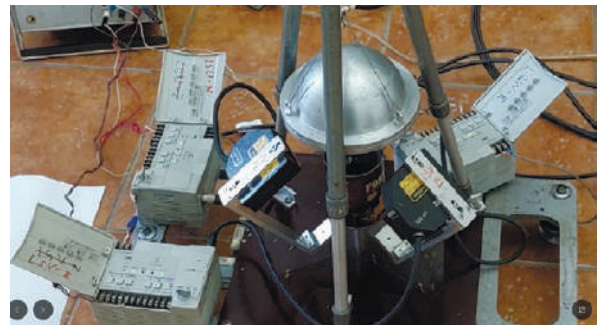
Fig. 8. General scheme of the 3D laser inclinometer, which was located in the 3rd building of the KPL.

Statistical analysis of laser inclinometer data. The next major stage of scientific research into the condition of the KPL introduced a new approach to long-term measurements of ground tilts in various areas of this historic site. This was necessary due to the significant tilting of the KPL Bell Tower, caused by the many underground cavities. For this purpose, a functional working 3D model of a laser inclinometer with a Foucault pendulum was used. (Fig. 8, 9).

The laser 3D inclinometer used to monitor these hazardous processes was situated in the middle section of the third building of the KPL, approximately 60 meters from the Bell Tower.

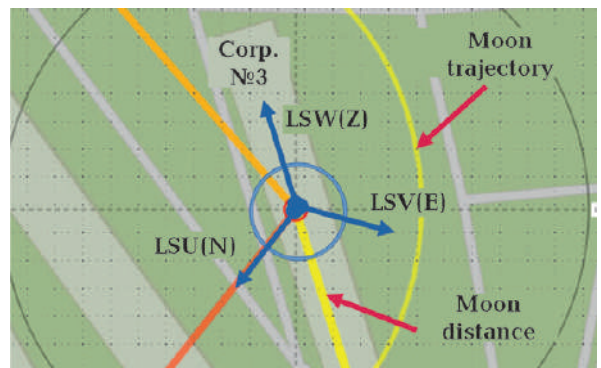
Fig. 9. Own coordinate system of the UVW type for tying 3 lasers to the architectural structure of building No. 3.

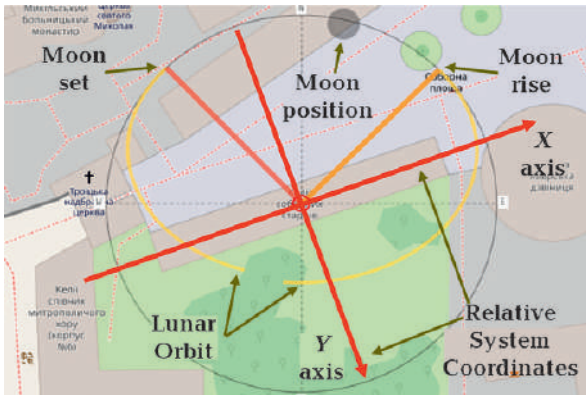
Fig. 10. The relative system of 2D XY coordinates of the 3D laser inclinometer to the basic technical UVW coordinate system (see Figs. 8, 9), which is tied to the spatial orientation of building No. 3 of the KPL.

After tying the 3D laser inclinometer to the architectural structure of relative locations, we had to develop special software to ensure the transition from the coordinate system of the 3D laser inclinometer to the XYZ coordinate system, and this 3D coordinates system is already directly related to the 2D location structure of the 3rd KPL building. For this, we used a special matrix for the UVW coordinate system. As part of these results, the 3D laser inclinometer records have already been modified from the UVW system to the XYZ system, the XY axes of which are tied to the spatial 2D orientation of the case No. 3 (Fig. 10), for scientific statistical analysis.

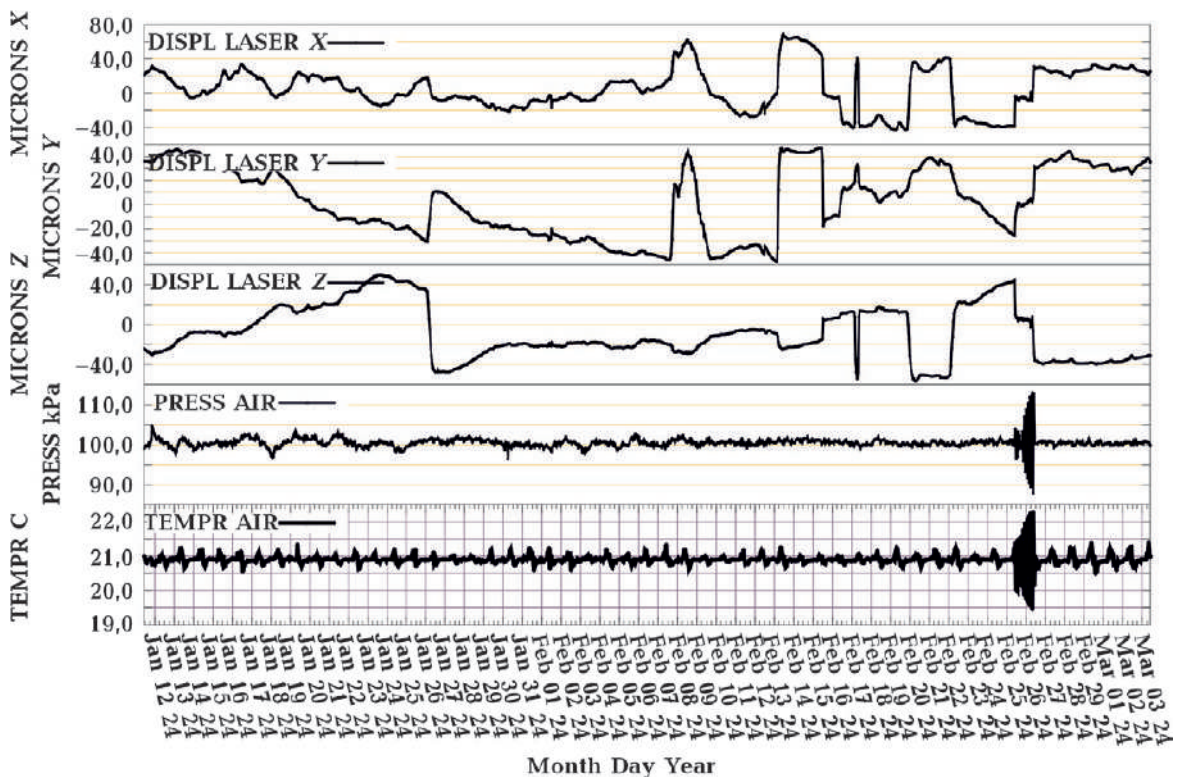
Fig. 11. Average values of statistical processing of data from a 3D laser inclinometer and air temperature and pressure gauges at the observation point of the third building of the KPL (see Fig. 8, 9, 10).

The total operating time interval of the 3D laser inclinometer in the third building of the KPL lasted from 2024-01-11 13:06:31 to 2024-03-03 12:06:23 (Fig. 11) and amounted to approximately 51.95 days or 1246.997 hours. In this figure (Fig. 11), we can observe the following:

As shown in Fig. 11, the use of these two high-precision digital recorders of atmospheric parameters was crucial for monitoring external thermodynamic factors that could affect the operation of the technical optical and electronic components of the 3D laser inclinometer system. Additionally, Fig. 11 illustrates that the air temperature did not negatively impact the behavior of the laser devices.

Analysis of the data of the 3D laser inclinometer and atmospheric pressure and temperature gauges (see Fig. 11) shows the following:

- lack of influence of the dynamics of the thermodynamic parameters of the atmosphere on the operation of the lasers of the 3D inclinometer;

- several anomalous phenomena (approximately 3) of significant displacement with non-standard shapes, which are displayed on the graphs of the 3D laser inclinometer from above;

- daily oscillation of temperature which has almost the same amplitude, which is important for confirming the stability of the lasers.

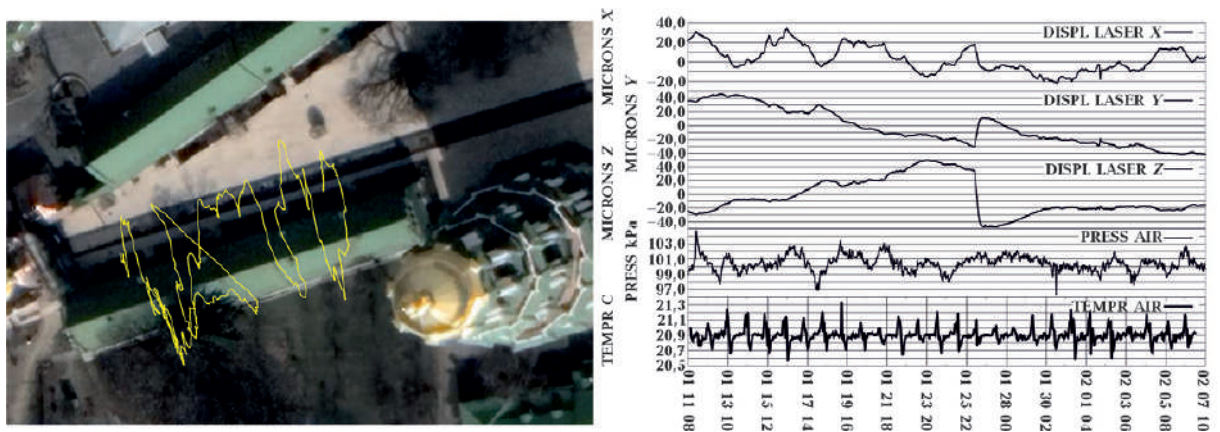
Fig. 12. Daily periodic displacements of the laser 3D inclinometer pendulum from 2024-01-11 13:06:31 to 2024-02-06 23:05:32 and plotted on the photo of building No. 3 on the map <http://lavra.igs-nas.org.ua/GoogleMaps/TST01/>.

To analyze and identify the primary reasons for the initial significant deviation from its zero position value in relative displacement to this new point, it is optimal to collect data over a specified period from 2024-01-11 13:06:31 to 2024-02-06 23:05:32 (Fig. 12, b) plotted on the Google map <http://lavra.igs-nas.org.ua/GoogleMaps/TST01/> (Fig. 12, a). In the 2D drawing (Fig. 12, b) of these data, it can be seen that there are both «soft» oscillations and a significant displacement in the direction of artificial voids on the territory of the closed garden of the KPL.

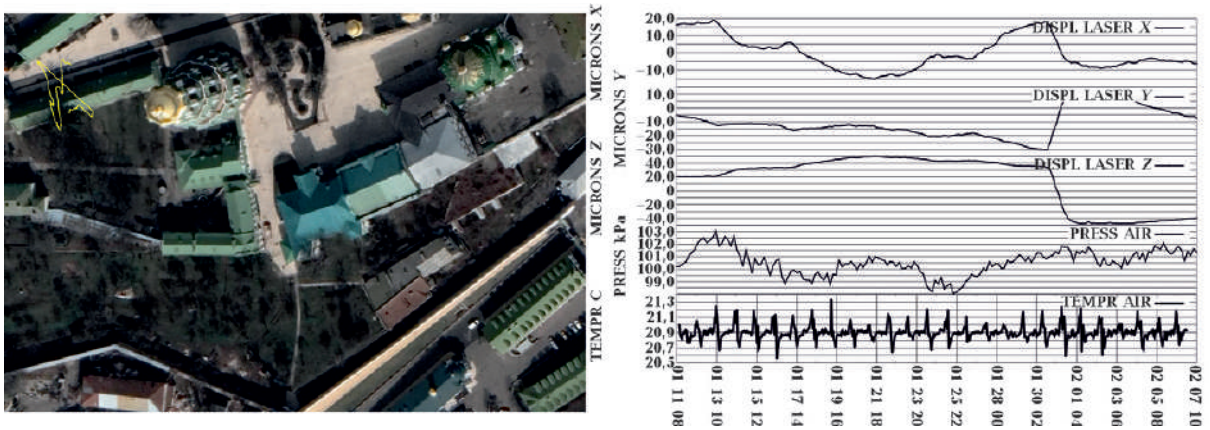
Fig. 13. Daily periodic displacements of the laser 3D inclinometer pendulum from 2024-01-21 00:06:44 to 2024-01-28 06:05:20 and plotted on the photo of building No. 3 on the map <http://lavra.igs-nas.org.ua/GoogleMaps/TST02/>.

The analysis of the second significant deviation of the value of the position of the 3D laser inclinometer is carried out for the period 2024-01-21 00:06:44 — 2024-01-28 06:05:20 (Fig. 13, b) and plotted on the Google map <http://lavra.igs-nas.org.ua/GoogleMaps/TST02/> (Fig. 13, a). In the 2D drawing (Fig. 13, b) of these data, we can see that there are both «soft» oscillations and a significant displacement in the direction of already two artificial voids with different coordinates on the territory of the closed garden of the KPL.

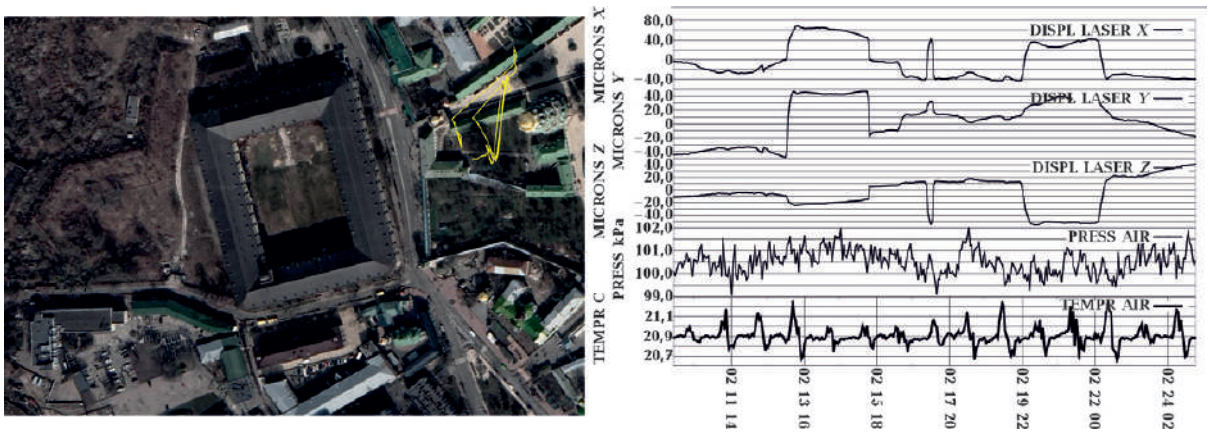
Fig. 14. Daily periodic displacements of the laser 3D inclinometer pendulum from 2024-02-10 00:05:02 to 2024-02-24 23:05:14 plotted on the photo of building No. 3 on the map <http://lavra.igs-nas.org.ua/GoogleMaps/TST03/>.

The analysis of the third group of significant deviations of the position values of the 3D laser inclinometer was carried out for the period 2024-02-10 00:05:02 — 2024-02-24 23:05:14 (Fig. 14, b) and plotted on the Google map <http://lavra.igs-nas.org.ua/GoogleMaps/TST03/> (Fig. 14, a). In the 2D drawing (Fig. 14, b) of these data, we can see that in this time interval there are already no «soft» oscillations. Also, a group of significant displacements dominates in the direction of both two different artificial voids formed on the terri-

tory of the closed garden of the KPL and in a third direction, which is significantly shifted to the left relative to the vertical, presented in Fig. 14, a. In addition to long-term displacements, rapid displacement was also discovered. It can have dangerous consequences for the historical structures of the KPL due to the significant speed of its development.

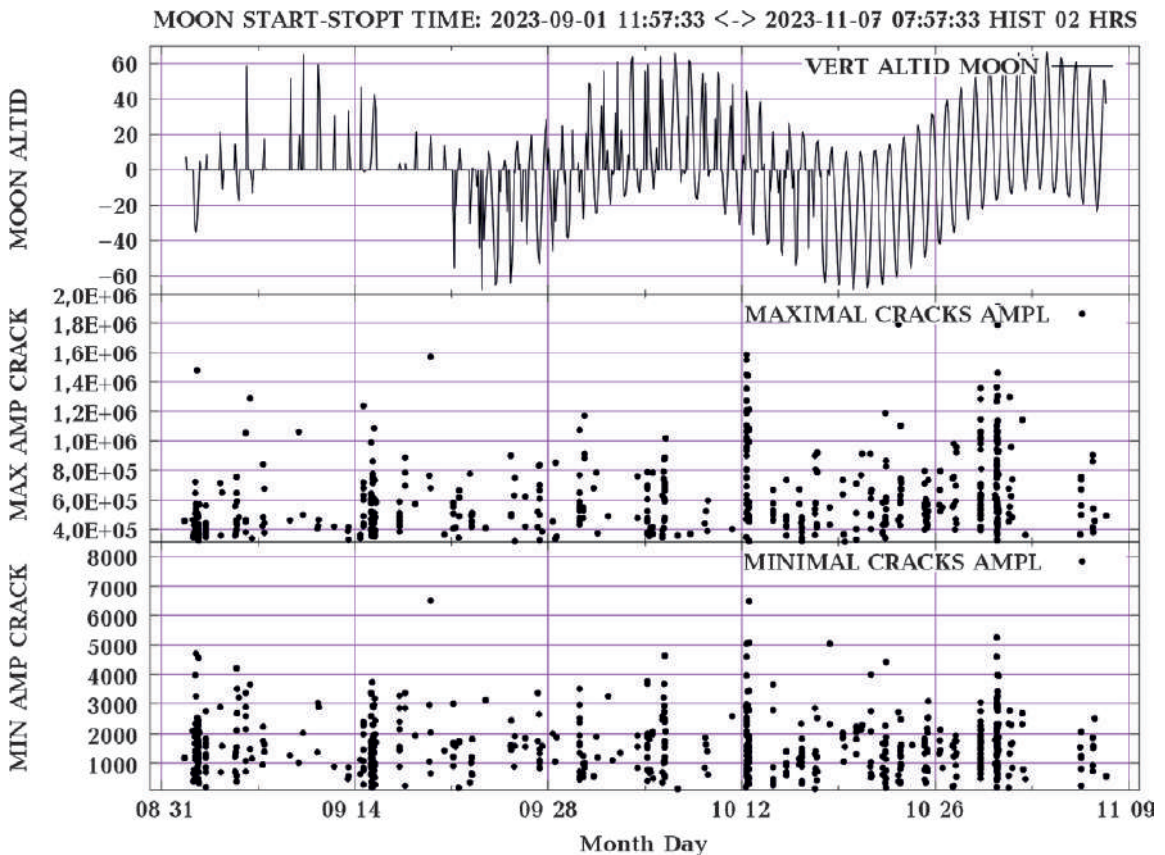
Fig. 15. General view of the implementation of the process of formation of the number of cracks in building No. 4 of the KPL and their minimum (bottom) and maximum (middle) amplitudes for the research period from August to November 2023.

In order to find an answer to these questions, it is optimal to add the results of parallel studies of the influence of the moon's condition on the formation of cracks in building No. 4 of the KPL. To do this, we will consider the position of the Moon during this last period of time of abnormally sharp landslide studies, which is presented in Fig. 15, 16.

– anomalous sharp displacement is associated with the trajectory of the Moon (see Fig. 15, 16) relative to these voids on the territory of the KPL, because such significant and sharp shifts do not occur in other regions of homogeneously filled regions of the upper part of the KPL environment.

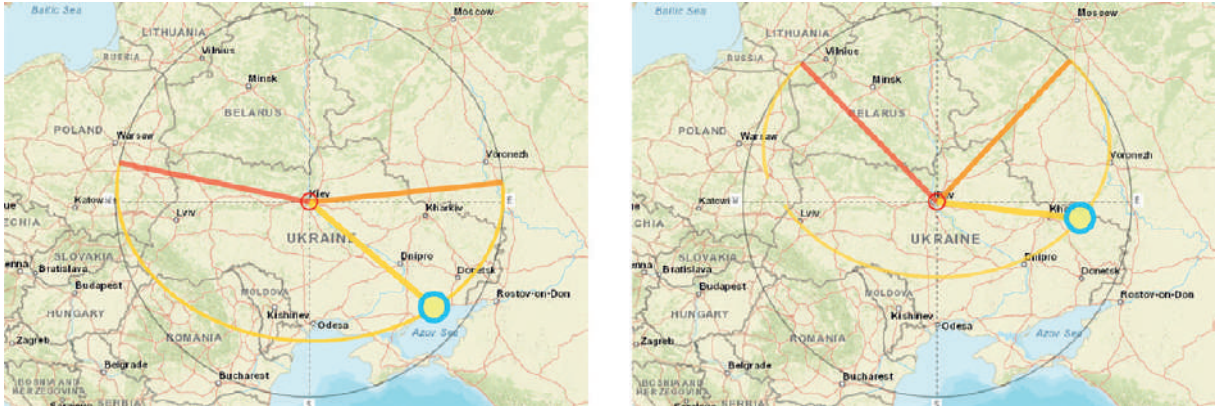
Fig. 16. Trajectories of the Moon's movement for the period from 2024-02-10 00:05:02 to 2024-02-24 23:05:14 relative to the location point of the laser 3D inclinometer on the full-scale map of the country to track its relative position relative to North and South of Ukraine <https://www.mooncalc.org/#/50.5187,30.38,5/2024.02.06/23:58/1/3>. The Moon trajectory: a — 13 February 2024 12:35 UTC+2 (see Fig. 14, b); b — 18 February 2024 12:35 UTC+2 (see Fig. 7).

In Fig. 16, you can see that the direction and angle of the relative movement of the Moon relative to the observation points in buildings No. 3 and No. 4 does not change and does not depend on the time of the Moon's movement relative to these observation points for any time interval. Unfortunately, such almost constant values of the angles and directions of the Moon's movement relative to these
