## ORGANIZATION OF GEOMECHANICAL MONITORING FOR NON-METALLIC DEPOSITS CHAMBERS ROOFS

<sup>1</sup>*Skipochka S.I., <sup>1</sup>Serhiienko V.M., <sup>1</sup>Amelin V.A., <sup>2</sup>Sytnichenko O.Yu.*

<sup>1</sup>*Institute of Geotechnical Mechanics named by N. Poljakov of National Academy of Sciences of Ukraine, <sup>2</sup>Additional Liability Company «Siniat»*

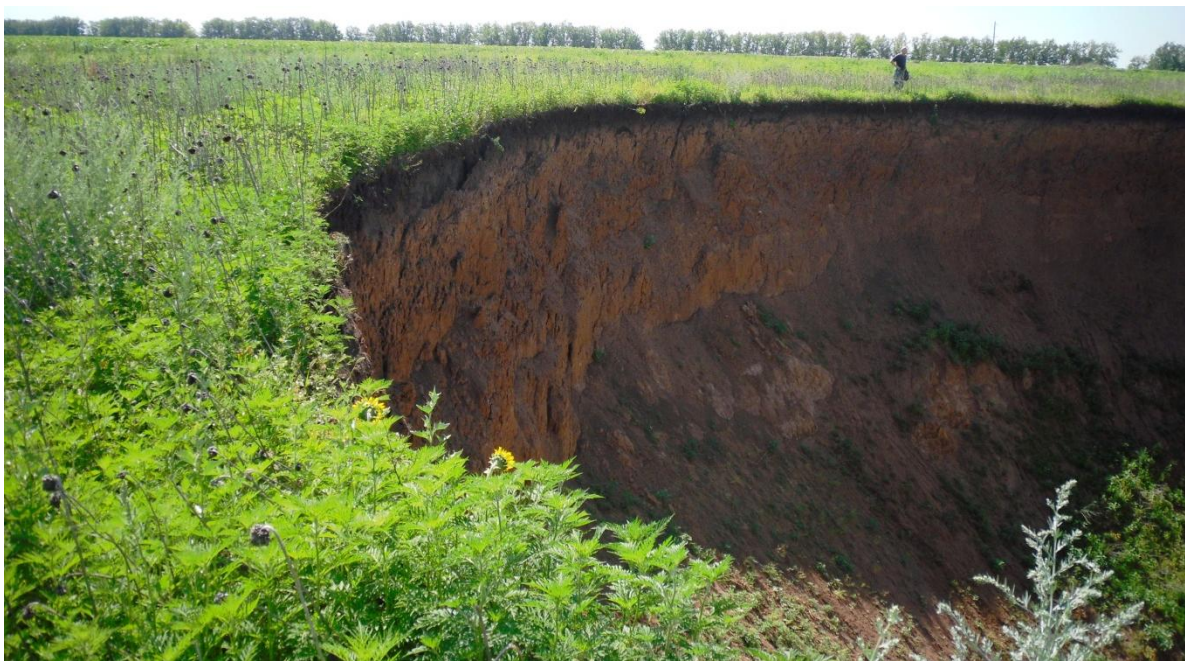
Figure 1 – The pit over gypsum mine workings in Bakhmut (Ukraine)

gradual decrease in stability of a roof of chambers. In the absence of control, the caving of a roof is possible. Large accidents in gypsum mines in Nikitovka (Ukraine), Shante-Lu (France) and Koshava (Bulgaria) are known. In zones of geological faults mining operations provoked intrushes in a roof and on the gypsum field in Bakhmut (Ukraine). As a result of it on the land surface pits were formed (Figure 1).

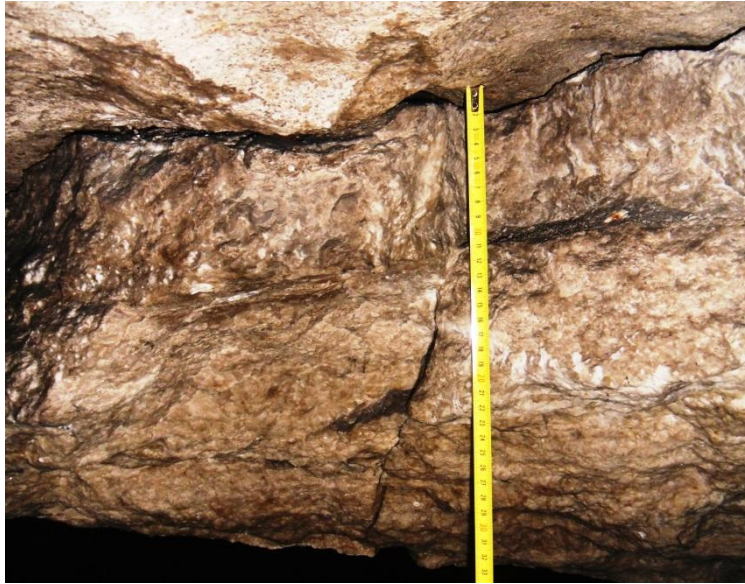
Figure 3 – A photo of separation in a roof of the main transport gallery

In case of high level monitoring execution the most problem sections are exposed to visual survey are photographed. The periodicity of photography accepted by default – once a quarter. In case of explicit progressing of deformation processes the temporal period between executions of monitoring is reduced. Place a measured tape for determination of the extent of defect in a frame. The example of the exfoliating rock slab in a roof of workings given in the Figure 3.

In case of computer processing of the picture the necessary linear extent of defect is determined. The analysis of electronic archive of photos for long time allows keeping track of dynamics of development of deformation processes in a ceiling of roof.

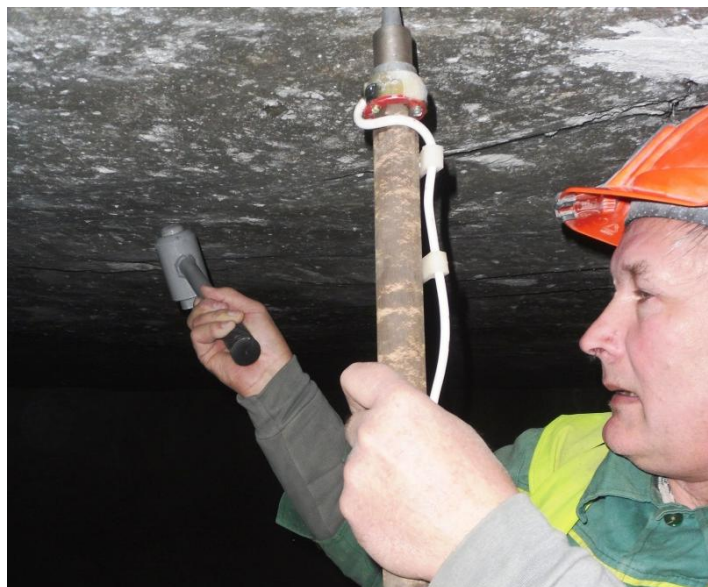
Figure 4 – Realization of vibroacoustic diagnostics of a roof of development by basic option

The equipment description and operation instructions are provided in [10, 11]. Diagnostics of a roof is carried out from the telescopic elevator. The operator installs the contact receiver of vibration on a roof and about 1 m strikes blow in a controlled point apart. The equipment keeps result of monitoring on the given time slice. Process of monitoring is illustrated by Figure 4.

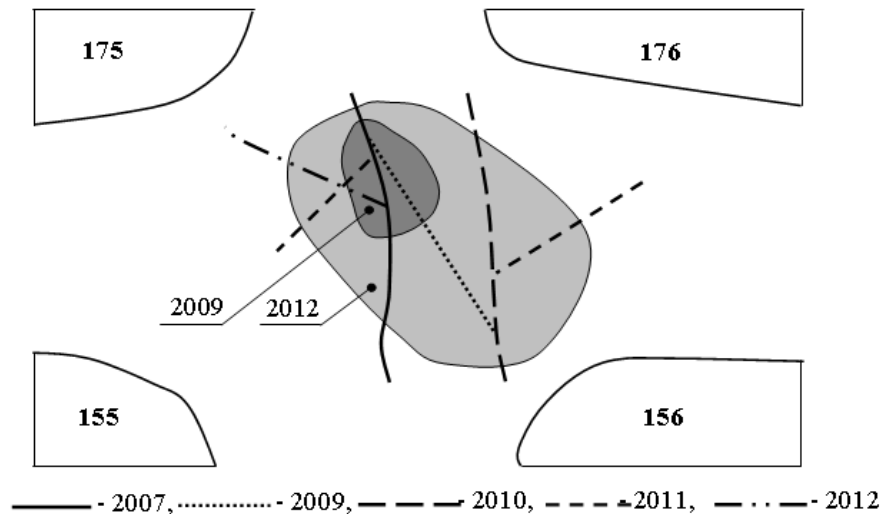
Figure 9 – Development by years of a system of fractures and increase of area of stratification in a ceiling of chamber

Dynamics of development of fractures and zone of stratification in a roof by results of vibroacoustic monitoring is illustrated on the example of chamber No. 31 of the VII stall (Figure 9).

The chamber was fulfilled in 1992 and within more than 10 years its visual inspection did not show signs of violation of a roof. The first longitudinal fracture in a roof appeared in 2007, following – in 2009. The first signs of stratification in a roof received with use of a vibroacoustic method were also found in 2009. Development of block structure in a roof of working happened 4 years. Periodic measurements of disclosure of an initial longitudinal fracture were shown by its increase for the specified period from 5 to 10 mm. Disclosure of other fractures by 2012 made from 1 to 3 mm.

Regularly carried out vibroacoustic diagnostics showed the considerable expansion of a zone of stratification in a roof. Due to potential danger of further operation, working was closed access for people and machines. In two years there was a working roof caving.
