## STUDIES OF THE SIRKO RAVINE IN ORDER TO PREVENT THE DEVELOPMENT OF LANDSLIDE-HAZARDOUS PROCESSES

<sup>1</sup>Zmievskaya K.O.

<sup>1</sup>Institute of Geotechnical Mechanics named by N. Poljakov of NAS of Ukraine

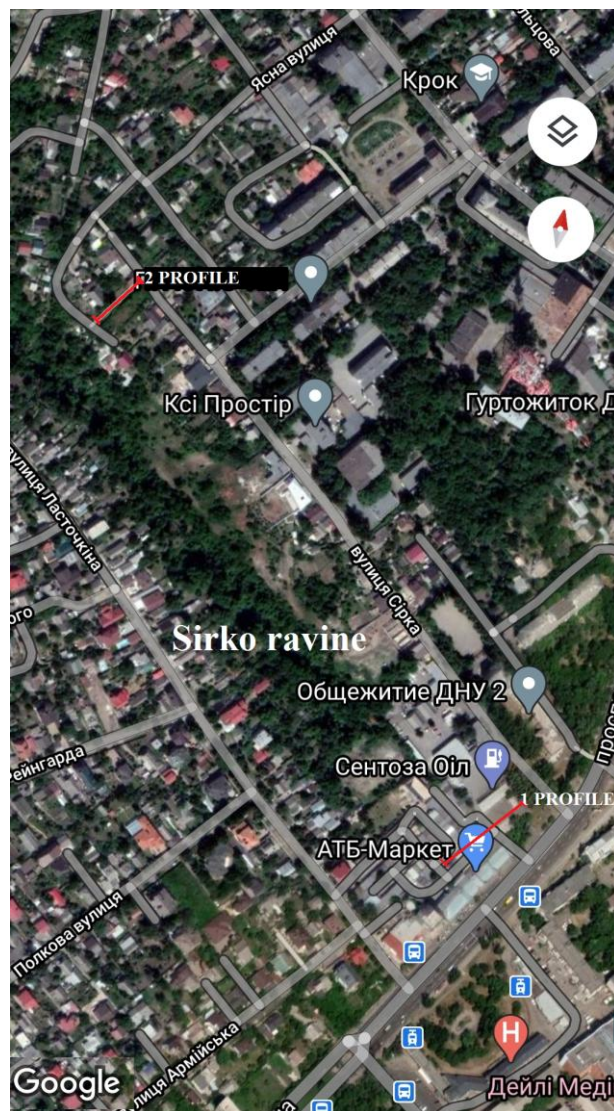
Figure 1 - Position of the Sirko ravine and observation profiles of ENPEMF

To assess the degree of landslide hazard of its slopes, the express method of observation of ENPEMF was chosen. Since it is difficult to apply other geophysical methods in the conditions of urban development and man-made interference. The observations were carried out at the top of the ravine in the area of Gagarin Ave, as well as in the area of the widest part of its thalweg (Fig. 1).

On the territory available for research, observations were made on two profiles. The observation step was 10 m. The first profile is located at the top of the Sirko ravine - along Gagarin Ave, through a gas station and a garage cooperative. The length of the first profile was 100 m. The second profile is located on the northeastern side of the ravine, (across the strike of the thalweg of the ravine) along Sirko str., the length of the second profile is 90 m (see Fig. 1).

thalweg, taking into account the leveled part, is ~ 1200 m. The area of the ravine is over 10,000 m<sup>2</sup>, the average depth to its thalweg is approximately 30 m. The strike azimuth is 315° (Fig. 1).

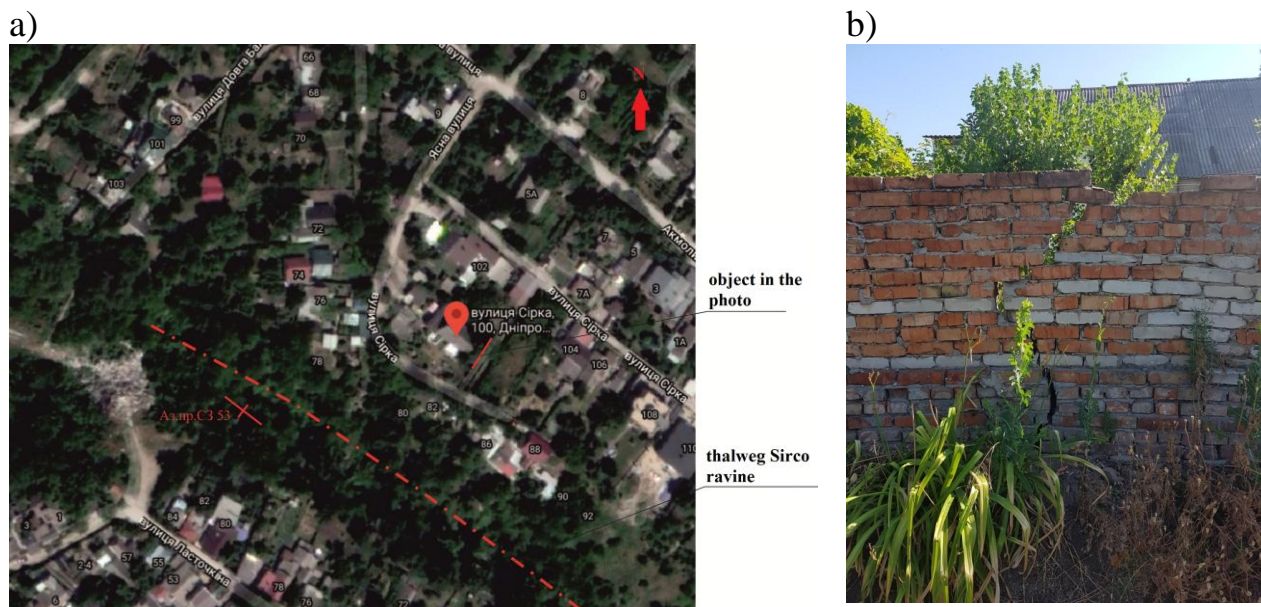
Figure 2 - The position of observation points (a) and examples of deformations of the fence on the Sirko 100 str. (b)

The observation points are shown in Fig. 2. As can be seen from fig. 2, bursting cracks of the fence made of bricks are observed, manifested in the rupture of the masonry both in the cement mortar and in the bricks.

The formation of the reduced cracks on the brick fence indicates the presence of subsidence and ground movements in the direction of the ravine thalweg.

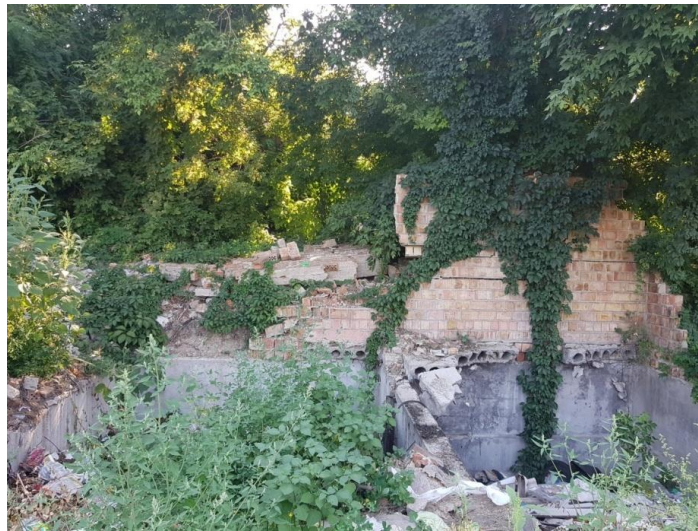
Figure 3 - Destroyed garages in the area of Dovha Balka str.

In fig. 3 shows fragments of destroyed garages, in the area of the junction of the Dovha and Sirko ravines.

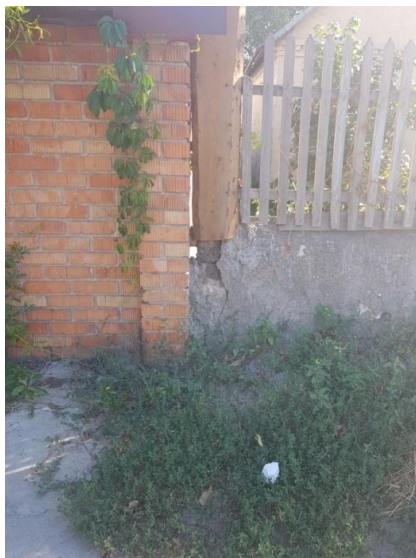
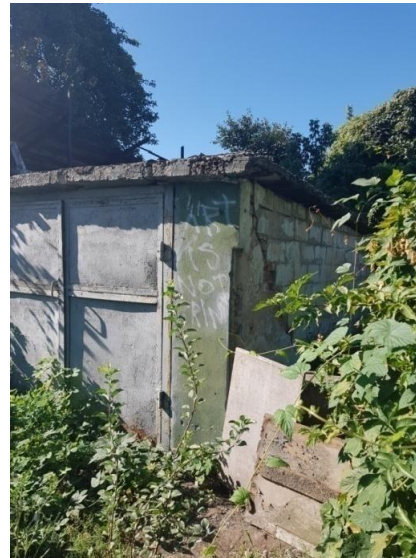
Figure 4 - Deformation of structures on the Lastochkina, 48 str.

In fig. 4 a, b shows examples of the destruction of the fences of the household farmsteads located on the Lastochkina, 48 str. The location of these observation points on the satellite map is shown in fig. 5 b.

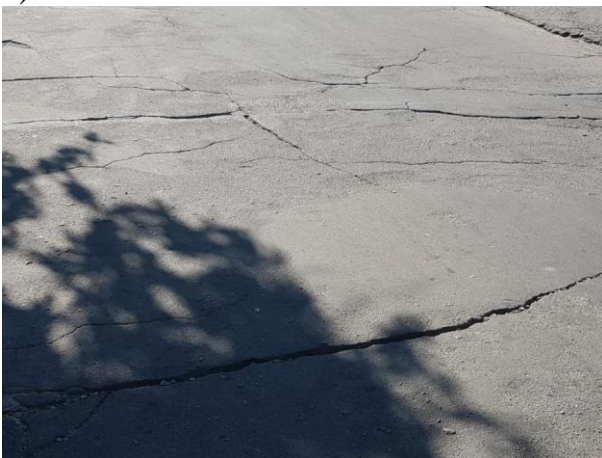
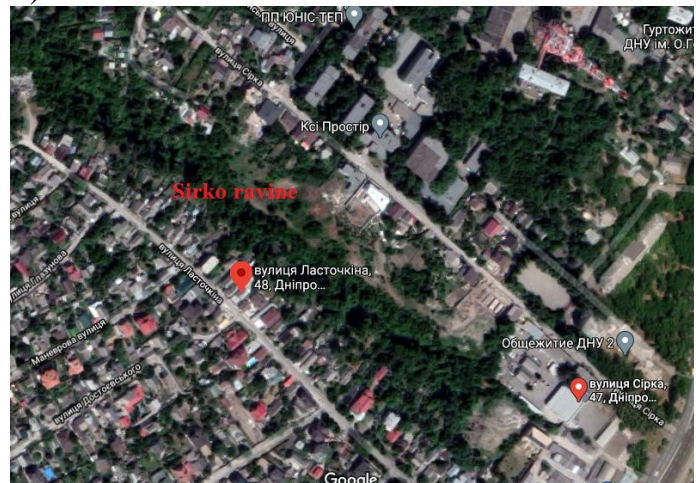
Figure 5 - Cracked asphalt pavement on the Sirko, 47 str. (a) and the position of observation points on a satellite map (b)

In addition to violations of buildings and fences, deformations are observed on the asphalt pavement on the Sirko str. and Lastochkina str., separation cracks, which show the direction towards the Dovha ravine (Fig. 5 a, b).

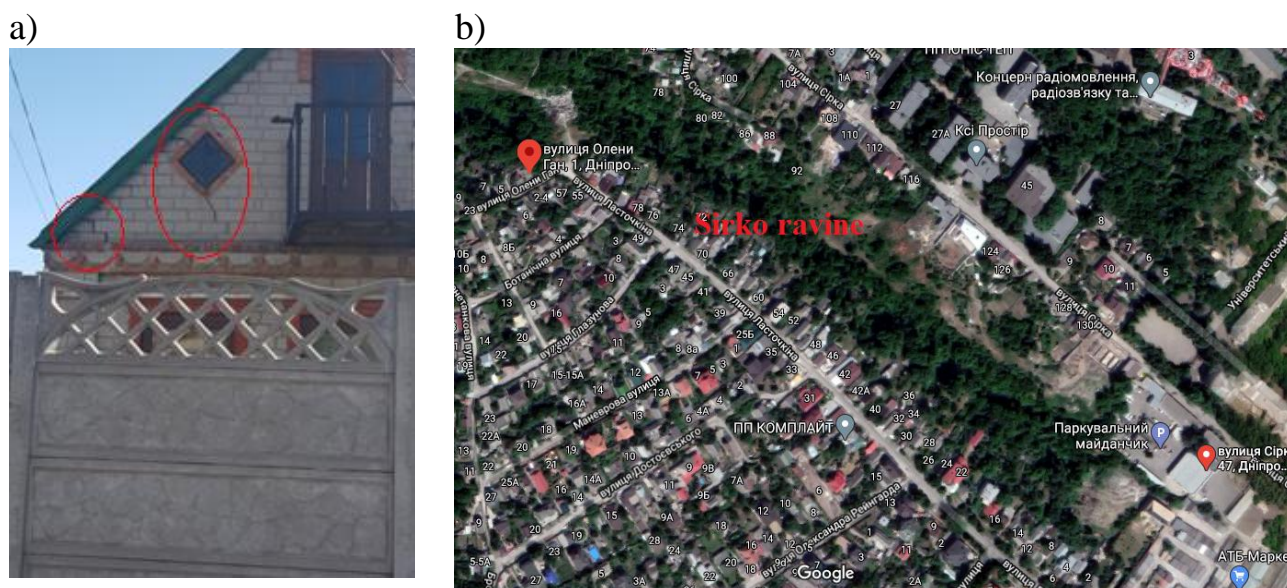
Figure 6 - Deformations of the walls of the house (a) and the position of observation points on the satellite map (b)

An example of deformations of buildings, as well as the position of observation points on a satellite map on the Olena Han, 1 str. is shown in Fig. 6 a, b.

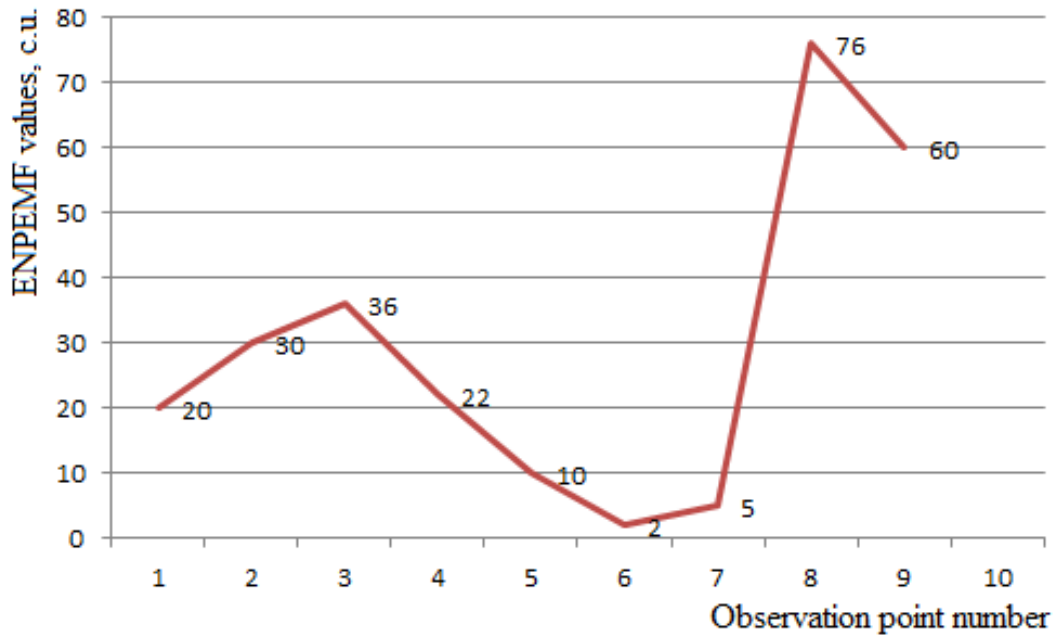
Figure 7 - Plots of flux density ENPEMF on 1 observation profile across the strike of the Sirko ravine

Further, according to the ENPEMF observational data, the flux density graphs were plotted, shown in Fig. 7 -8. So in fig. 7 shows a graph of the flux density ENPEMF on the first observation profile. The northeastern and southwestern parts of the observation profile (points 1-4, 8-9) are located in the upper parts of the sides of the ravine (the ENPEMF flux density is more than 20 conventional units (cu). The lowest values (less than 10 cu .) are confined to the ravine thalweg (5-7 observation points).

The data presented indicate that the Sirko ravine is confined to a deep fault, and its northeastern side is characterized by significantly higher values of the flux density ENPEMF. Taking into account the geological structure and active water cut and soaking of its slopes during maintenance, it is possible to predict the development of landslide phenomena in the territory of the observed areas.

1. According to the observation results, a sharp decrease in the values of the flux density of the ENPEMF allows us to conclude that the slopes of the ravine are characterized by a high degree of landslide hazard.

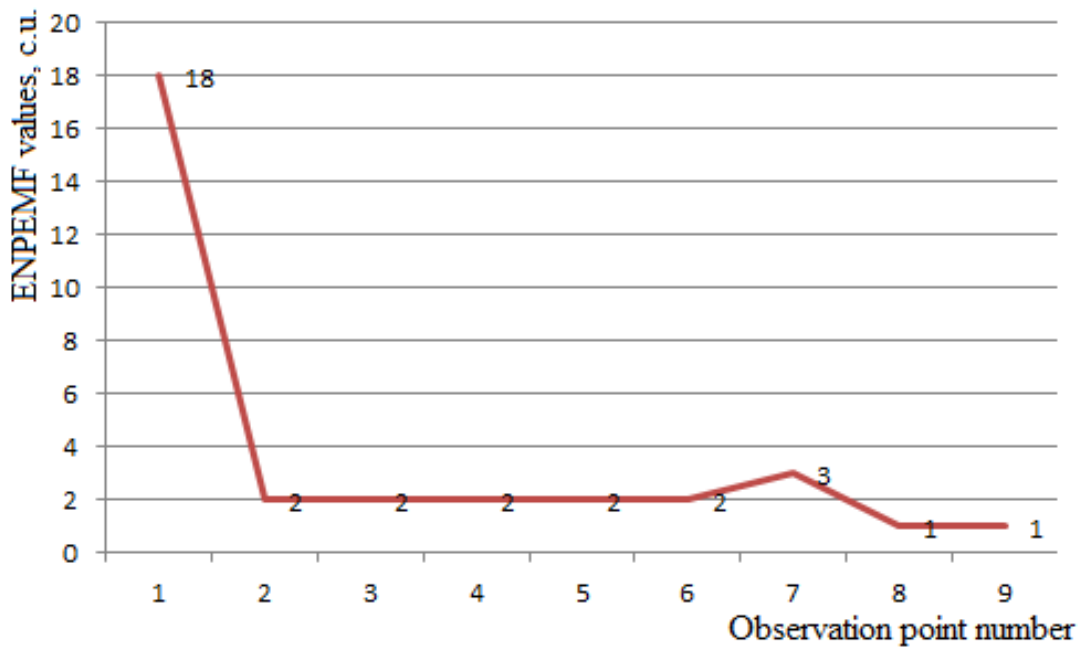
Figure 8 - Plots of flux density ENPEMF on 2 observation profile across the strike of the Sirko ravine

The second profile (Fig. 8) was passed from the northeastern side of the ravine to its thalweg, which is quite long at this point. At the upper point of the ravine side, the ENPEMF flux density is characterized by 18 cu. (observation point 1). In the thalweg area, across the strike of the ravine (observation points 2-9), the ENPEMF flux density sharply decreases to 2 cu - which can be explained by the confinement of the ravine thalweg to the watered part of the fault. As shown earlier, in the obtained copyright certificates, discontinuous faults are characterized by the lowest values of the flux density Fig. 7-8. Plots of flux density EIEMPZ on observation profiles across the strike of the Sirko beam. [8].

2. To preserve the maintenance suitability of the north-eastern slope of the Sirko ravine, it is recommended to take measures to reduce its soaking capacity by organizing a centralized drainage system - sewer and storm water systems, as well as conducting an audit and, if necessary, repairing the water supply system.
