# AUTOMATED SYSTEM FOR DIAGNOSTICS AND REPAIR OF REACTOR CONTAINMENT SHELL AT BILIBINSKAYA NPP

**Keywords:** *reconditioning by welding and surfacing, gas industry and power engineering, object diagnostics, versatile robotic complexes*

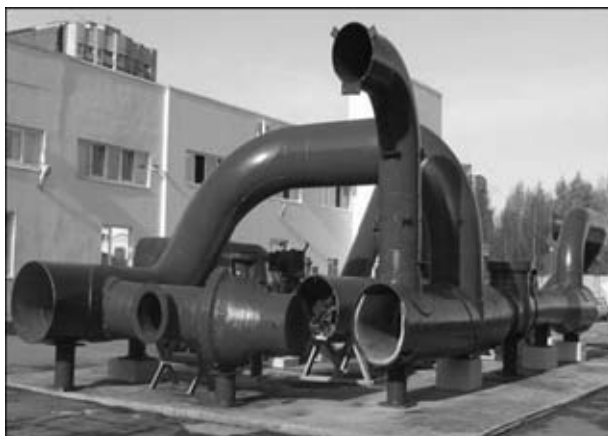
In St.-Petersburg training in operation of this system was organized in a test stand with built-in pipes with various defects, where features of system operation under the actual conditions can be followed (Figure 2).

Figure 2. Test stand with artificial and natural defects

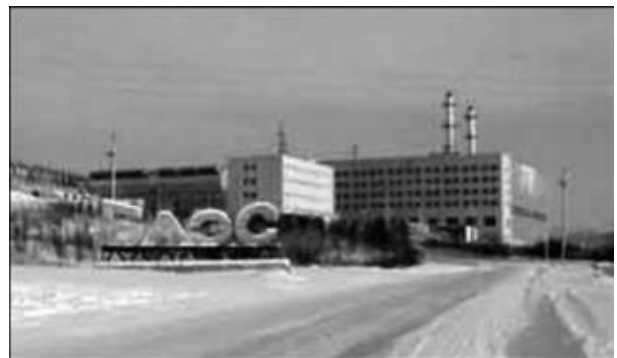
**Development of the technology of diagnostics and repair of NPP equipment using welding.** During the scheduled inspection of reactor 1 at Bilibinskaya NPP, Russia (Figure 4) defects were found in the

so-called biological shield, enclosed into external and internal steel shell.

Figure 4. Appearance of reactor 1 of Bilibinskaya NPP [2]

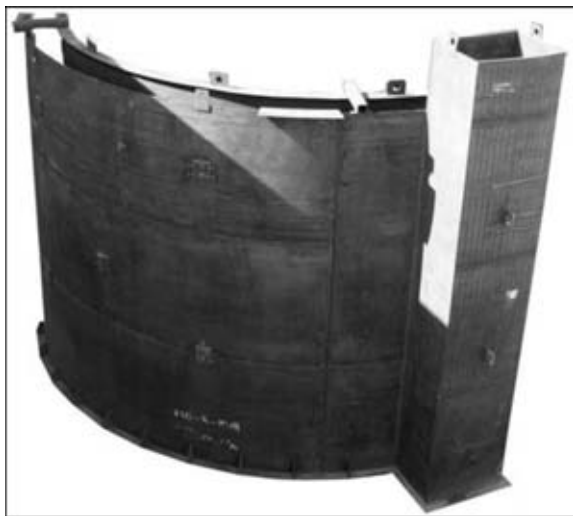
Full-scale test stands were manufactured for trial experiments, allowing retrofitting of individual work stages and determining all the needed control parameters (Figure 5).

Figure 5. Test stand from steel S 223 of 20 mm thickness

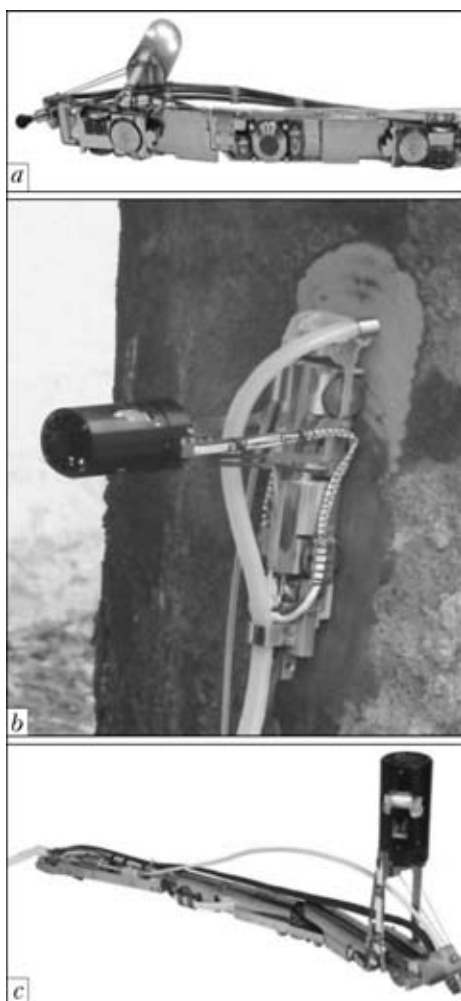
For the working zone a specialized remotely-controlled robot was designed (Figure 6), which carries

Figure 6. Appearance of robot with electromagneto-acoustic sensor (a), tool for abrasive cleaning (b) and welding torch (c)

the measuring and work tools. Robot, consisting of approximately 1000 individual parts, can move vertically or horizontally, recognize and overcome various obstacles, for instance, reinforcement in the wall.

After preparatory operations, concerning mainly, the sequence of repair performance, the system was applied for the first time at Bilibino. First the internal steel wall was examined. Analysis of the found defects showed certain deviations from values specified by the customer when defining the repair task. It was found that layers of up to 5 mm thickness came off as a result of corrosion, instead of maximum 2 mm. Distance from biological shield to reactor case is just 408 instead of 420 mm. Height of steps between individual sections of steel plates on the inner wall was 10 instead of 18 mm. In addition, tubes for thermocouples, not indicated in the documentation, were found in the robot lock zone. All the mentioned differences required mandatory adaptation of the used equipment. For this reason the robot, shown in Figure 6, b with a tool for abrasive cleaning, was additionally created. Speed of

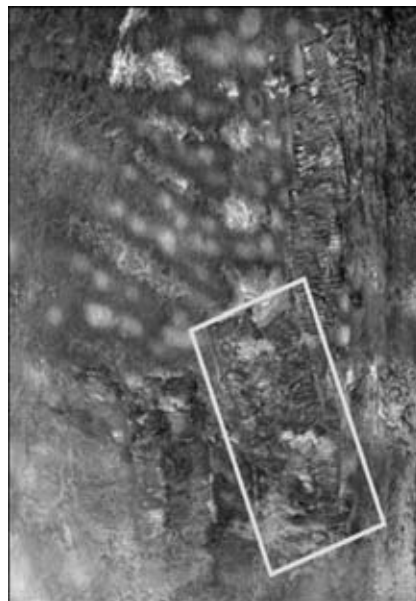
**Figure 9.** Defects eliminated by cladding on inner steel shell (marked section of the surface, where the network of cracks was rewelded, is shown in Figure 8)

Surfaces of the damaged area after welding, shown in Figure 9, were repaired by cladding.
