EXPERIENCE IN HARDFACING OF PROPELLER SHAFTS AT THE PJSC KHERSON SHIPYARD

The industrial experience in repair arc hardfacing of marine propeller shafts is described. Data on the upgraded hardfacing machine and on the peculiarities of selection of shafts with defects to repair them by the hardfacing technology are given.

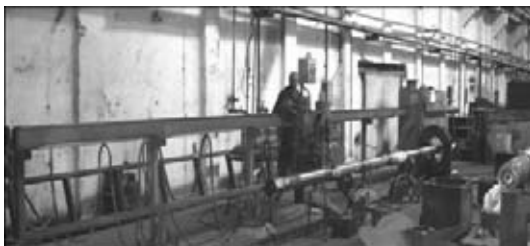
Figure 1. Hardfacing installation on the base of machine RM 461E

At the «Kherson Shipyard» to make hardfacing of propeller shafts of diameter up to 400 mm under flux the installation is applied, mounted on the base of the machine RM 461E for gas cutting of pipes with smooth control of speed of shaft rotation and dependent movement of electrode along the element of a shaft (Figure 1).

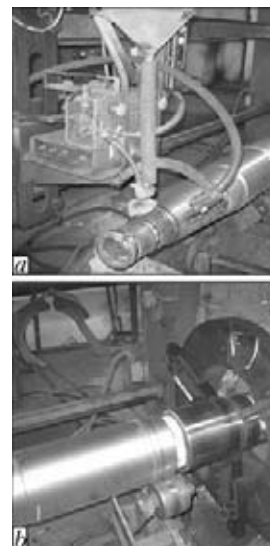
Figure 2. Hardfacing head of the installation (a) and shaft mounted in cartridge (b)

The installation is equipped with hardfacing head from feeding mechanism of the semi-automatic machine PDG 508M and flux hopper (Figure 2, a). In capacity of power source the rectifier VS 630 is used. The hardfacing of the first (experimental) propeller shafts was carried out according to the program approved by RMRS.

The shaft prepared to surfacing is installed on wheel carriages, inserted into the cartridge (see Figure 2, *a*) and slightly clamped and then adjusted according to the level. After verification the shaft is finally clamped.

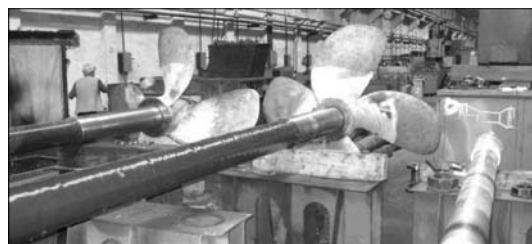
Figure 5. Propeller shaft as-assembled with screw

One of the deposited propeller shafts, as-assembled with a screw before mounting to the ship, is shown in Figure 5.
