RESTORATION SURFACING OF PARTS OF TITANIUM ALLOY VT22

The article gives the results of investigations of application of a flux-cored wire of PPT-22 grade as a filler material and magnetically-impelled arc in argon arc surfacing of worn-out parts of alloy VT22. It is shown, that in restoration of geometric sizes of worn-out surfaces using surfacing, the feasibility appears to control the shape of deposition and to produce the deposited metal with properties at the level of base metal after the standard heat treatment. 6 Ref., 1 Table, 10 Figures.

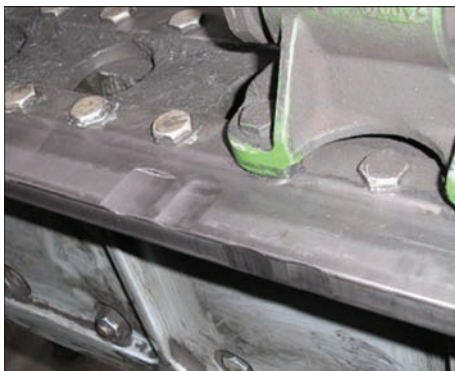
Figure 1. Working surface of rail with worn-out regions

One of the significant drawbacks of the most titanium alloys, in particular alloy VT22, is a low wear resistance. Therefore, during service of components and parts the defects of surface are occurred, caused by its wear. These defects are observed in some parts of present passenger and transport aircrafts, in particular in wing mechanization rails of aircraft «AN». Depth of worn-out regions reaches 2 mm (Figure 1). Due to occurrence of these defects it is necessary to replace the worn-out part by a new one, thus leading to large expenses for its manufacture.

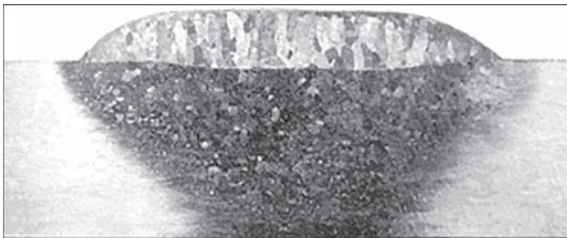
Figure 6. Macrosection of joint, deposited by a flux-cored wire PPT-22 on VT22 alloy plate in as-surfaced state

Surfacing with a filler flux-cored wire PPT-22. For making deposits the experimental filler flux-cored wire of PPT-22 grade was used as a filler material. Its design represents a tubular sheath of commercial titanium of VT1-00 grade. Inside the sheath there is a metallic core, consisting of granules of alloy VT22. Appearance of deposited metal is given in Figure 5, macrosection is shown in Figure 6. The made radiographic analysis of deposited specimens showed the absence of pores in them (Figure 7).
