REPAIR OF THE BODY OF CONNECTING ROD OF MOBILE JAW CRUSHER METSO LOKOTRACK LT 120

The paper describes the experience of repair welding of service defects in the body of the connecting rod of mobile jaw crusher Metso lokotrack LT 120, which is a rather rigid honeycomb structure from cast low-alloyed steel of 20GL type with thickness of external walls of 60 mm and of partitions of not less than 45 mm and more than 5 t weight. It was found that the most significant defects — fatigue cracks and cleavage which are incompatible with performance, naturally formed near the structural stress raisers, service damage, caused by contact impact of armour protection, casting defects, as well as in the sites of unsmooth connection of elements, etc. Crack opening displacement is equal to 2–3 mm that is indicative of the start of shape change of the body and need for prevention of further operation in such a state. Rigid structure of the connecting rod body and general state of destruction required special technology of repair welding, which was created and realized by the authors. It included new welding consumables, technological measures and engineering solutions and those verified by our own p

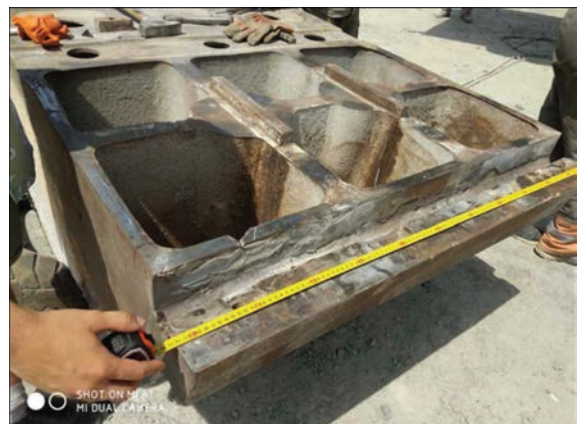
Figure 1. Design features of the connecting rod body

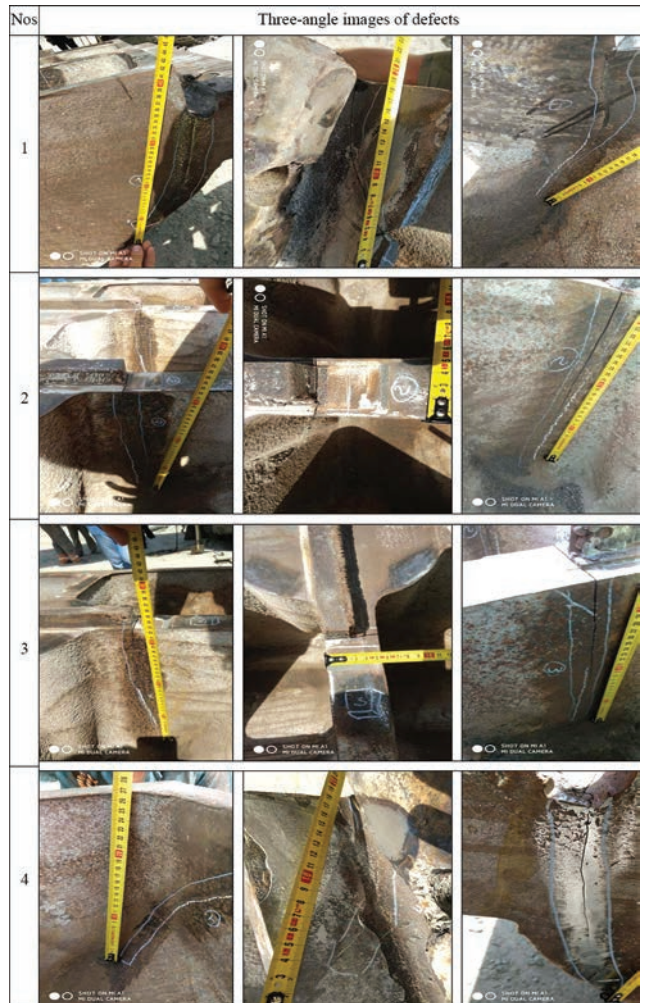
Photofixation of cracks Nos 1–4, incompatible with further performance of the rod, is given in Table 2.

Table 2. Location and parameters of defects (through-thickness cracks) Nos 1–4

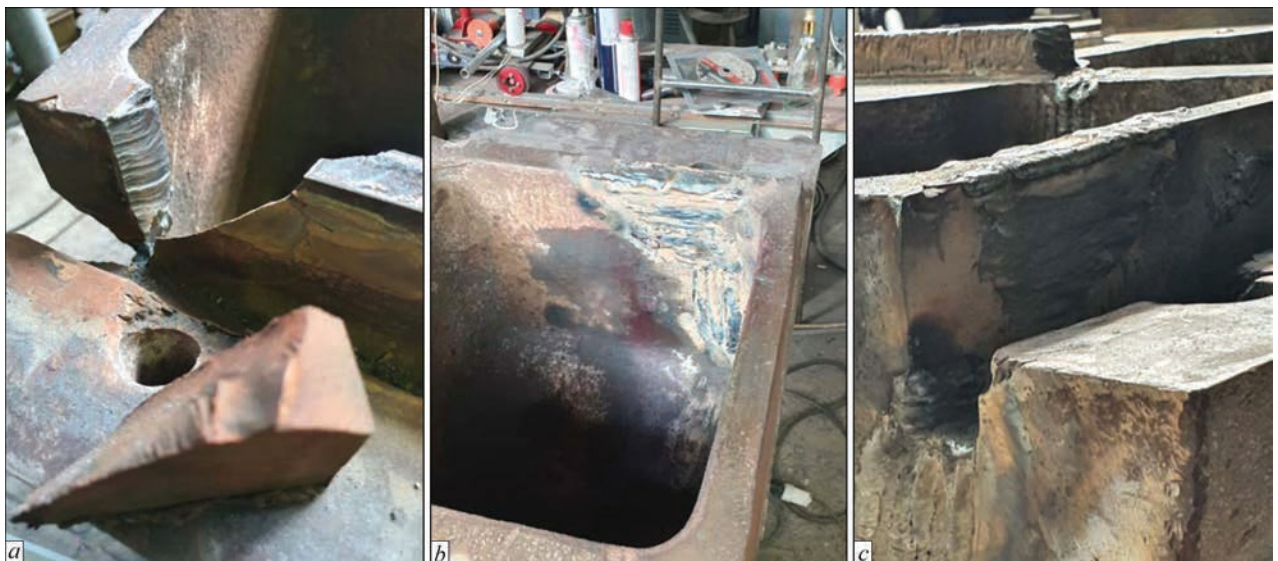
**Figure 4.** General view of the region of repair of crack No. 1 on the front wall (a), after thermal removal of a wall fragment (b), after welding (c) from the inside and outside, respectively

Repair of defects Nos 1–4 was performed after crack cutting out, edge facing with electrodes of Bohler FOX EV 50 grade with subsequent mechanized welding up of the groove, using Bohler DMO-IG wire according to the scheme, given in Figure 3. An example of the general view of the region of repair of crack No. 1 on the front wall is given in Figure 4, and that of the crack No. 2 — in Figure 5. When going over to welding of the weld outer side, the weld root cleaning must be performed. During welding mechanical peening of deposited metal layers by an impact tool was performed up to a change of the weld pattern, except for the first layer in the weld root and the facing layer. Weld interpass temperature was maintained in the range of 130–150 °C.

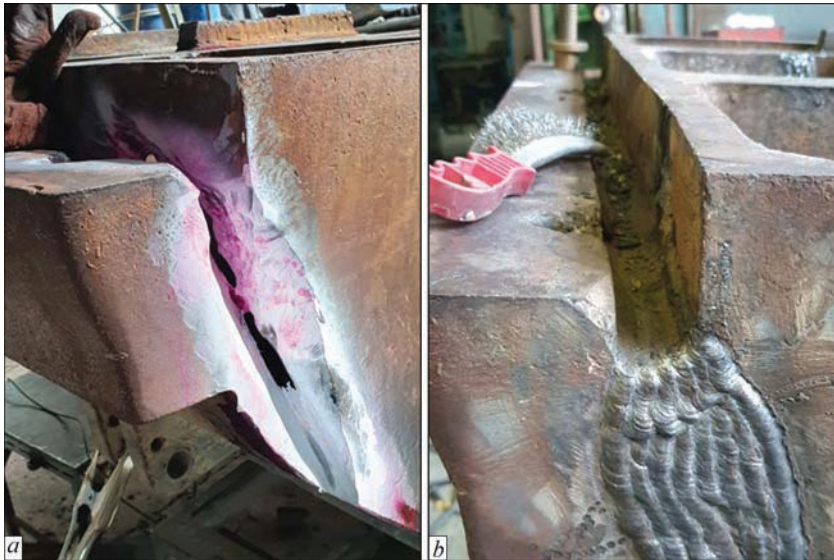
Figure 5. General view of repair of crack No. 2 on the front wall after mechanical edge preparation (a) and after welding (b)
