## APPLYING MODERN CONSTRUCTION 4.0 TECHNOLOGY TO DAMAGED BUILDINGS

**Abstract.** *The work purpose was to conduct a comparative analysis investigating the damage caused to a high-rise building (HRB) under dynamic impacts of two types: periodic industrial explosions at the iron ore quarry of «UGOK» mining and processing plant in Kryvyi Rih and a rocket strike on HRB in Kyiv on February 26, 2022. fib bulletin 59 was used as the basis. The study demonstrates how the life cycle curve of HRB transforms under periodic dynamic impacts and a one-time combat action influence compared to the standard fib bulletin 59 curve. The applied methods included visual and instrumental inspection of buildings using non-destructive testing methods, geodetic and vibration instruments with IoT for refining initial-boundary conditions during the creation of the HRB Construction 4.0 (Digital Twins). Therefore, its experimental verification was conducted. The calculation package LIRA-CAD was used for calculations. It can be noticed while comparing vibration displacement projections at identical points of buildings 6-A and 6-B. Under current conditions, the operational lifespan of 6-A decreases by approxima

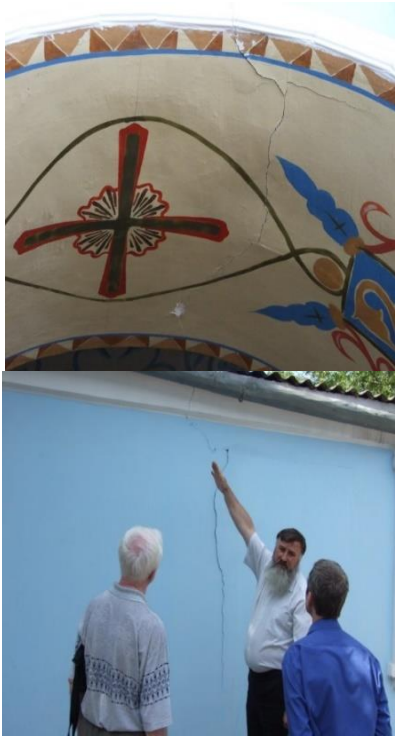
Fig. 2. Church's reaction to the explosion in the quarry. Top – cracks in the brick vault of the Church. Bottom – the priest pointing out vertical cracks on his house located within the Church's premises

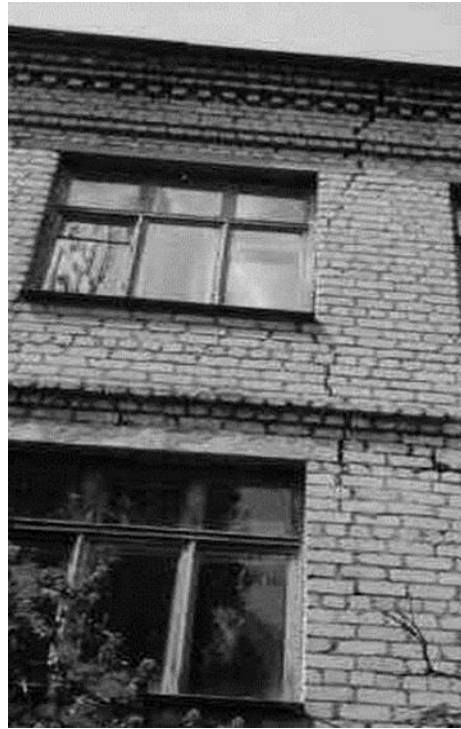
Fig. 3. Visual inspection of School No. 40 revealed cracks up to 0.05 m wide in external load-bearing walls. Crack gauges and vibration monitoring are required to assess seismic and explosion-related impacts

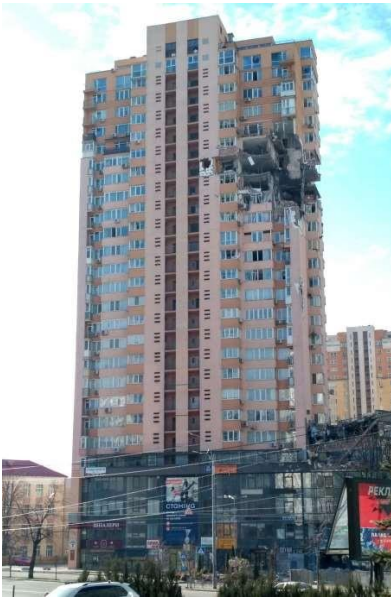
Fig. 6. General view of the building at 6A Lobanovsky Avenue after the rocket impact on April 26, 2022

The investigation was conducted on the high-rise building at 6-A Lobanovskyi Avenue in Kyiv, which suffered significant damage from a missile strike on February 26, 2022 (Figure 6, Figure 7).
