EVALUATION OF LOAD BEARING CAPACITY OF CYLINDRICAL SHELL OF ABOVE-GROUND VERTICAL STEEL WELDED TANK FOR OIL STORAGE AFTER REPAIR

A. Barvinko, Y. Barvinko, A. Yashnik, O. Kostenevich

E.O. Paton Electric Welding Institute of the NAS of Ukraine. 03150, Kyiv, 11 Kazymyr Malevych Str.
E-mail: tanksweld@gmail.com

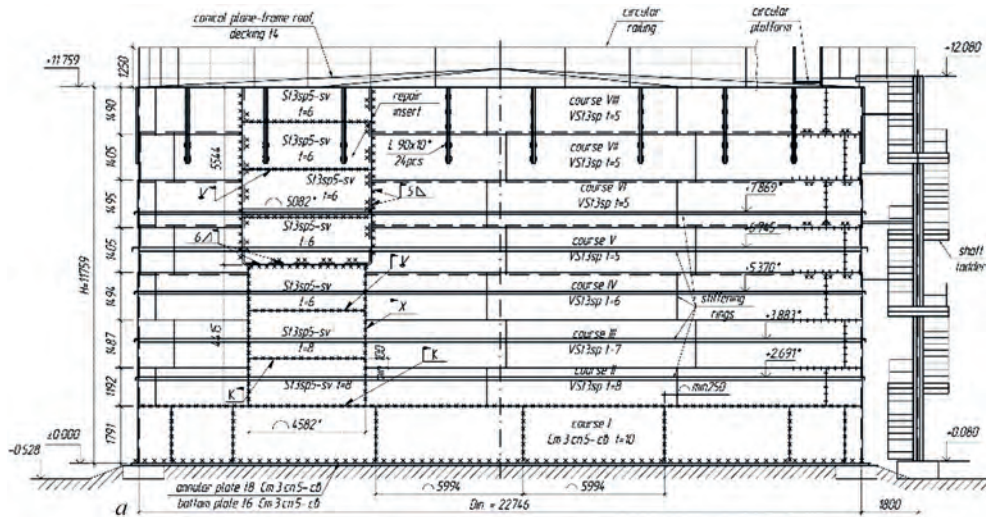
Fig. 1. Process of tank repair: *a* – design schema; *b* – shell after installation stiffening rings, tank is empty

For welding repair insert it was used the process 135 in the mix M21 with the solid electrode wire G3Si1. Vertical butt welds in insert had X-joint preparation, horizontal welds had X-joint preparation (see Fig. 1). Existing shell welds were welded with using process 121.

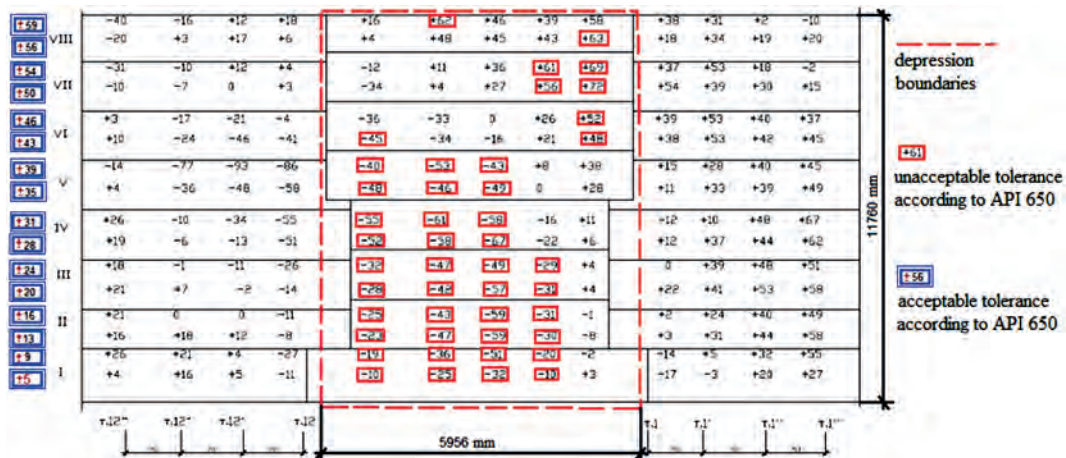
The depression was caused by insufficient transverse shrinkage compensation in vertical welded joints [14]. This required revising the oil filling height during further operation of the tank.

A deviation from the vertical weld technology caused the repair insert to deform, which created a depression taking up the full height of the shell characterized by unacceptable [6] vertical deviations (Fig. 2). Estimation of the geometric shape of the deformed shell (local deviations) using a template (straightedge) showed that it met the standard requirements [5, 6].

Fig. 2. Size of depression and out-of-plumbness values for tank with installed stiffening rings, «+» outside of tank, «-» inside of tank

In order to reduce the initial deviations from the design geometry, the tank shell was reinforced with four L-shaped stiffening rings (L100×8 mm, L125×8 mm) installed at the marks +2.691 m, +3.883 m, +5.370 m, and +7.869 mm during the filling of the tank. The stiffening rings strengthened the structure, allowing for the general stability of the tank shell. Fig. 2 presents the out-of-plumbness values for the empty tank after the hydrostatic test has been completed and the stiffening rings fixed to the shell.

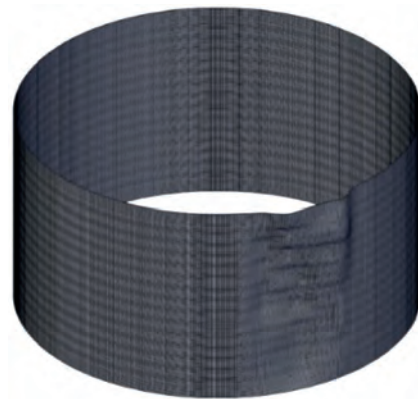
Analytical description of the imperfections in the shell geometry was performed using third order approximation curves according to the study by A.A. Krysko [18]. Fig. 3 shows the results of computer simulation of the tank shell with the depression (the surface imperfections are 10 times magnified for illustrative purposes). The junction between the depression and the cylindrical shell was described by a sinusoidal curve.

Fig. 3. Tank shell geometry obtained using third order approximation curves [18]. Magnification ×10

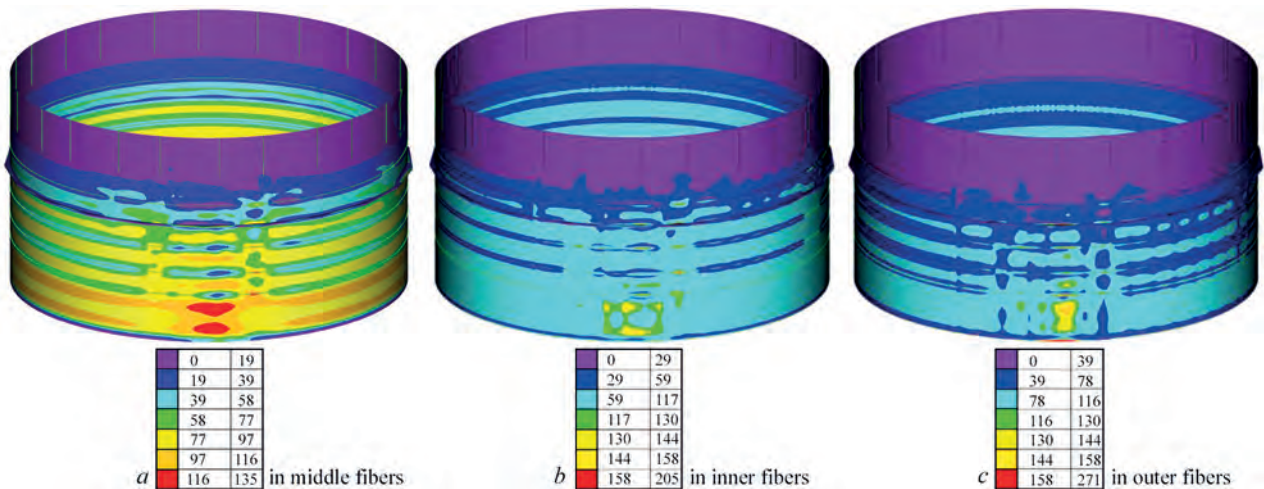
The analysis of the nonlinear calculation results (Fig. 4, *a–c*, Table 1) shows that deviations from the design geometry cause additional stresses in the outer/inner fibers of the deformed area of the shell.

The highest equivalent stresses in the middle fibers of the shell (equivalent membrane stresses) were observed for the 1st and 2nd courses: $\sigma_{eq,\,m}$ = 120 MPa (H_f = 9 m) and $\sigma_{eq,\,m}$ = 135 MPa (H_f = 10 m), the equivalent stresses in the outer fibers were σ_{eq} = 143 MPa (H_f = 9 m) and σ_{eq} = 158 MPa (H_f = 10 m).

The analysis of the data from Table 1 shows that when the filling height is increased to the design value H_f = 10 m, the strength condition [6] in the first and second courses is not met (Table 1). Additional

bending stresses in the shell cause the design equivalent stresses σ_{eq} to increase by 10% relative to the allowable values σ_{all}.

Fig. 4. Equivalent (von Mises) stress σ_{eq}, MPa in shell with rectangular depression formed after repair welding

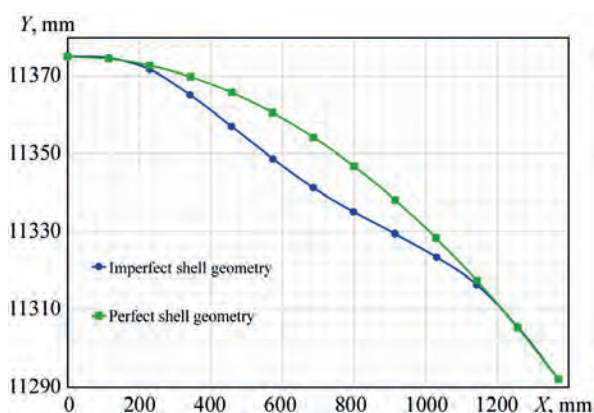
Let us consider the stress state of the local deviation from the ideal cylindrical shape on the example of an isolated rectangular depression with a length of 914 mm in the circumferential direction and a maximum depth of 13 mm (Fig. 5, 6), which spreads along the entire tank shell height and is considered allowable as per API 650 [6]. The results of nonlinear calculation of equivalent stress fields according to the von Mises theory in the middle, inner and outer fibers of the tank shell with an isolated 13 mm deep depres-

Fig. 5. Approximation of geometric shape rectangular depression with 914 mm wide in tank shell

The analysis of the obtained data (Fig. 6, Table 2) shows that, although the 914 mm wide and 13 mm deep depression is deemed acceptable according to the API 650 [6] standard, the cylindrical tank shell with such a deformation, besides the circumferential membrane stresses, also develops sufficiently large additional bending stresses (40...50% of σ_{eq}) in the inner and outer fibers. This means that the presence of such depression does not allow meeting the strength condition for the shell as per the standards [5, 6] (Table 2).

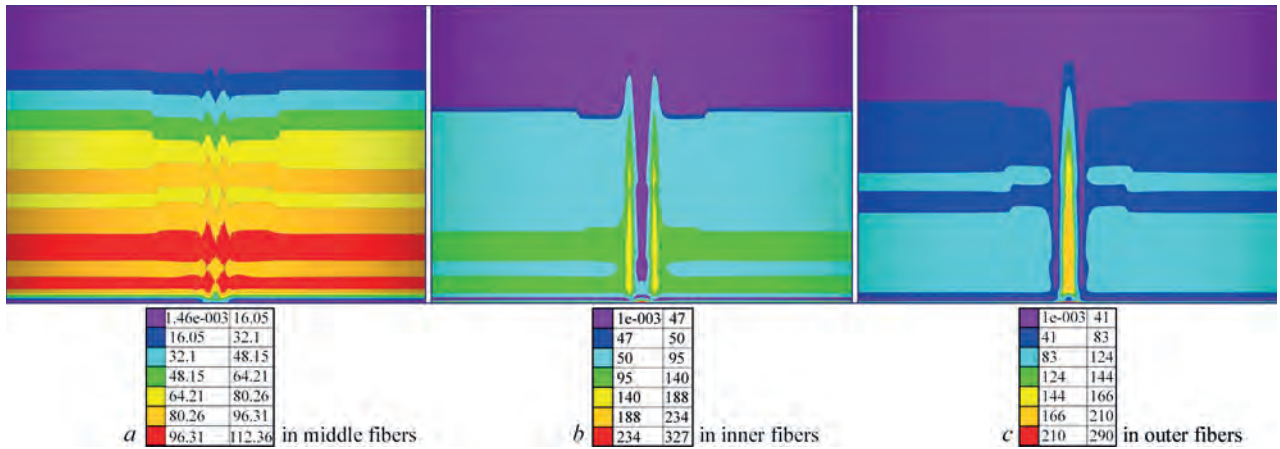
Fig. 6. Equivalent (von Mises) stress σ_{eq}, MPa, in shell with rectangular depression with 914 mm wide

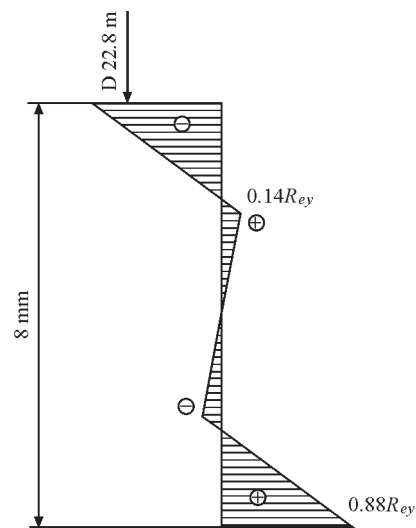
Fig. 7. Residual stresses in the lower course of the tank with a volume of 5000 cub. m (D = 22.8 m, H = 12.0 m) when constructed by rolling method [19]. Material of shell is non-alloy structural steel VSt3sp, with min yield strength R_{ey} = 210 MPa (analog of S235 steel). «+» stretched fiber, «-» compressed fiber

the destruction of the tank. A similar situation occurs with tanks constructed from coiled sheets. Here, along with the circumferential stresses, the shell also exhibits residual bending stresses from folding and unfolding of the roll [19] (Fig. 7). In such a case, the residual bending stress can reach the yield strength of steel.
