DETERMINATION OF THE CAUSES FOR CRACK INITIATION IN STRUCTURAL ELEMENTS OF THE TOWER OF NEW VENTILATION PIPE AT CHERNOBYL NPP

V.M. TOROP¹, E.F. GARF¹, A.V. YAKIMKIN¹ and E.E. GOPKALO²

¹E.O. Paton Electric Welding Institute, NASU

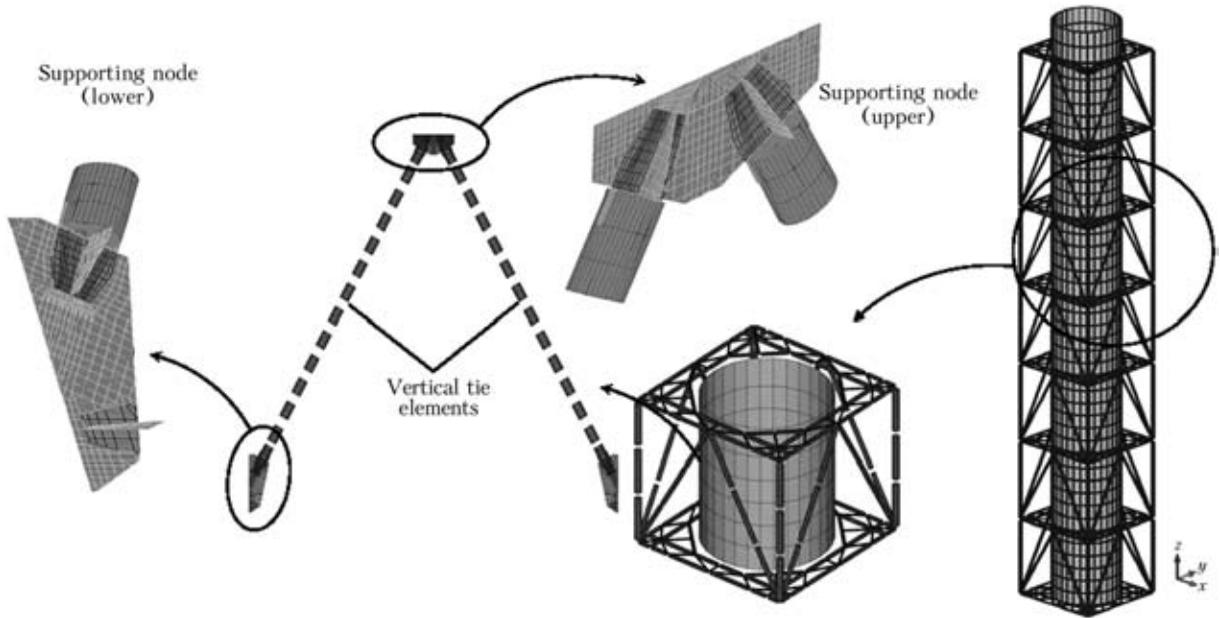
Figure 12. NVP FEM models

As a result of calculation of shell-rod 3D FEM models (Figure 12) forms and periods of system natural vibrations were determined.

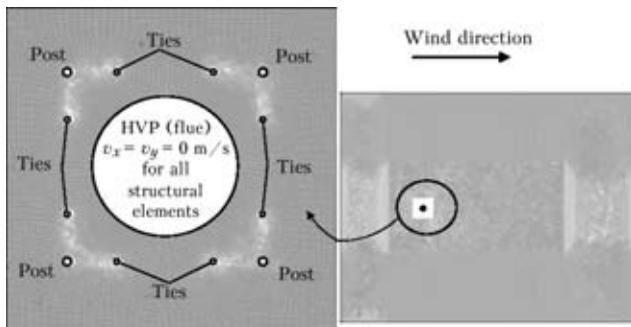
Figure 14. Aerodynamic model: general view, loads and boundary conditions ($v_x = 12$, $v_y = 0$ m/s, $P = 0$ Pa)

Using the value of critical velocity $v_{cr} = 12 \text{ m/s}$ of wind flow as initial data, the aerodynamic model (Figure 14) was applied to determine the nature of distribution of wind flow and pressure over the surface of NVP structural elements.

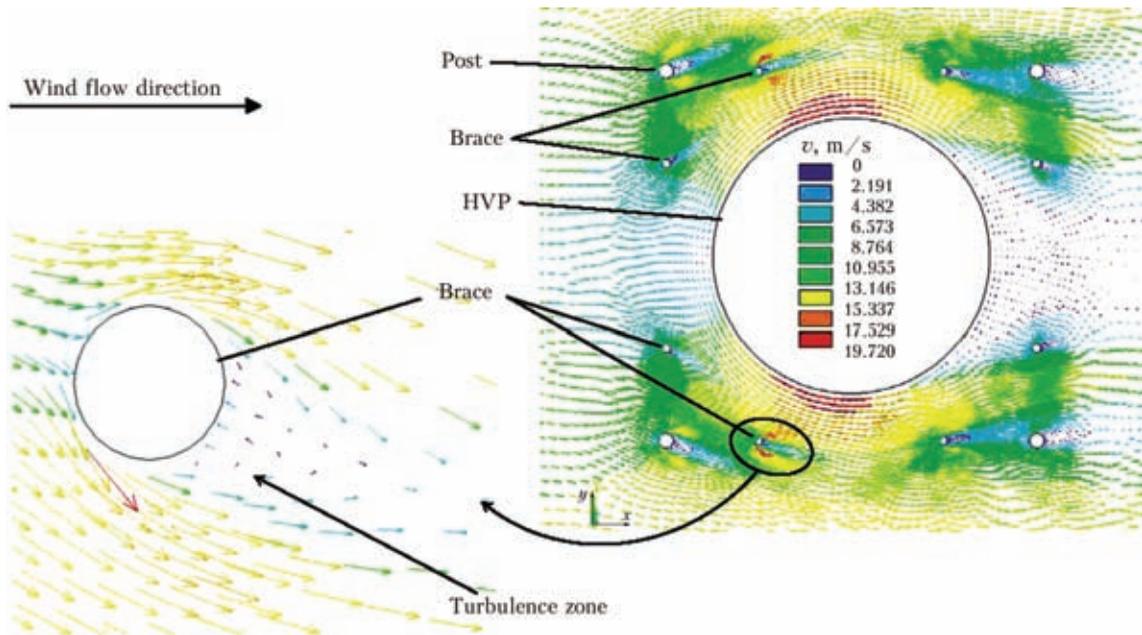
Figure 15. Direction of wind flow velocity vectors

tower flue and elements of vertical ties. Increase of wind flow velocity along the flue side surface (Figure 15) leads to the braces located in this zone becoming exposed to higher magnitudes of wind pressure (Figure 16).

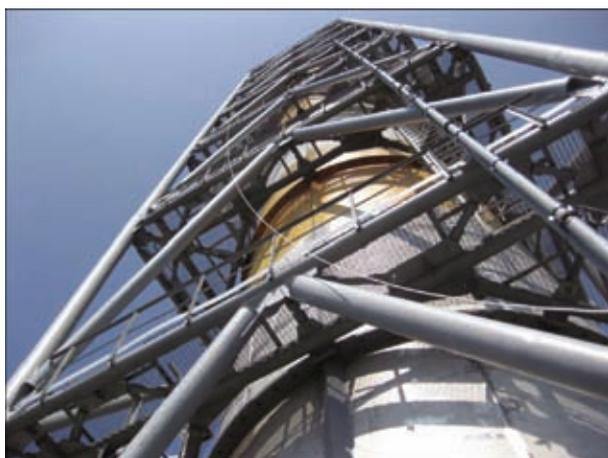
Figure 19. General view of NVP tower structure

Analyzing the causes for crack initiation in the nodes of NVP tower, we cannot avoid assessment of the taken design solutions. The load-carrying frame of NVP tower is made of cylindrical pipes (Figure 19).
