RESTORATION REPAIR OF ELEMENTS AND UNITS OF GAS TURBINE ENGINES

V.M. NESTERENKOV¹, Yu.V. ORSA¹, K.S. KHRIPKO¹ and Yu.V. GUSEV²

¹E.O. Paton Electric Welding Institute of the NAS of Ukraine

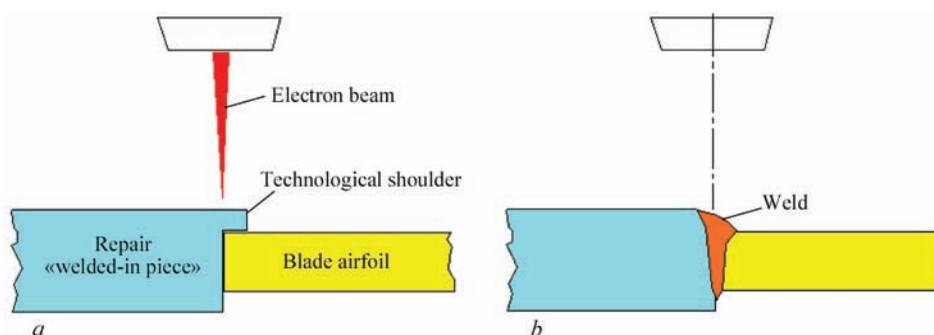
Figure 1. Scheme of repair EBW-joint of «welded-in piece» and blade airfoil: *a* — before welding; *b* — after

The following scheme of repair «welded-in piece» and blade airfoil welded joints was developed. It in principle does not depend on the fact whether it is spot or extended defects (Figure 1).

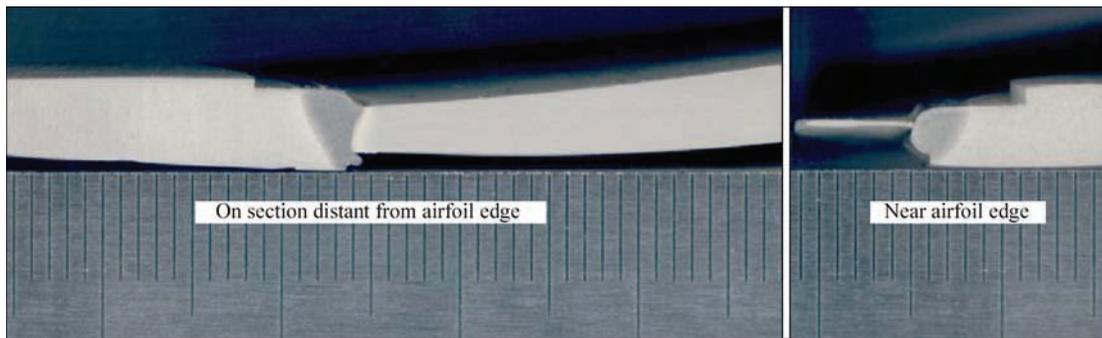
Figure 2. Macrosections of repair EBW-joint of «welded-in piece» and blade airfoil

reached in the areas with sufficiently larger airfoil thickness as well as in the thinnest places adjacent to the edge (Figure 2).

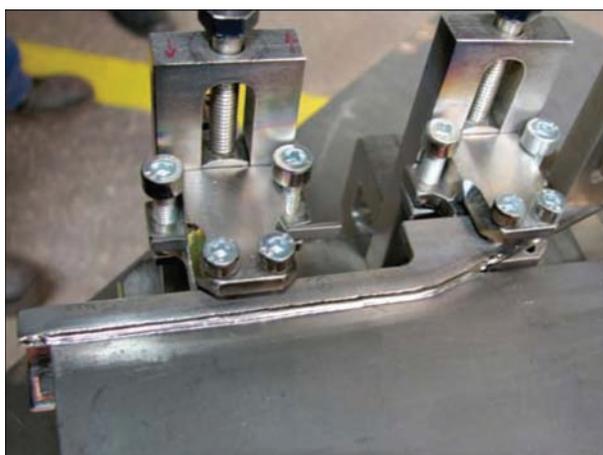
Respectively, uniform pressing of such «welded-in pieces» along the whole length of curved joint with the airfoil requires other more complex assembly-welding fixture (Figure 6).

Figure 6. EBW joint of blade airfoil with extended repair «welded-in piece» in assembly-welding fixture

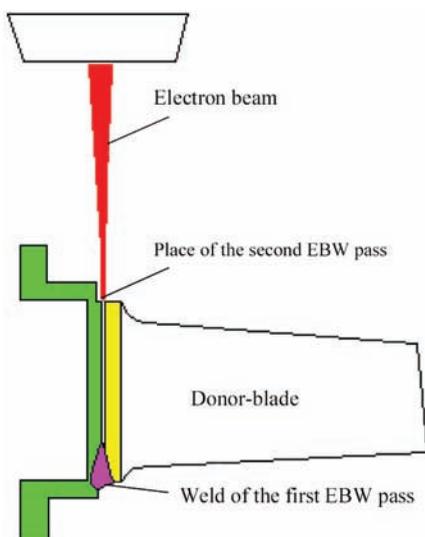
The next scheme of welded joint of donor-blade and wall of semi-ring guide case was developed (Figure 10). Joining of the blade with wall is carried out using double-side EBW with intermediate turning of the product by 180°. Structural strength of two similar welds is enough for reliable fixing of the blade, which is not inferior to brazed ones.

Figure 10. Scheme of double-side EBW of donor-blade with wall of guide case semi-ring

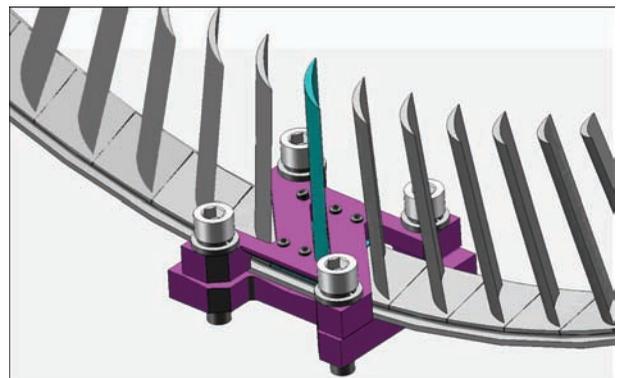
Taking into account that this is a stator (i.e. immovable) part of the engine, it is not necessary to use extremely high requirements to geometry accuracy of donor-blade setting. Therefore, it is no need in very complex assembly-welding fixture that is usually the most expensive part when using EBW. Developed laboratory fixture (Figure 11) provided sufficiently accurate regulation of spatial orientation of the donor-blade and its reliable fixing in further welding. Later on the Customer got the design documentation for commercial variant of such a fixture for repair of the semi-rings of guide case installed on EBW machine of KL-188 type.

Figure 11. Model of assembly-welding fixture for EBW of cantilever donor-blade with guide case semi-ring
