# EVALUATION OF DAMAGE OF ALL-WELDED LONGITUDINAL MAIN BEAMS OF THE E.O. PATON BRIDGE ACROSS THE DNIPRO RIVER

The problem of general evaluation of technical condition of main longitudinal beams of the E.O. Paton Bridge was considered based on the results of selective non-destructive testing of truss elements. It is shown that the main cause of damage to the elements of the main beams is corrosion of the nodal welded joints in the places of debris accumulation. High quality of welded butt joints made by automatic and semi-automatic submerged arc welding was noted. 10 Ref., 18 Figures.

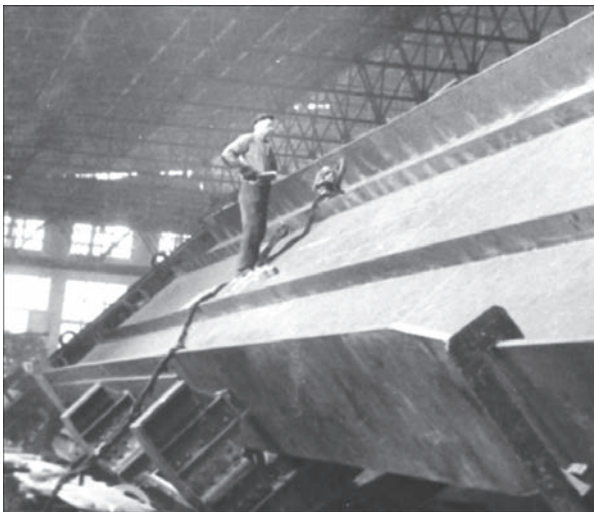
**Figure 1.** Welding of longitudinal stiffeners and girth welds of the truss [3]

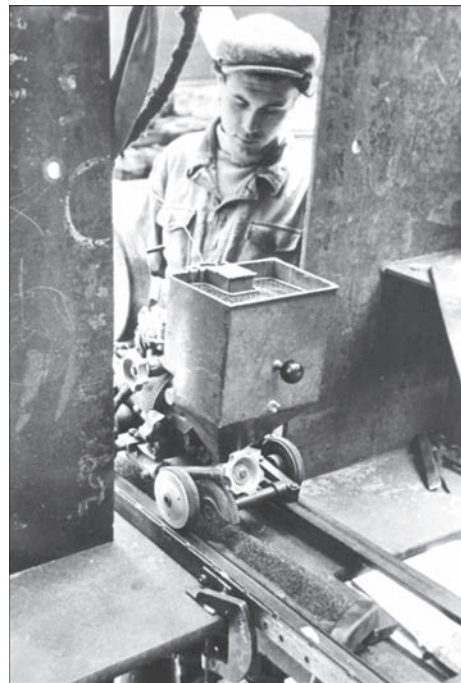
**Figure 2.** Example of applying automatic submerged arc welding of the lower girth while joining trusses of the main beams [4]

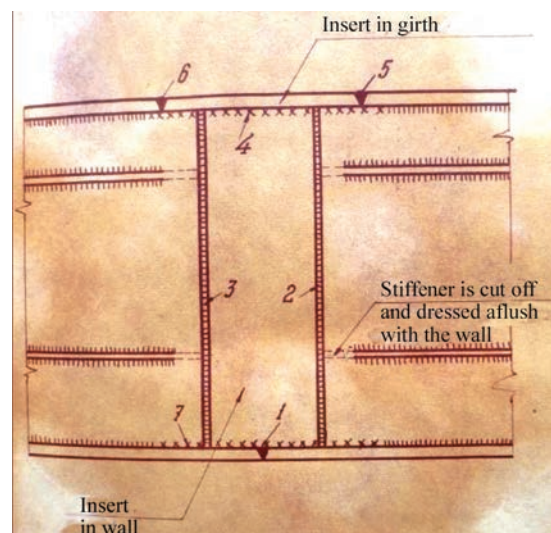
- development of a special design of the erection joint of trusses with an insert in a vertical wall and an upper flange and a sequence of their joints by means of automatic submerged welding of girths with extension of a weld on additional laths (Figures 2, 3).

**Figure 3.** Order of erection assembly and welding of typical bridge trusses [4]

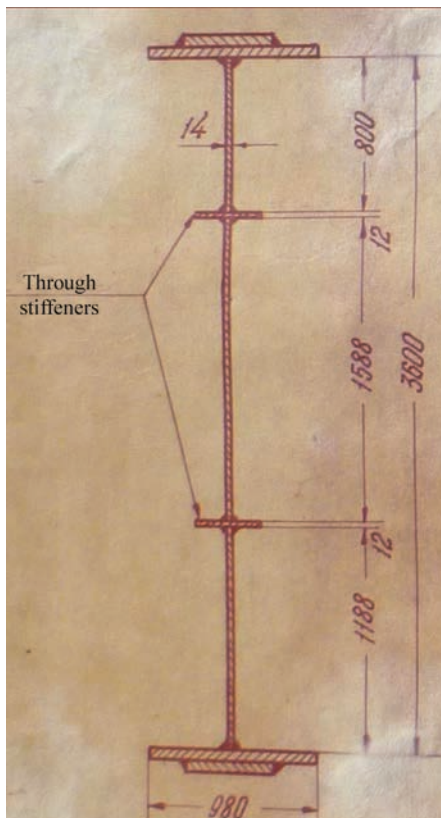
**Figure 4.** Cross-section of the truss of the main longitudinal beams of four- and five-span structures of the bridge [4]

to 80 mm, with a width of up to 1000 mm (Figure 4). The stability of the beam wall is additionally provided by vertical stiffeners mounted with a step of 7.25 m.

When designing horizontal stiffeners, their welding-on to the vertical wall of the truss without a full penetration was provided (Figure 4), which significantly reduced the residual stresses over the thickness of the metal and, as a result, considerably lowered the risk of propagating this defect.
