POWER CABLE DEFECTS AND THEIR INFLUENCE ON ELECTRIC FIELD DISTRIBUTION IN POLYETHYLENE INSULATION

Kucheriava I.M.

**Institute of Electrodynamics, National Academy of Sciences of Ukraine,
pr. Peremohy, 56, Kyiv, 03057, Ukraine. E-mail: rb.irinan@gmail.com**

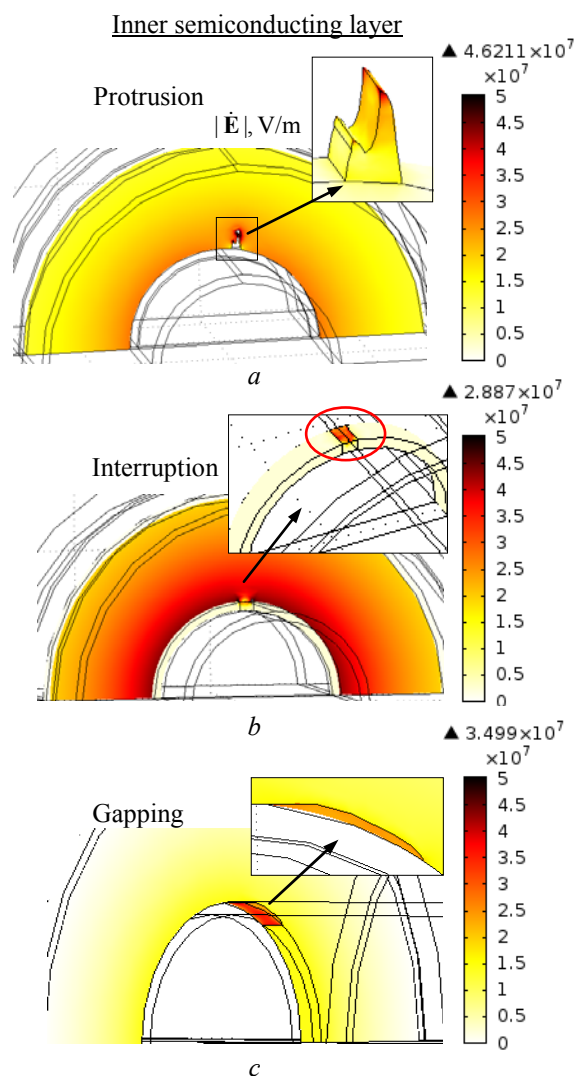
Fig. 4

The protrusion of the inner semiconducting layer into the insulation (fig. 4, *a*), interruption of the layer (fig. 4, *b*) and its air gapping (fig. 4, *c*) are dangerous in the context of increased electric intensity (as compared to fig. 2, *c*). As shown, such defects contribute to the reduction of dielectric strength of the insulating material. The peak value of electric field takes place at the sharp tip of the protrusion (fig. 4, *a*). This is a weak area of the insulation close by the cable conductor.
